AIRPROX REPORT No 2021159

Date: 24 Aug 2021 Time: 1320Z Position: 5134N 00017E Location: Upminster

PART A: SUMMARY OF INFORMATION REPORTED TO UKAB

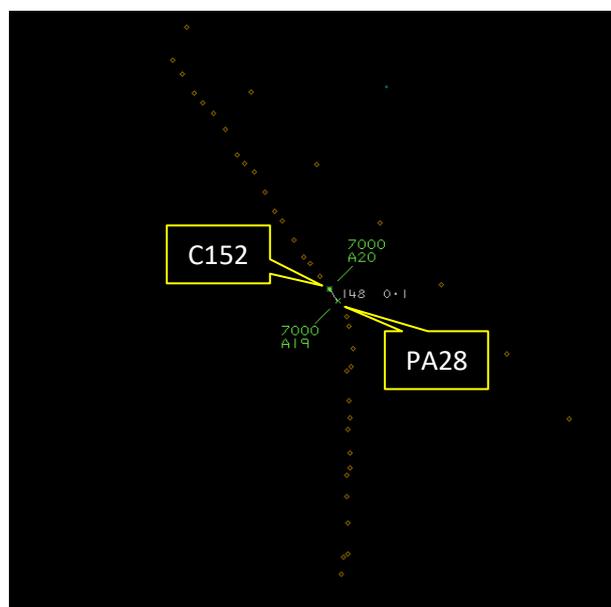
Figure 1 – 1319:48 – radar CPA

An analysis of the NATS radar replay was conducted. Both aircraft were detected by the NATS radars; the PA28 was tracking northbound at a consistent altitude of 1900ft and the C152 was tracking south-eastbound at 1900ft initially, climbing to 2000ft approximately 30sec prior to CPA. At 1319:40 (approximately 10sec prior to CPA) the PA28 pilot initiated a slight left turn, which altered the geometry between the 2 aircraft from converging to head-on. Radar CPA occurred at 1319:48 with a recorded separation of 100ft vertically and 0.1NM horizontally. However, there was no track deviation detected from either aircraft after radar CPA (see Figure 2) and so actual CPA is assessed to have occurred between radar sweeps and is therefore estimated to be <0.1NM horizontally and 100ft vertically.
