**AIRPROX REPORT No 2021040**

Date: 25 Apr 2021 Time: 1156Z Position: 5631N 00243W Location: Carnoustie

**PART A: SUMMARY OF INFORMATION REPORTED TO UKAB**

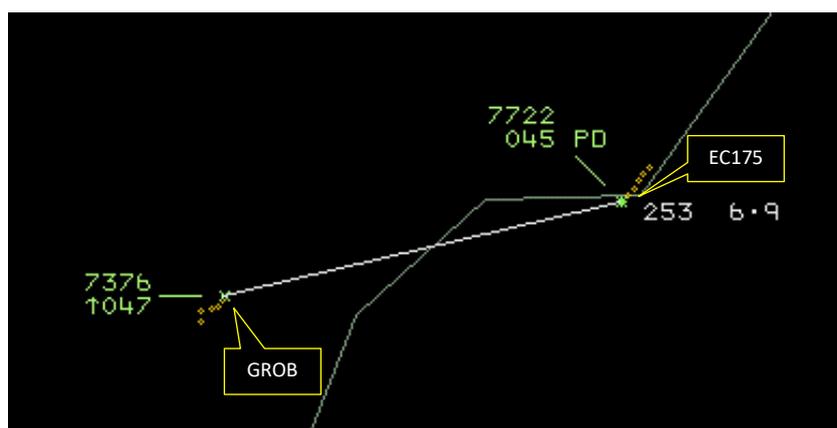
Figure 1 – 1154:00

At **1154:00** the EC175 pilot made initial contact with the Dundee Approach controller. The controller advised that information Lima was current, the QNH was 1032 and that RW09 was in use. The pilot was instructed to squawk 7374. The pilot provided a full and accurate readback. The pilot advised that they were currently 3 miles north of Arbroath, passing 4400ft climbing to altitude 5000ft, on QNH1032, and requested an RNP Approach to RW09. The controller asked what type of service was required. A Procedural Service was agreed. The controller asked the pilot which initial approach fix they wished to route to, and the pilot responded with MARIV. The controller asked, "*roger do you wish to route there direct from your current position*". The pilot responded, "*actually can we make that to IVGEX... and affirm*". The controller responded, "*roger, and report your distance to run to IVGEX*". The pilot told the controller to standby and, after a few seconds, advised that they had 28 miles to run to IVGEX. The controller responded, "*roger climb and maintain altitude 5000ft and report when you've got one zero nautical miles to run to IVGEX*". The pilot read back, "*maintain altitude 5000ft, QNH 1032, routing IVGEX and wilco 10 miles to run*" (Figure 1).

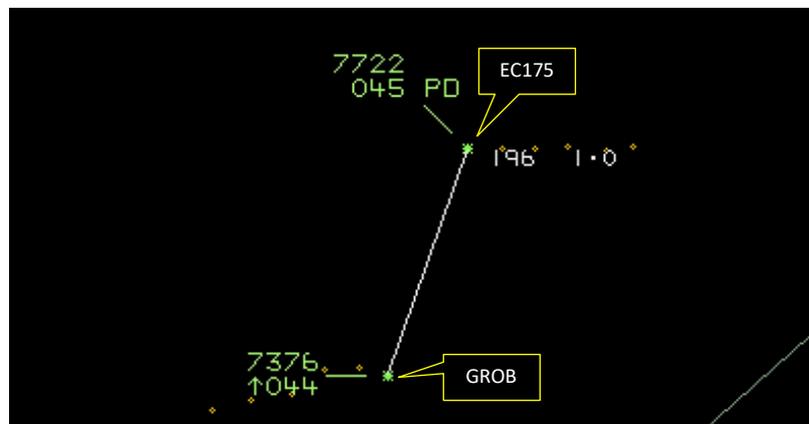
Figure 4 – 1156:20 - CPA

At **1156:20** CPA occurred, with the aircraft separated by 1.0NM laterally and 100ft vertically, with the Grob displaying a climb arrow (Figure 4).
