AIRPROX REPORT No 2019201

Date: 21 Jul 2019 Time: 1029Z Position: 5225N 00001W Location: 5NM SW Chatteris

PART A: SUMMARY OF INFORMATION REPORTED TO UKAB

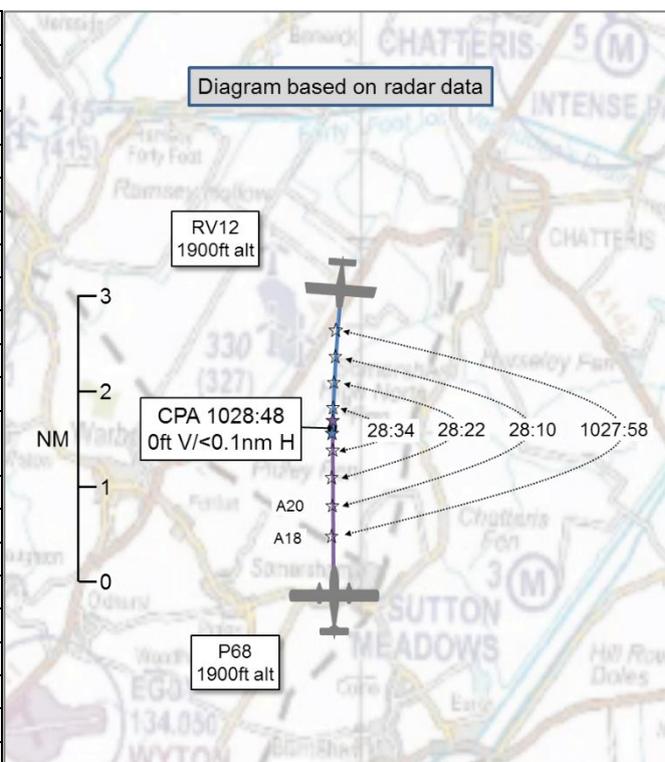
Recorded	Aircraft 1	Aircraft 2
Aircraft	RV12	P68
Operator	Civ FW	Civ Comm
Airspace	London FIR	London FIR
Class	G	G
Rules	VFR	VFR
Service	Listening Out	Basic
Provider	(Stansted)	London Info
Altitude/FL	1900ft	1900ft
Transponder	A, C, S	A, C, S
Reported		
Colours	White, blue	White, blue
Lighting	Strobe, flashing landing light, nav	Nav, beacon
Conditions	VMC	VMC
Visibility	>10km	>30km
Altitude/FL	1800ft	1800ft
Altimeter	QNH (1020hPa)	QNH (1019hPa)
Heading	182°	358°
Speed	100kt	120kt
ACAS/TAS	TAS	Not fitted
Alert	None	N/A
Separation		
Reported	50ft V/0m H	20ft V/0m H
Recorded	0ft V/<0.1NM H

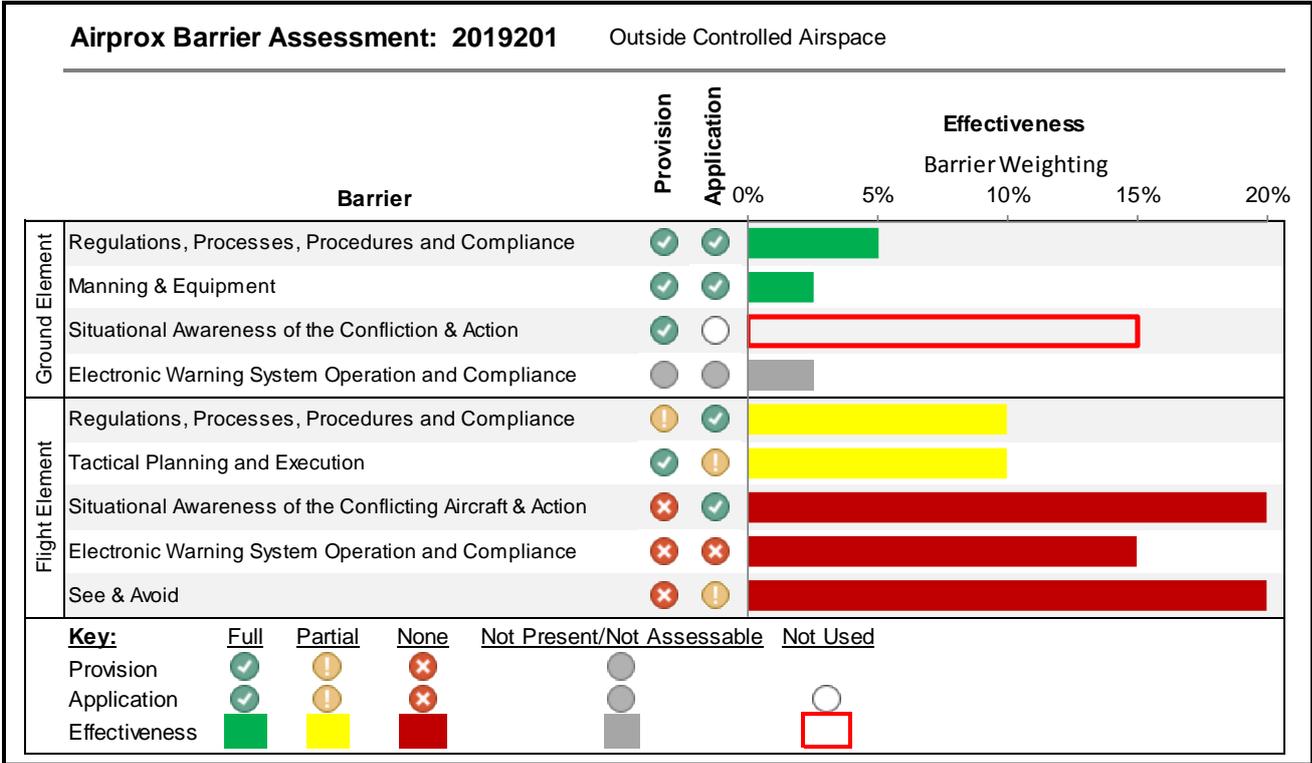
In assessing the effectiveness of the safety barriers associated with this incident, the Board concluded that the key factors had been that:

Ground Elements:

Situational Awareness of the Confliction and Action were assessed as **not used** because neither pilot was in receipt of a service that required controller monitoring and action.

Flight Elements:

Regulations, Processes, Procedures and Compliance were assessed as **partially effective** because the company operations manual did not sufficiently mitigate the MAC risk whilst conducting single-pilot survey operations.

Tactical Planning and Execution was assessed as **partially effective** because the RV12 pilot opted not to obtain a FIS (albeit LARS availability was reduced at the weekend).

Situational Awareness of the Conflicting Aircraft and Action were assessed as **ineffective** because neither pilot was aware of the other aircraft's proximity until at a very late stage.

Electronic Warning System Operation and Compliance were assessed as **ineffective** because the P68 was not fitted with a TAS and the RV12 TAS did not alert on the P68.

See and Avoid were assessed as **ineffective** because the P68 pilot did not see the RV12 until at about CPA and the RV12 pilot did not see the P68 until very shortly before CPA.
