## **AIRPROX REPORT No 2019293**

Date: 02 Oct 2019 Time: 1532Z Position: 5147N 00219W Location: 8nm SW Gloucester

### **PART A: SUMMARY OF INFORMATION REPORTED TO UKAB**

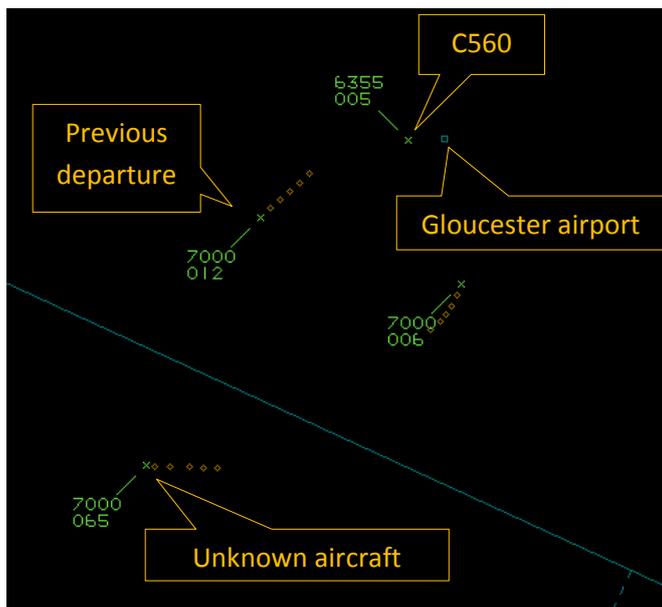
Figure 1 - 1529:37

An Airprox was reported by the pilot of a C560 against an unknown aircraft whilst in the climb to FL70 having departed Gloucester-Staverton, en-route to Bristol. The C560 was first observed on the radar replay at 1529:37 (Figure 1). The unknown aircraft had been manoeuvring in an area

approximately 7nm to the south of Gloucester for a sustained period prior to this. It appeared to be carrying out manoeuvres consistent with aerobatics. Aircraft levels were reported as Flight Levels on the radar replay.

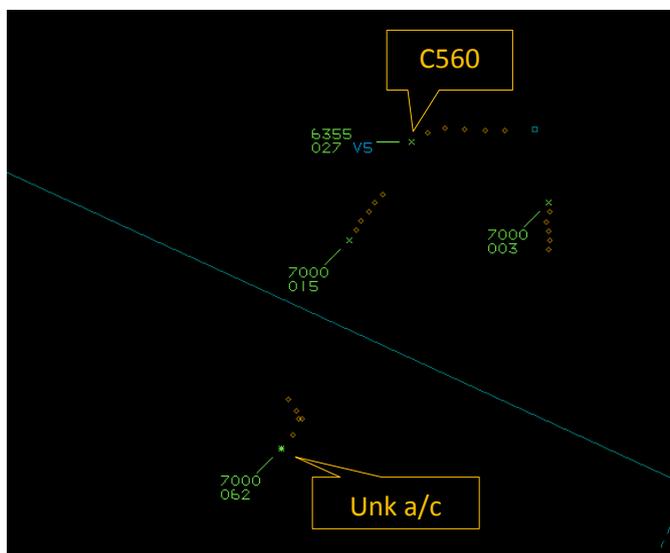
Figure 2 - 1530:20

The C560 had departed on a clearance from the Gloucester Tower controller on track to a reporting point 19.7nm to the south-west of the airfield, climbing to an altitude of 3000ft. At 1530:15 the pilot made their first call to the Gloucester Approach controller. They were advised that it was a Procedural Service and, at 1530:20, were cleared to climb to FL70, but instructed to remain clear of controlled airspace (Figure 2).

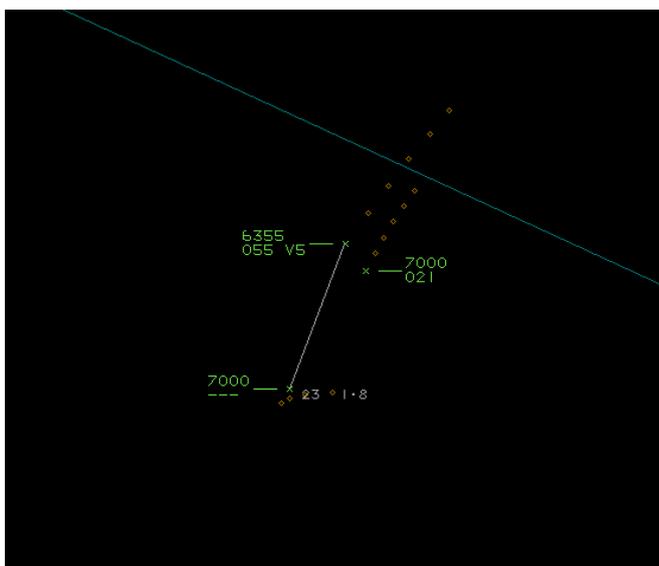
Figure 4 - 1532:00

At 1532:00 (Figure 4), the approach controller instructed the C560 pilot to contact Bristol Radar. However, the pilot had to ask twice for the frequency, and did not acknowledge the last call by the controller.

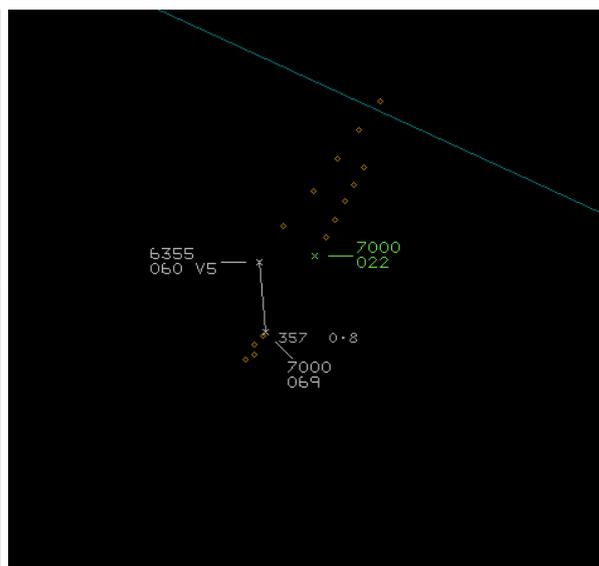
Figure 5 - 1532:18

CPA took place at 1532:23 (Figure 6), with the aircraft separated by 0.5nm laterally. The radar-reported level of the unknown aircraft was only available intermittently on the radar replay, likely due to the rapid changes in level during its manoeuvres, but had been observed to be FL69 at 1532:18 (Figure 5 above), but then FL60 at 1532:31 (Figure 7).
