AIRPROX REPORT No 2011083

PART A: SUMMARY OF INFORMATION REPORTED TO UKAB

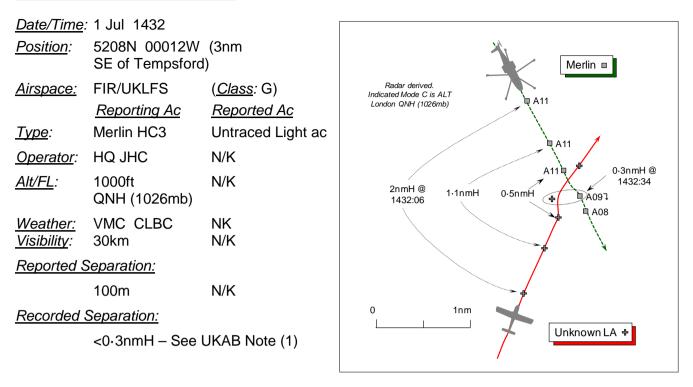
UKAB Note (1): The Stansted Radar recording shows the Merlin helicopter maintaining a steady course in a level cruise indicating 1100ft London QNH (1026mb). The untraced LA is shown as a primary contact only, maintaining a steady NE'ly track for some miles as the two ac close on a steady relative bearing to one another. The relative geometry remains unchanged until 1432:34, when the LA's primary contact swerves to the L and thence astern of the Merlin, which simultaneously descends 200ft, before levelling on the next sweep at 800ft London QNH. The minimum horizontal separation evinced by the radar recording of 0.3nm (556m) is significantly more than the 100m reported by the Merlin pilot, which might have been caused by plot extracted 'track jitter' at these low altitudes.
