AIRPROX REPORT No 2022063

Date: 30 Apr 2022 Time: 1419Z Position: 5347N 00111W Location: Sherburn-in-Elmet ATZ

PART A: SUMMARY OF INFORMATION REPORTED TO UKAB

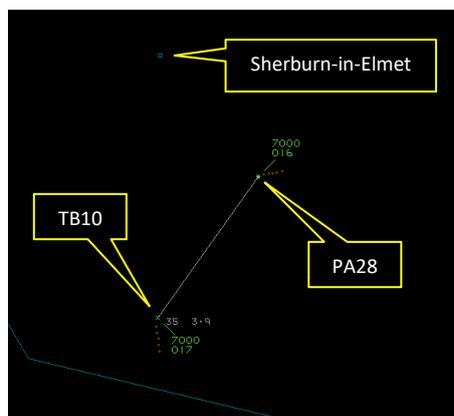
Figure 1 – 1417:15.

At 1417:15, the PA28 was 3.5NM to the southeast of the airfield at an altitude of 2000ft. There was an aircraft approximately 4NM to the southwest of the PA28, also at 2000ft, which was identified as the TB10, (Figure 1).

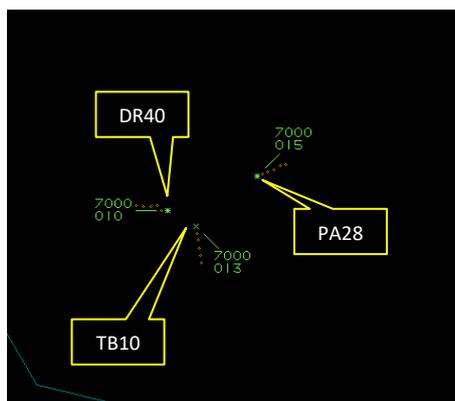
Figure 2 – 1418:11.

The DR40 was first detected by the NATS radars at 1417:22 in the climb. At 1418:11, the TB10 was to the southeast of the DR40, 300ft above it, (Figure 2). At this time, the PA28 pilot was in a slow descent. The TB10 crossed in front of the DR40 at 1418:19.

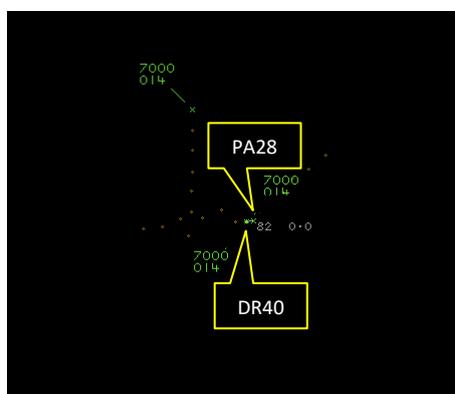
Figure 3 – CPA.

At 1418:31 the PA28 pilot was flying level at an altitude of 1800ft whilst the DR40 pilot continued their climb. CPA occurred at 1418:42 with a measured separation of less than 0.1NM horizontally and 0ft vertically (Figure 3).
