AIRPROX REPORT No 2022075

Date: 08 May 2022 Time: 1407Z Position: 5202N 00129W Location: 5NM west of Banbury

PART A: SUMMARY OF INFORMATION REPORTED TO UKAB

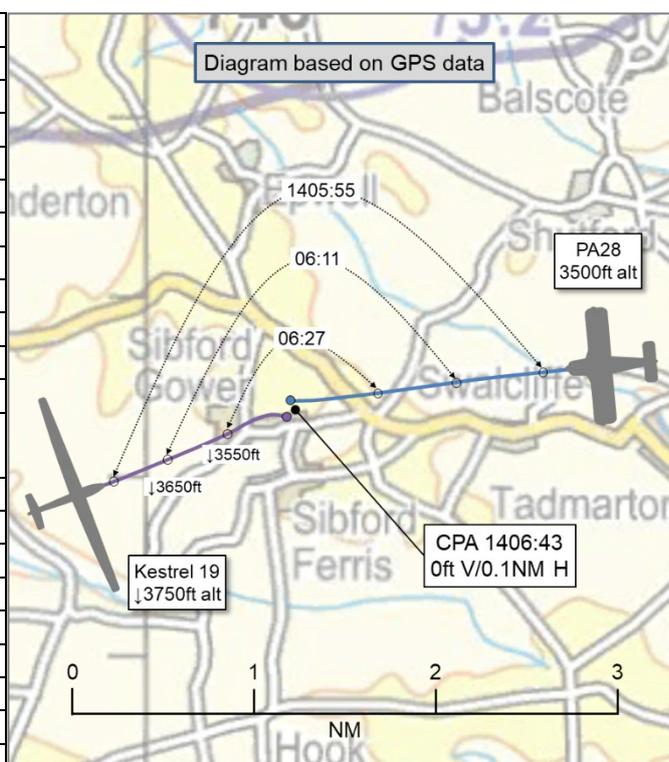
An analysis of the NATS radar replay and GPS data for both aircraft was undertaken. Although the PA28 was detected by the NATS area radars, the Kestrel 19 could not be positively identified and so GPS data from both aircraft has been used to construct the diagram on page 1 and to measure the CPA.

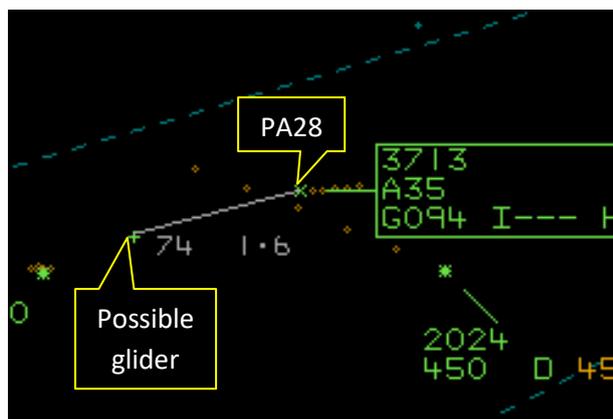
Figure 1 – Primary contact appears on radar

Prior to the PA28 showing a right-hand turn on the radar screen, a primary contact, believed to be a glider, tracking east appears on the radar screen. Separation was measured at 1.6NM. Twenty seconds later, the primary contact faded from radar and did not reappear. Separation decreased to 0.7NM.
