AIRPROX REPORT No 2022083

Date: 12 May 2022 Time: 1225Z Position: 5204N 00032W Location: 3NM E Cranfield airfield

PART A: SUMMARY OF INFORMATION REPORTED TO UKAB

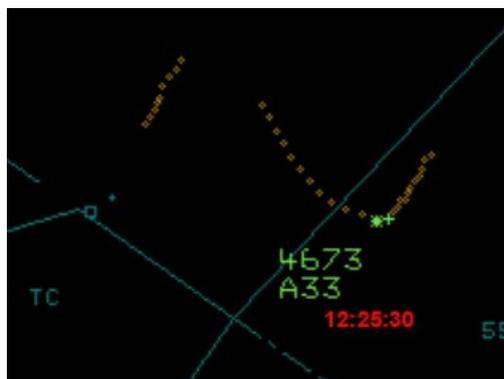
[The PA31 pilot] initiated a left turn and a primary contact was observed on radar to track southwest in close proximity at 1225:30 (See Figure 1) approximately 2.8NM east of Cranfield.

Referring to the pilot reports, Safety Investigations assessed the primary return to potentially be [the Arcus]. The pilot of [the Arcus] reported that the aircraft appeared on their right-hand side as they were tracking approximately 230°. This was the only visible radar interaction with [the PA31] near to Cranfield around the timings provided by the [Arcus] pilot.

This interaction did not correlate with the geometry of the event as per the [Arcus] pilot’s report. Therefore, Safety Investigations assessed it more probable the previous interaction detailed in Figure 1 was the Airprox.

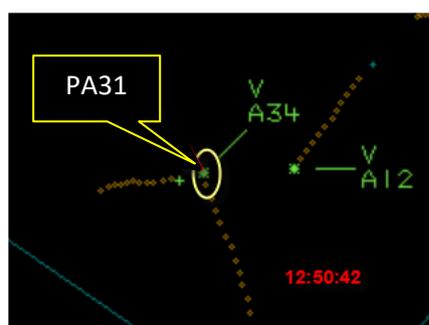
Figure 2

The pilot report from [The PA31 pilot] reported that they sighted a glider as they were returning after completing the task. A primary radar return crossed in the vicinity of [the PA31] at 1250:42 as they were 2NM north of Cranfield (Figure 2).
