AIRPROX REPORT No 2022079

Date: 08 May 2022 Time: 1521Z Position: 5219N 00020W Location: Kimbolton

PART A: SUMMARY OF INFORMATION REPORTED TO UKAB

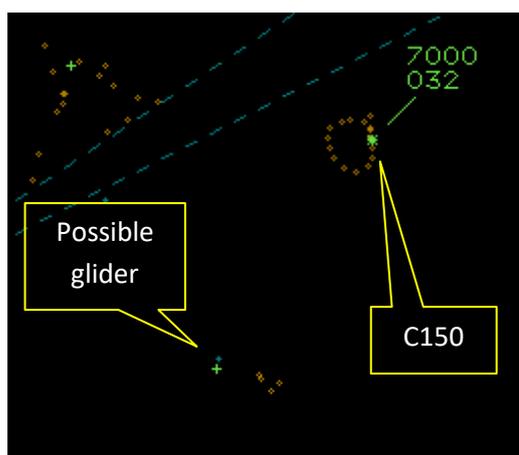
Figure 1 - 1520:07

An analysis of the NATS radars was undertaken. The C150, squawking 7000, could be identified using Mode S information and at 1520:07 had conducted a 360° turn as described in the pilot's report (Figure 1). At this stage no gliders could be seen in close proximity to the C150, however the radar showed a number of primary contacts further away that were probably gliders. At 1520:47 the C150 was flying on a southerly heading and a primary contact, likely to be the glider, had appeared on the radar 0.6NM from the C150 (Figure 2). Radar CPA occurred at 1520:58 with the two aircraft indicating 0.1NM apart laterally. The altitude of the glider was unknown.

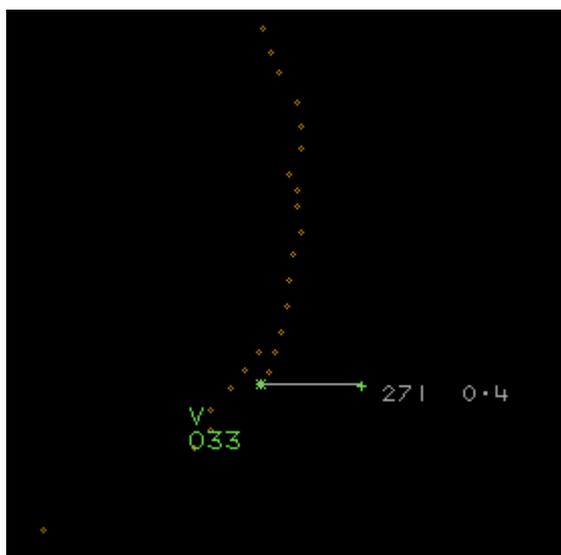
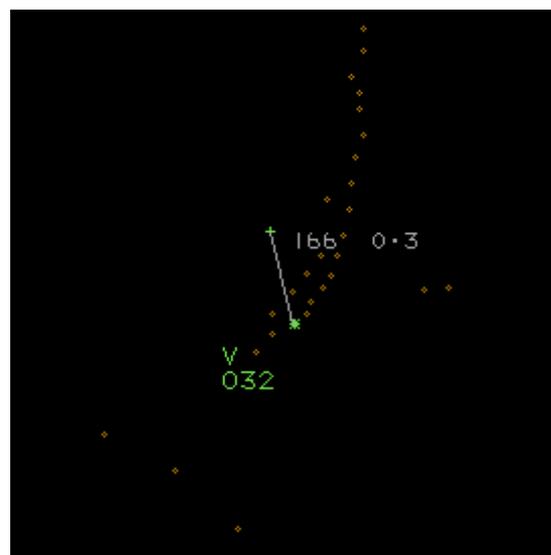
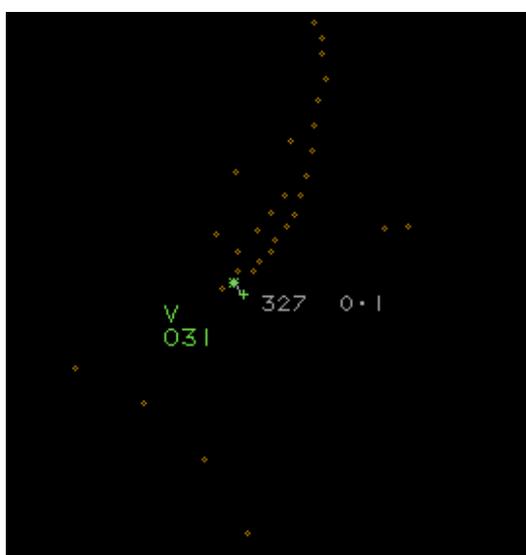
However, following radar CPA, the primary contact faded from radar and reappeared every few sweeps, still in the vicinity of the C150. It is possible that the glider had been manoeuvring above the C150 without being seen and then descended down to cross ahead of the C150, see Figures 5-7.
