AIRPROX REPORT No 2022081

Date: 12 May 2022 Time: 0926Z Position: 5112N 00104W Location: 2NM NW Lasham

PART A: SUMMARY OF INFORMATION REPORTED TO UKAB

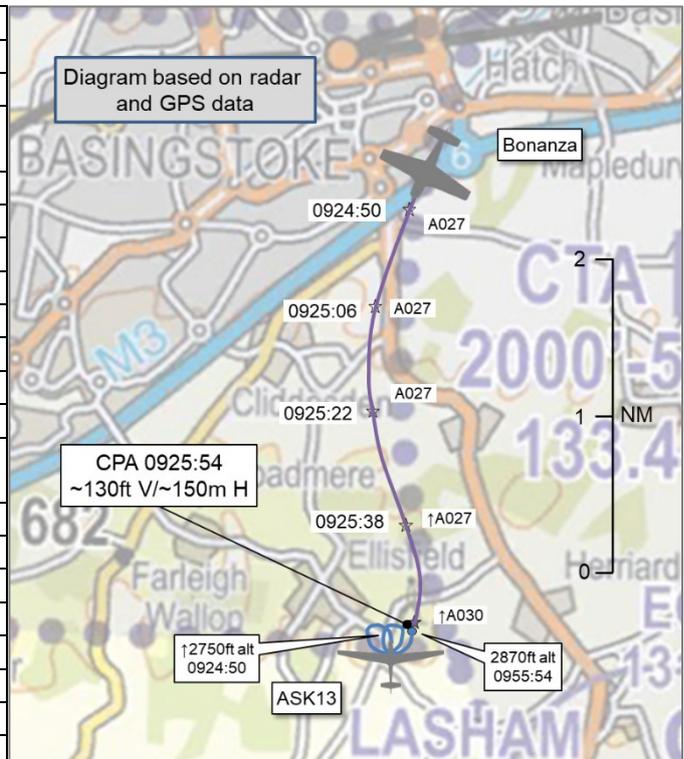
An analysis of the NATS radar replay was undertaken and the Beech aircraft was detected and identified using Mode S data. There was an intermittent primary-only return observed in the locality of the Airprox, however, it could not be verified that this was the ASK13. Fortunately, the ASK13 pilot was able to supply the UKAB Secretariat with a GPS data file and this has been used, along with the radar data, to create the diagram on page one of this report and to measure CPA which, due to the necessity to combine differing data sources, has been recorded as an approximation.
