## AIRPROX REPORT No 2022091

Date: 29 May 2022 Time: 0951Z Position: 5238N 00221W Location: 1.5NM WSW Cosford

### PART A: SUMMARY OF INFORMATION REPORTED TO UKAB

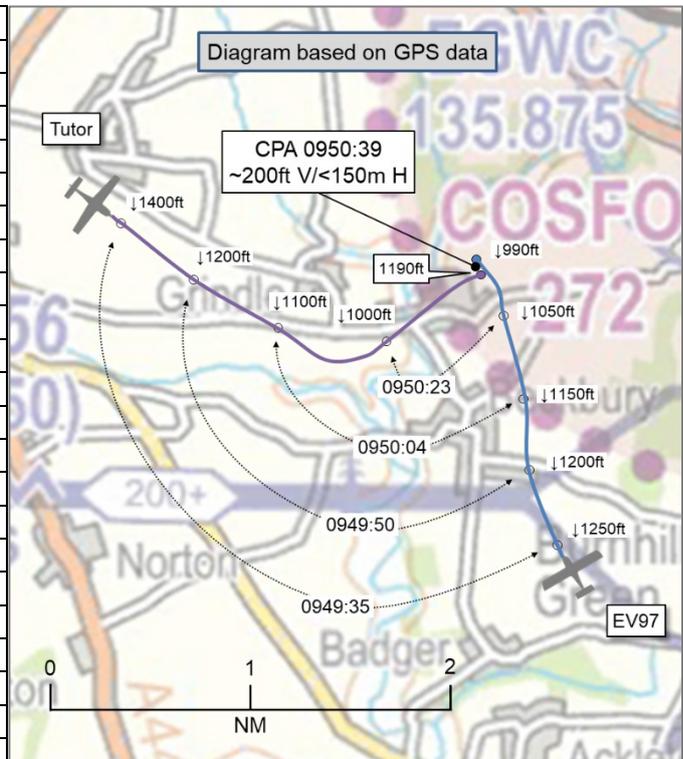
Recorded	Aircraft 1	Aircraft 2
Aircraft	EV97	Tutor
Operator	Civ FW	HQ Air (Trg)
Airspace	Cosford ATZ	Cosford ATZ
Class	G	G
Rules	VFR	VFR
Service	None <sup>1</sup>	Basic
Provider	N/A	Cosford Tower
Altitude/FL	990ft	1190ft
Transponder	Not fitted	A, C, S
Reported		
Colours	Silver/Alloy	White
Lighting	NR	Strobes
Conditions	VMC	VMC
Visibility	5-10km	5-10km
Altitude/FL	NR	1300ft
Altimeter	QNH (1021hPa)	NK (NR hPa)
Heading	340°	060°
Speed	80kt	120kt
ACAS/TAS	PilotAware	TAS
Alert	Information	None
Separation at CPA		
Reported	3ft V/500m H	100ft V/200ft H
Recorded	~200ft V/<150m H

An analysis of the NATS radar replay was carried out and the EV97 was not visible; however, the UKAB Secretariat was able to obtain GPS data which displayed the routings of both the EV97 and the Tutor and, in the interests of utilising a single source of data, this was used to measure the CPA, however, some interpolation was needed between data points and so the separation at CPA is recorded as an approximation.
