AIRPROX REPORT No 2022095

Date: 01 Jun 2022 Time: 1101Z Position: 5048N 00041W Location: Bognor Regis

PART A: SUMMARY OF INFORMATION REPORTED TO UKAB

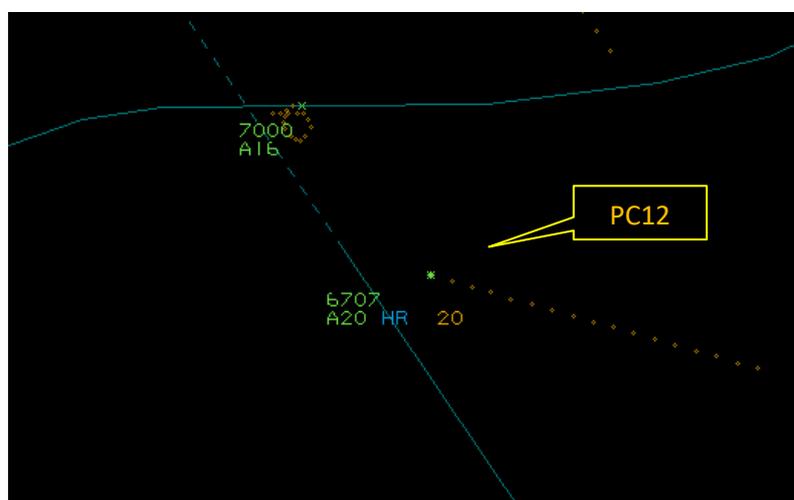
Figure 1 - 1059:03

An analysis of the NATS radars was undertaken. The PC12 could be identified through Mode S data, unfortunately the DG1001 did not display on the radar at all. The radar QNH was 1017hPa. At Figure 1, the PC12 could be seen heading NW, indicating 2000ft.

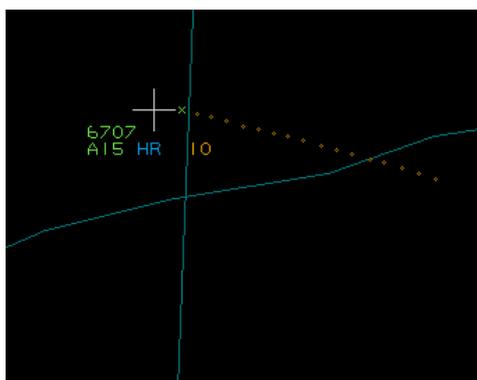
Figure 2 - 1101:19

By 1101:19 (Figure 2), the PC12 had descended to 1500ft. The position of Bognor Regis gliding club is marked on the screenshot with a white cross. The airfield elevation on the VFR chart is given as -1ft (although Pooley's Flight Guide gives an airfield elevation of 1ft). The PC12 continued the descent and was indicating 1300ft when 1km WNW of the gliding site, the position in which the DG1001 pilot reported that they were circling. However, the glider could not be seen on the radar so the exact separation could not be determined.

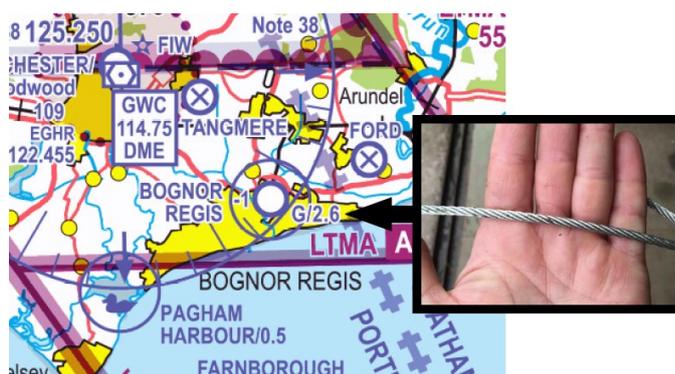
Figure 4

UK glider launch sites are listed in UK AIP ENR 5.5 and labelled on the CAA 1:500,000 and 1:250,000 charts with a "G" symbol, as shown in Figure 4. A greater density of gliders may be expected nearby at any time during daylight hours, and at any altitude up to cloud-base. Where winch launching is used, the maximum winch launch altitude is listed in the AIP and marked on the chart; this is 2600ft AMSL at Bognor Regis, as indicated by the black arrow. Overflying a winch site below this maximum notified altitude during daylight hours risks encountering high tensile strength cable (Figure 4) connecting a launching glider to the winch on the ground.

It is recommended to avoid glider sites, if this is not possible then good airmanship would be to make a radio call to improve everyone's situational awareness; most glider site frequencies are listed in the eAIP ENR 5.5 Aerial Sporting and Recreational Activities. Where possible pilots should report an Airprox on a suitable ATC frequency, although in this case the glider pilot had telephoned the expected destination of the PC12, if the pilot had reported the incident as an Airprox it would have helped the subsequent investigation.
