AIRPROX REPORT No 2022102

Date: 12 Jun 2022 Time: 1451Z Position: 5249N 00143W Location: Tatenhill ATZ

PART A: SUMMARY OF INFORMATION REPORTED TO UKAB

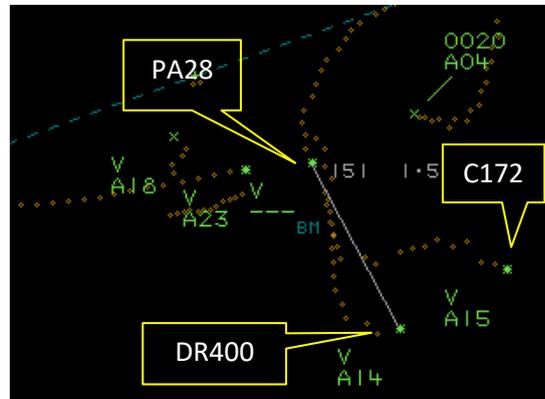
Figure 1 - 1448:51

An analysis of the NATS radar replay was undertaken and the three aircraft mentioned in the pilots' reports could be positively identified within the Tatenhill ATZ. A C172 was No1 in the circuit, the following DR400 flew an extended crosswind leg and turned downwind wider than the circuit flown by the C172, see Figure 1.

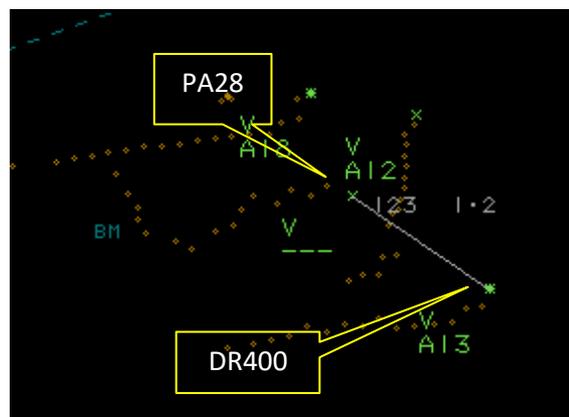
Figure 2 - 1449:58

Throughout the incident the Mode C on the PA28 could not be seen on the radar. The PA28 had joined the circuit via the overhead, and then flew a circuit inside that flown by the DR400 pilot. The C172 turned for base-leg and the DR400 extended the downwind leg, now to the right of the PA28, see Figure 2.

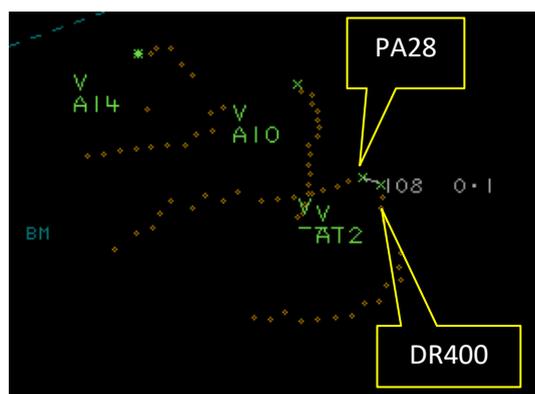
Figure 3 - 1450:23

As the DR400 turned for base-leg the PA28 crossed approximately 0.1NM ahead as it extended the downwind leg (Figure 3).

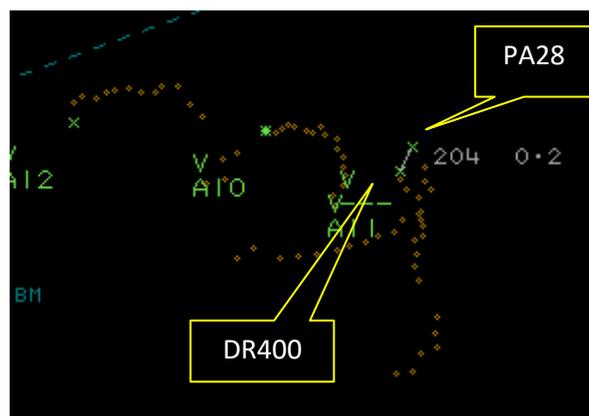
Figure 4 - 1450:50

The PA28 then turned onto base-leg, parallel and to the right of the DR400, see Figure 4.

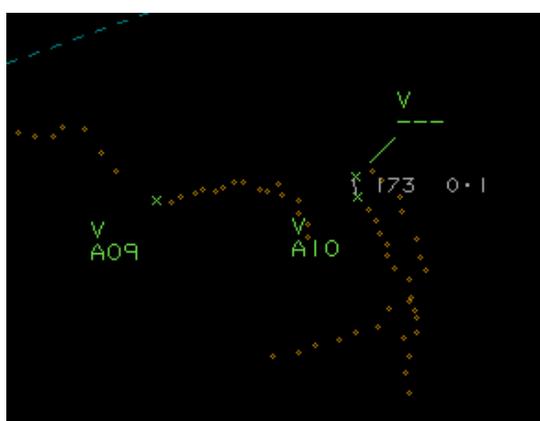
Figure 5 - 1451:07

CPA occurred when the DR400 turned final and the PA28 also made a left turn onto final (see Figures 5 and 6), the aircraft closed to less than 0.1NM horizontally, but because the altitude of the PA28 was not known, the vertical separation could not be determined.
