AIRPROX REPORT No 2022163

Date: 07 Aug 2022 Time: 1510Z Position: 5225N 00017W Location: 2NM SW Conington

PART A: SUMMARY OF INFORMATION REPORTED TO UKAB

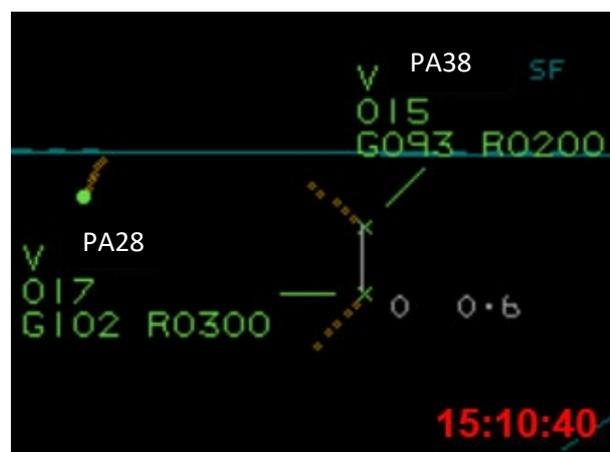
Figure 1 displays the point at which the pilot of [PA38 C/S] initially contacted LFIS (annotated radar screenshot). Radar subsequently displayed the closest point of approach between [PA28 C/S] and [PA38 C/S] at 1510:54 (see Figure 2).

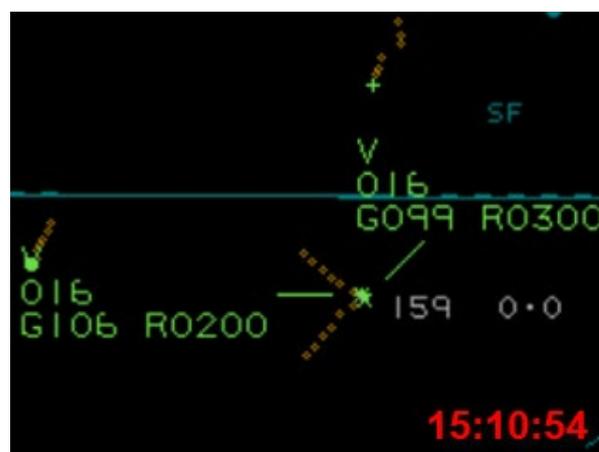
Figure 2 Closest point of approach.

The Airprox occurred when the pilot of [PA38 C/S] initially contacted London Information, but subsequently reported they were temporarily returning to their previous frequency of Conington. The closest point of approach occurred at 1510:54 and was recorded on Multi-Track Radar as 0.0NM and 0ft.
