AIRPROX REPORT No 2022167

Date: 06 Aug 2022 Time: 1213Z Position: 5231N 00253W Location: Long Mynd

PART A: SUMMARY OF INFORMATION REPORTED TO UKAB

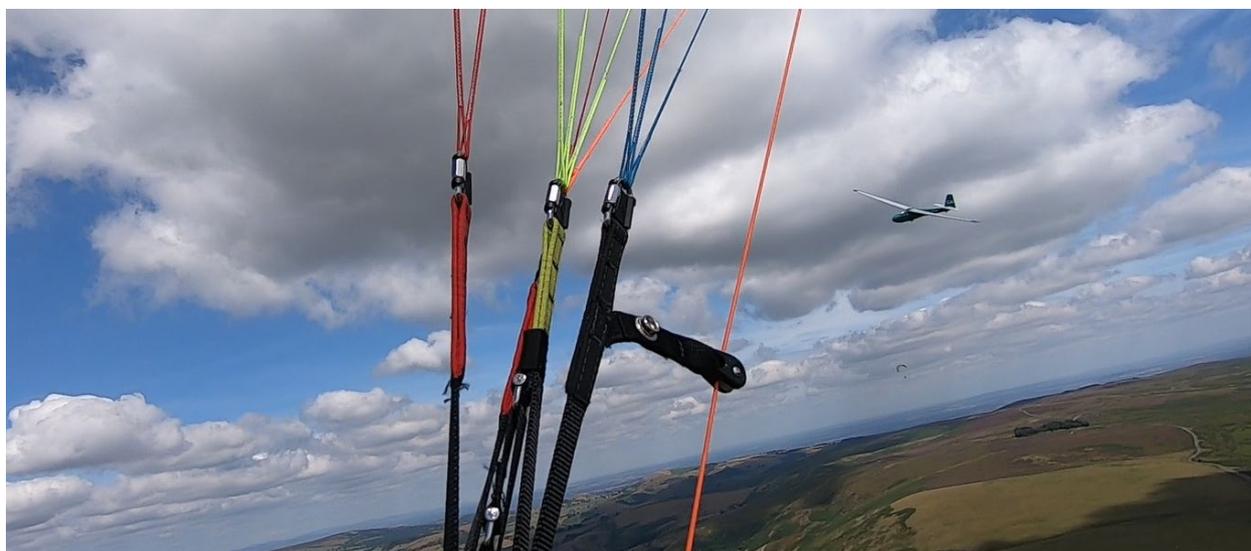
3sec before the CPA, the video showed that the K8 pilot had been utilising the same thermal as the paraglider pilot, and appeared to have been above the paraglider pilot, in approximately their 3 o'clock position, in a slight left-hand turn toward the paraglider, Figure 1.

Figure 1 – 3sec before CPA. The K8 in paraglider pilots' approximate 3 o'clock.

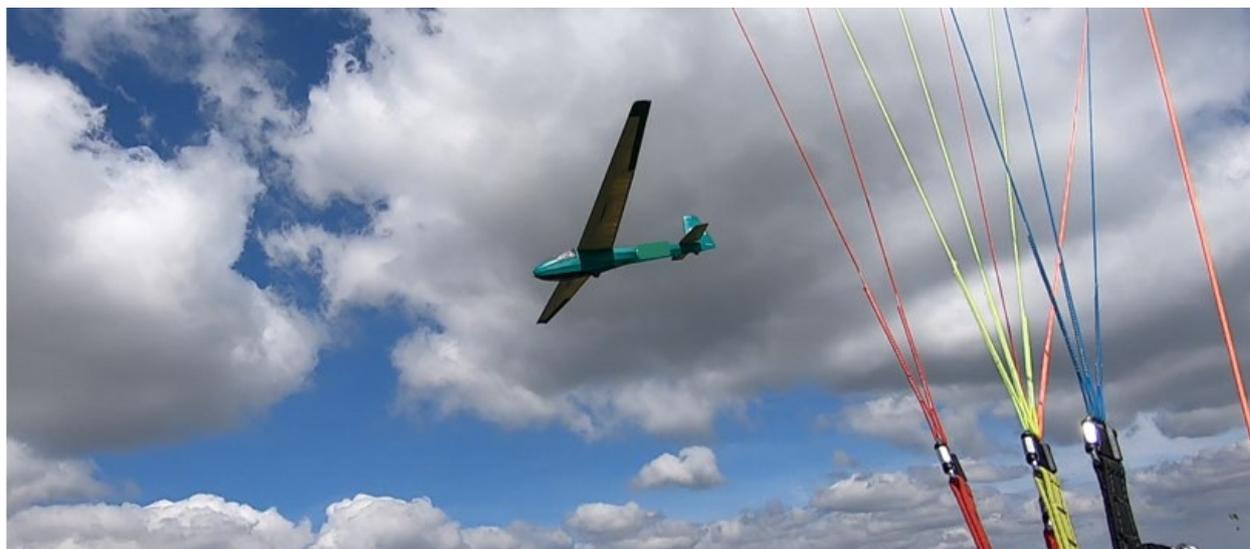
Approximately 1sec later, still above the paraglider, the K8 pilot made a slight turn to the right and passed through the paraglider pilot's approximate half-past 1 position, as described in the narratives provided by both the paraglider and the K8 pilots. Figure 2.

Figure 2 – 1sec before CPA. The K8 in paraglider pilots' approximate 'half-past 1'.

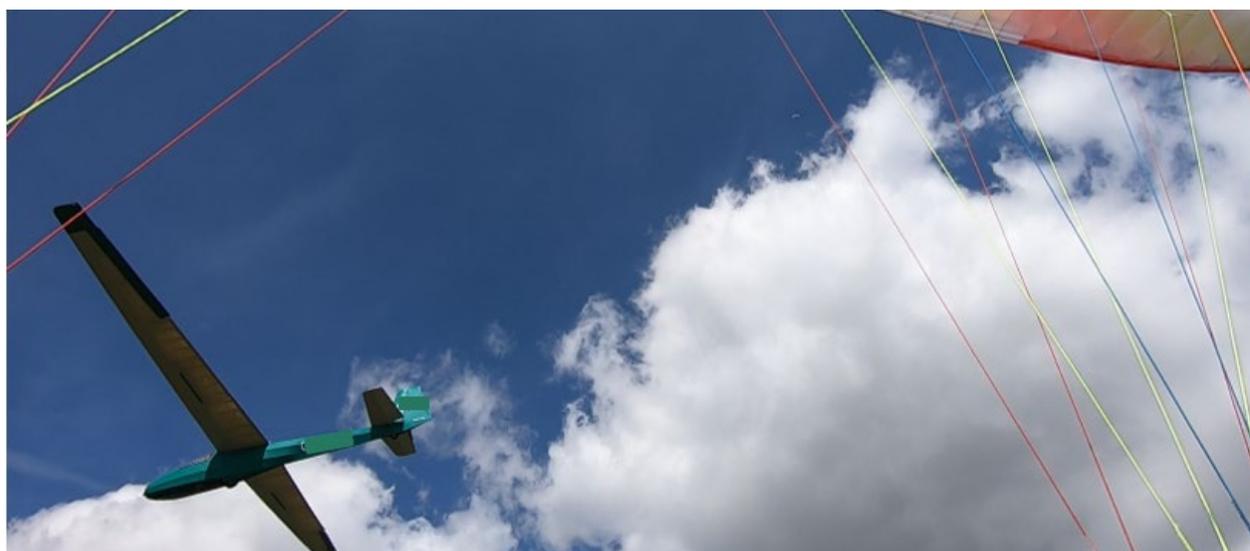
Both pilots then maintained their track and relative altitude, which caused the separation to continue to reduce until CPA which occurred as the K8 passed ahead of, and above, the paraglider, Figure 3.

Figure 3 – CPA. The K8 crossed ahead of, and above, the paraglider.
