AIRPROX REPORT No 2022178

Date: 16 Aug 2022 Time: 1029Z Position: 5300N 00107E Location: 4NM NE Blakeney Point

PART A: SUMMARY OF INFORMATION REPORTED TO UKAB

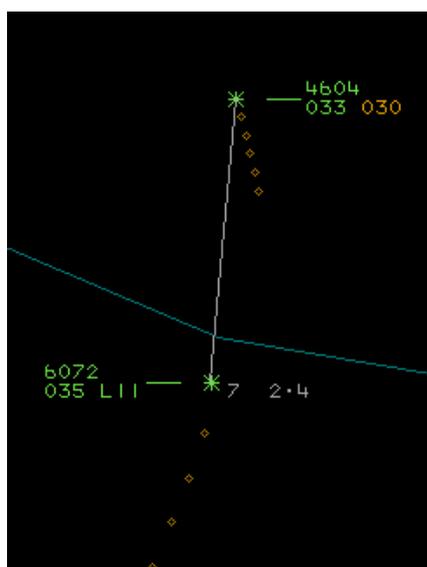
Figure 1: 1029:03 Swanwick(Mil) controller responds to the formation's return to base request.

At 1028:58 the Typhoon formation reported their sortie completed and requested to return to [destination]. The Swanwick(Mil) controller responded at 1029:03 (See Figure 1). Traffic Information was provided at 1027:00. At 1027:30 Norwich Approach contacted the Swanwick(Mil) controller, to accept handover of the Typhoon formation. On handover to Norwich, the Typhoons' position was reported with no reference to the AW139 traffic. Separation between the Typhoon squawking 6072 and the AW139 squawking 4604 measured at 2.4NM and 200ft. The Norwich controller said they would have to call back and the handover was not completed.

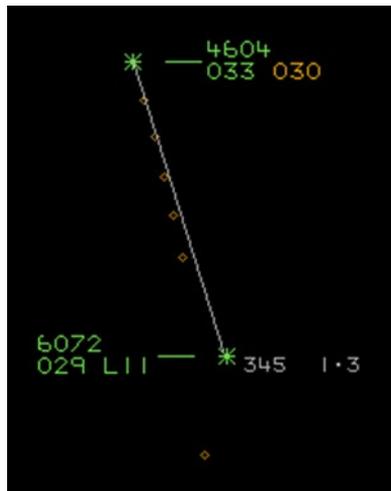
Figure 2: 1029:25 The Swanwick(Mil) Planner contacts Norwich Approach

The Swanwick(Mil) Planner contacted Norwich Approach, informing them that the Typhoon formation had completed their sortie and were returning to base. Figure 2, separation decreased to 1.3NM and 400ft.

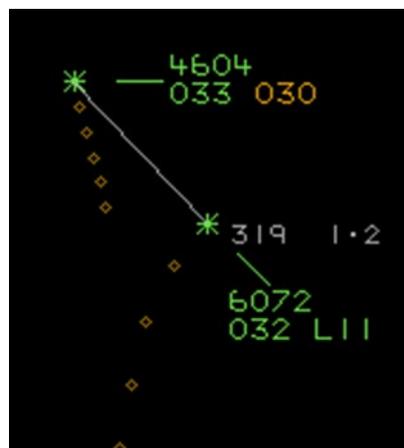
Figure 3: 10:29:30 CPA.

Figure 3 shows CPA measured at 1.2NM and 100ft. No Traffic Information was provided by the Swanwick(Mil) controller.
