**AIRPROX REPORT No 2022183**

Date: 16 Aug 2022 Time: ~1037Z Position: 5028N 00329W Location: 4NM N BHD VOR

**PART A: SUMMARY OF INFORMATION REPORTED TO UKAB**

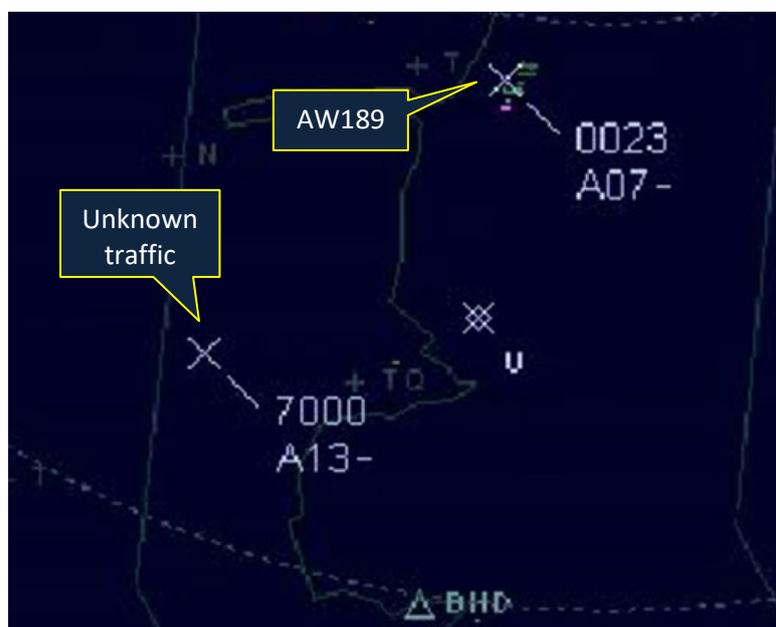
Figure 1 – 1034:50

At 1034:50, [the AW189] was indicating 700ft when the radar controller called unknown traffic to [the AW189 pilot]. Figure 1.

Controller: “[AW189 c/s] if you read there’s traffic over Torbay at the moment, it’s routing towards the Exmouth direction indicating 1200 feet, inland at the moment but heading towards Exmouth”

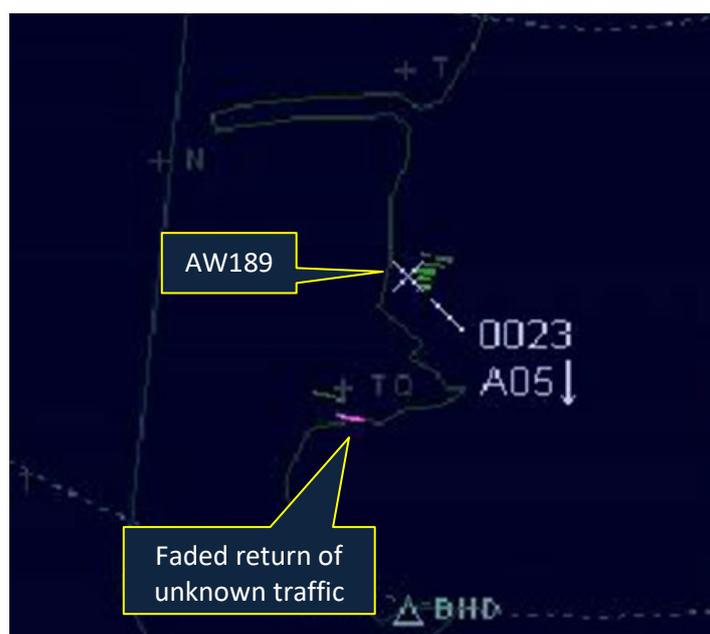
Figure 2 – 1036:09

At 1036:09, the radar controller updated [the AW189 pilot] on the position of the unknown traffic:

Controller: “[AW189 c/s] that unknown contact is believed to be about 2 miles ahead you now, the level is not known but it is now tracking towards the east, south.

No response was heard from [the AW189 pilot], Figure 2.
