AIRPROX REPORT No 2022185

Date: 05 Aug 2022 Time: 1038Z Position: 5153N 00207W Location: Gloucestershire Airport

PART A: SUMMARY OF INFORMATION REPORTED TO UKAB

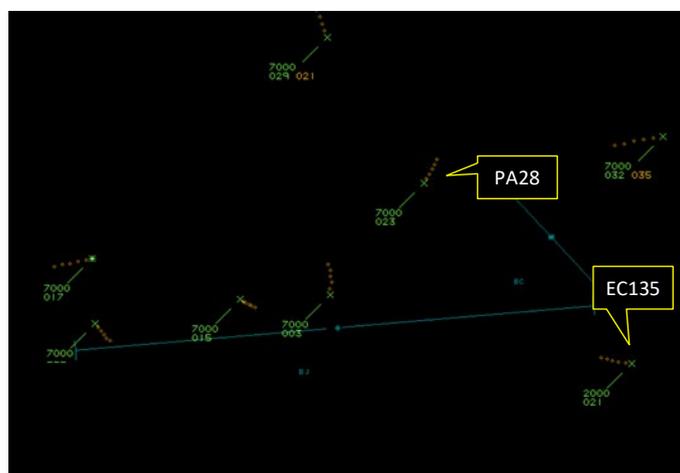
Figure 1 – 1031:21

At 1026:12, the EC135 pilot, who was now in the hold, reported ready for their approach next time over the NDB, and was given a clearance to commence the approach maintaining 3000ft until advised. The Approach controller then dealt with a number of other aircraft both inbound and outbound, before the pilot of the PA28 reported at 3 miles at 1031:21 (Figure 1).

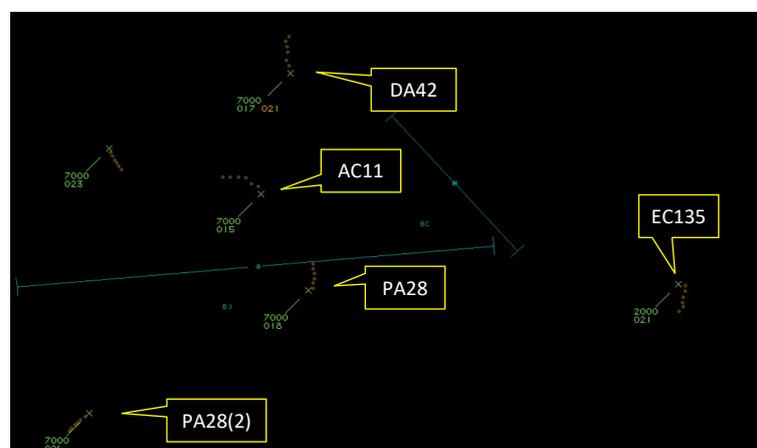
Figure 2 – 1033:30

At 1033:30 the PA28 pilot reported ready to descend. The Tower controller cleared them to descend on the deadside, advising that an RV6 was due to depart from RW27 to the north, which was acknowledged. Reciprocal Traffic Information was then passed to the RV6 pilot (Figure 2).

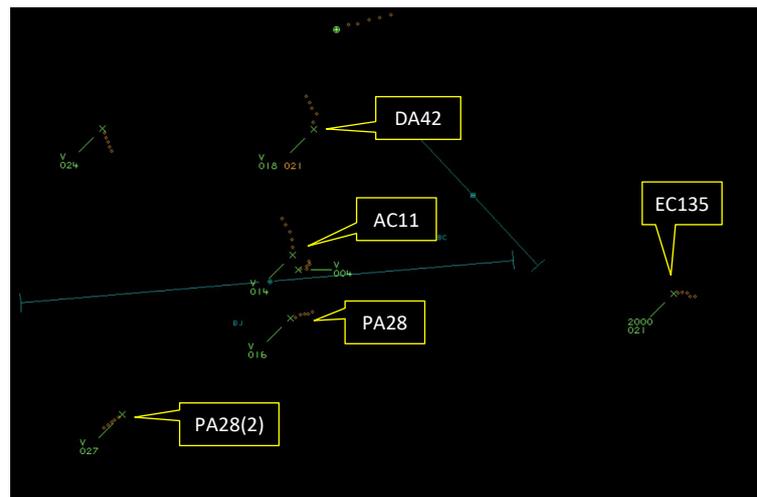
Figure 3 – 1034:00 EC135 at 8.5NM

On the Approach frequency, the pilot of the EC135 reported their base turn complete at 1034:00, and was instructed to report at 4DME by the Approach controller (Figure 3).

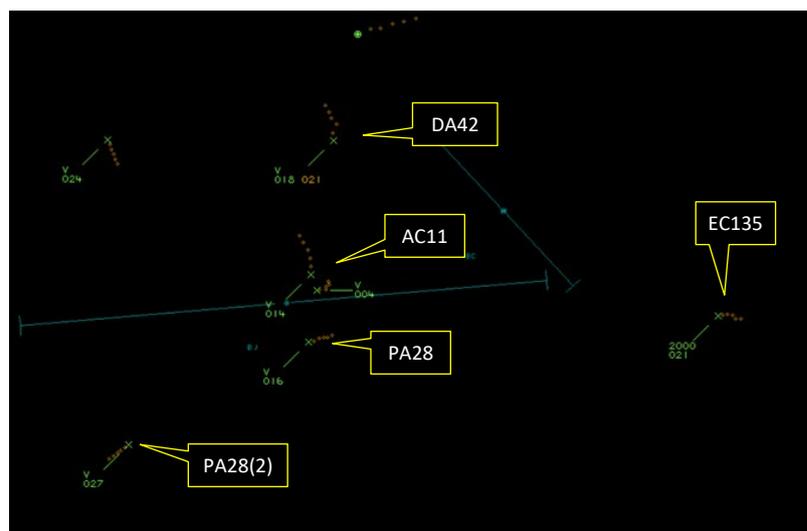
Figure 4 – 1034:10

At 1034:10 on the Tower frequency, the pilot of the AC11 reported descending on the deadside and advised that they were visual with the PA28 (Figure 4).

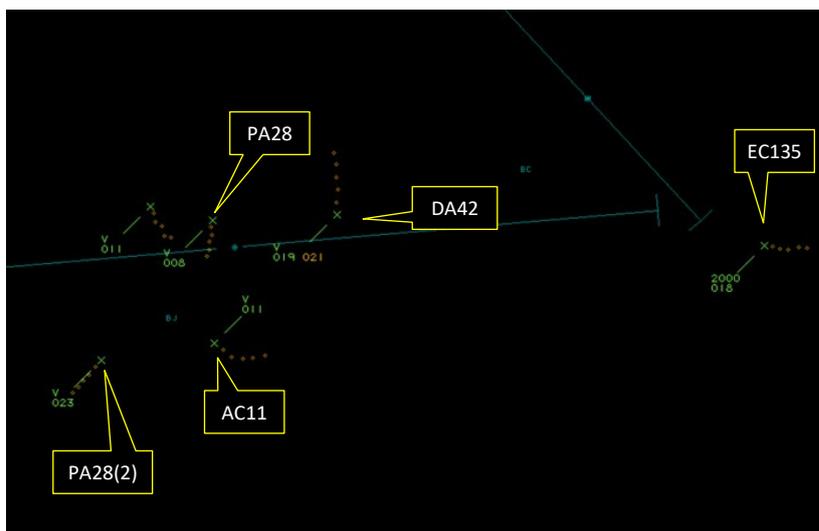
Figure 5 – 1035:20 EC135 6.3NM

At 1035:20 the Tower controller instructed the pilot of the PA28(2), inbound from the southwest, to remain in the overhead. They then passed Traffic Information to them on the inbound DA42 with a request that they report when they had that traffic visual (Figure 5).

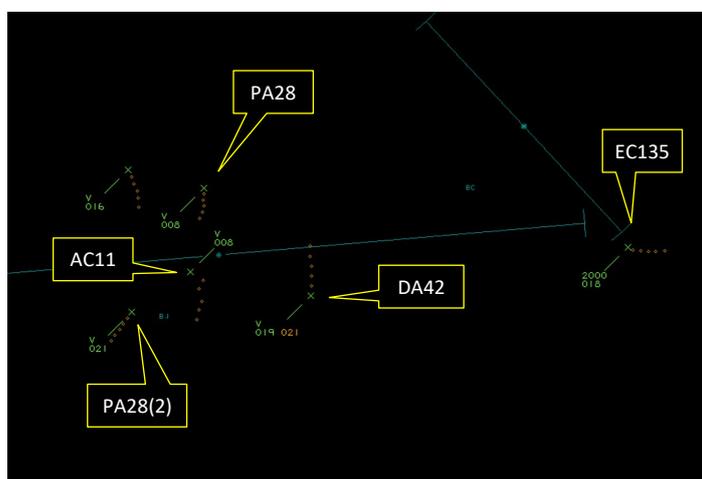
Figure 6 – 1035:48

At 1035:48 the pilot of the DA42 made their first call on the Tower frequency advising that they were ready to descend deadside (Figure 6).

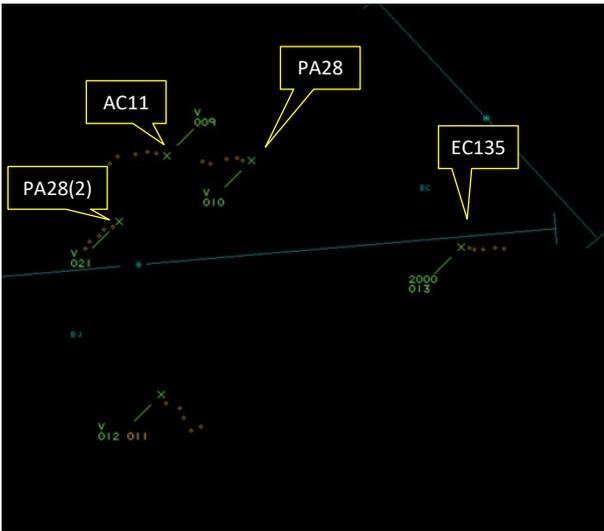
Figure 7 – 1036:55 EC135 3.9NM

At 1036:55, on the Approach frequency, the pilot of the EC135 reported just passing 4DME and was transferred to the Tower frequency (Figure 7).

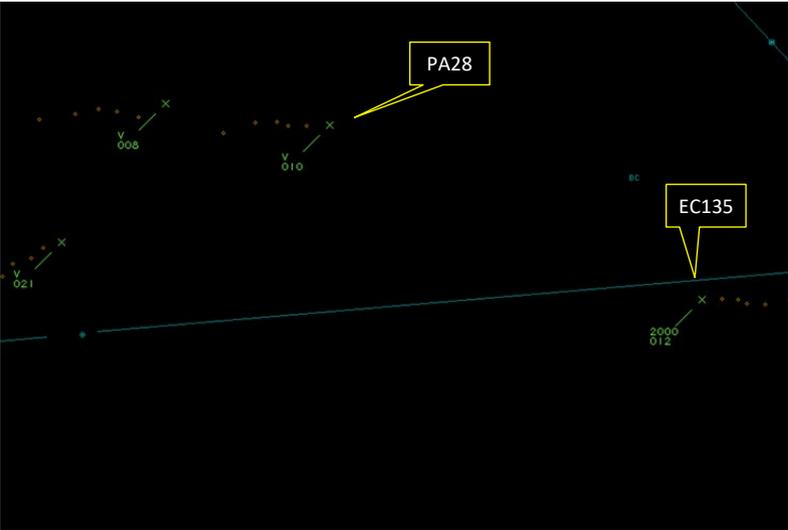
Figure 8 – 1037:00

At 1037:00 a pilot reported ready for departure on the Tower frequency. The Tower controller ignored that call and instructed the PA28 pilot to “turn base leg. Keep it tight, traffic at 4 miles is an EC135. You’re Number 1” to which the PA28 pilot replied “yeah roger – Number 1” (Figure 8).

Five seconds after the EC135 pilot had been transferred to the Tower frequency from Approach at 3.8NM, the Tower controller instructed the pilot of the PA28 to turn on to base-leg, advising they were No1. They also requested that the pilot “*keep it tight*” giving the reason “*traffic at 4 miles is an EC135*”. Even with the benefit of the radar replay it cannot be determined with any great certainty if that plan would have worked or not. However, as they were an experienced controller, familiar with operations at Gloucestershire and it was their judgement at the time, they must be given the benefit of the doubt. Ultimately, by the time the PA28 was observed to have commenced the turn onto base, 15sec later, it was clear that it would conflict with the EC135 on final approach. However, the Gloucestershire Tower controller did not have access to any surveillance-derived information.

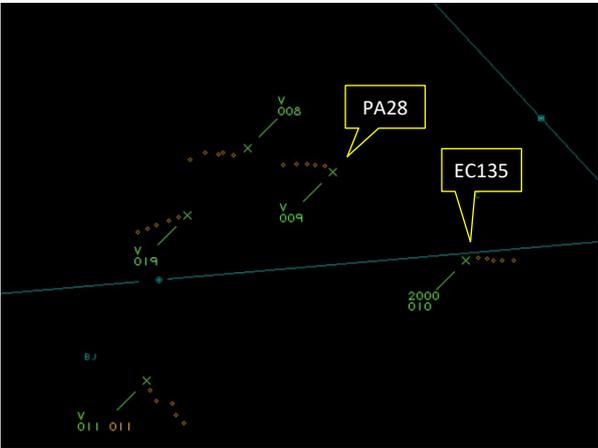
Figure 9 – 1037:15

The turn by the PA28 was not observed to have commenced on the area radar replay until 1037:15 (Figure 9).

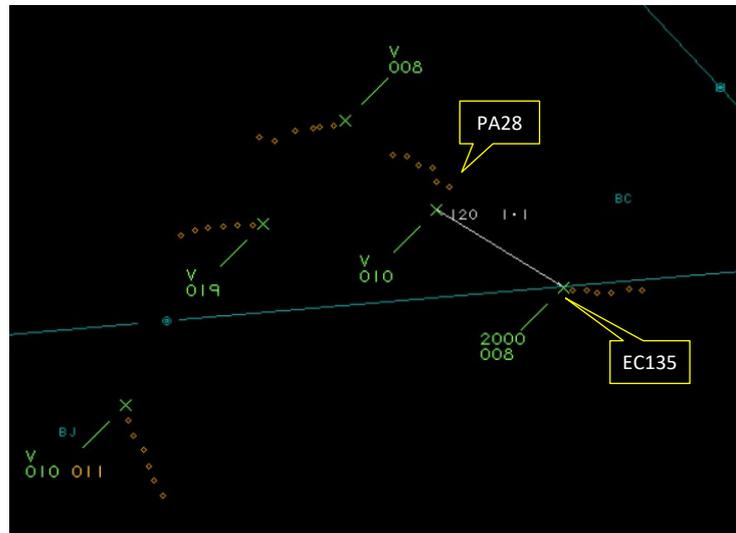
Figure 10– 1037:30

The Tower controller then lined-up an aircraft, instructing the pilot to be ready for an immediate departure. At 1037:30 the controller passed Traffic Information to the PA28 pilot on the departing aircraft, then broke the transmission to clear the pilot of the aircraft lined-up for an immediate take-off (Figure 10).

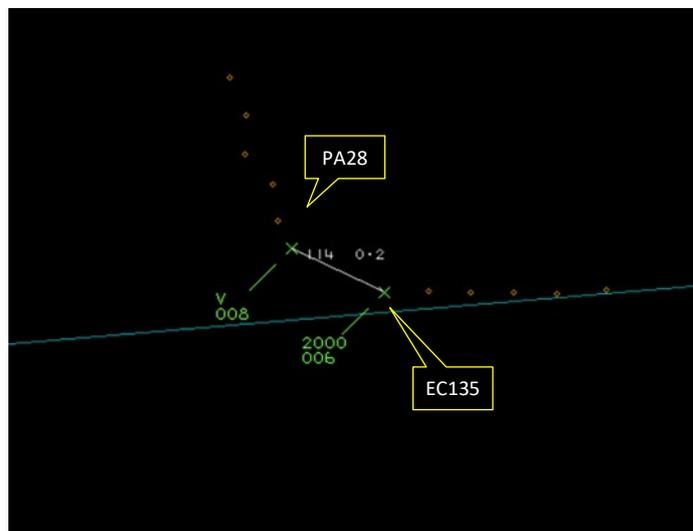
Figure 11 – 1037:55

At 1037:45 the Tower controller called an aircraft on the ground but received no reply. At 1037:55 the controller called the pilot of the EC135 (which had not yet called). The EC135 pilot responded 2 seconds later (Figure 11).

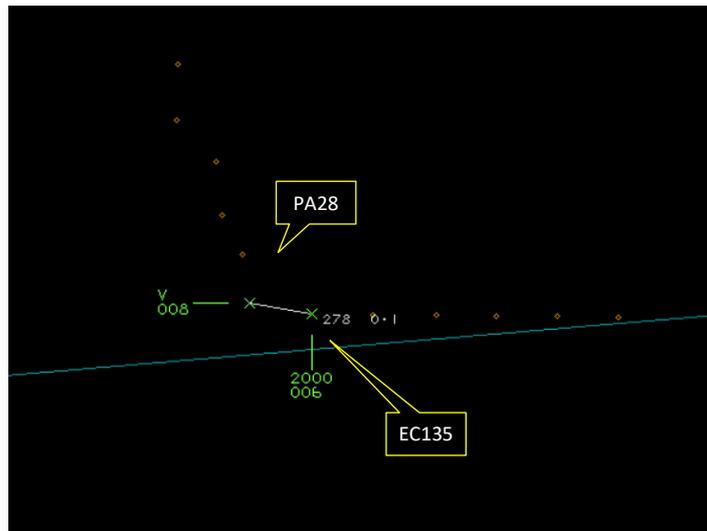
Figure 12 – 1037:58

The controller asked the pilot “are you visual with the Cherokee just turning ahead of you? Oh sorry – just behind...no he’s behind you”. The EC135 pilot did not reply.

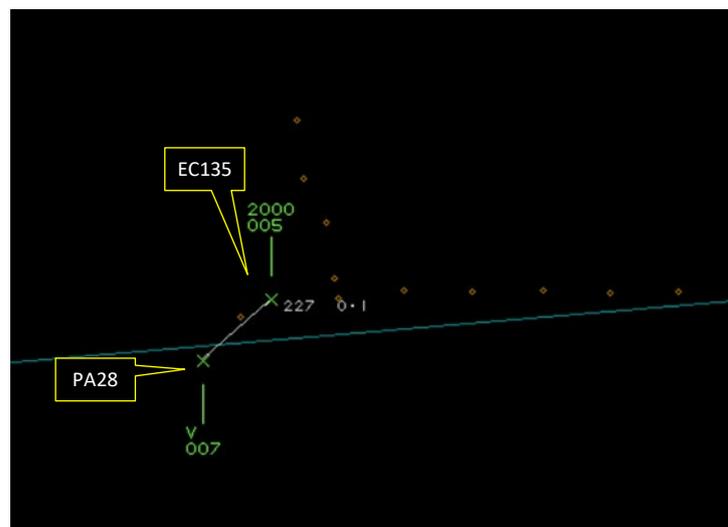
Figure 14 – 1038:05

At 1038:05 the controller asked the PA28 pilot “*you visual with the EC135 now on a 2 mile final?*” The pilot replied “*negative, but looking*” (Figure 14).

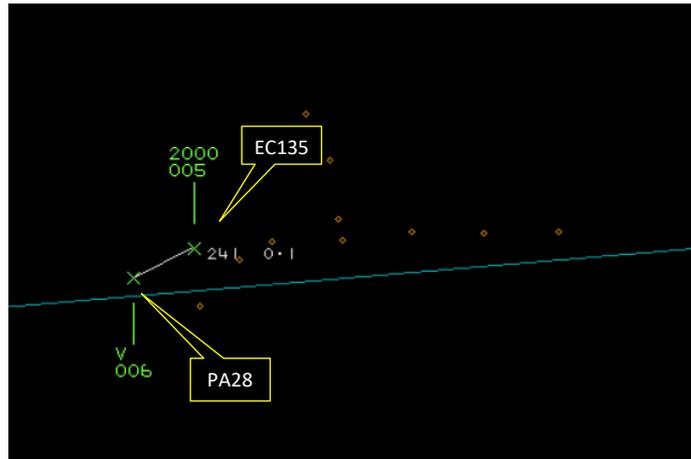
Figure 15 – 1038:10

At 1038:10 the controller instructed the PA28 pilot to “*Go around – break off to the south*” which was acknowledged by the pilot (Figure 15).

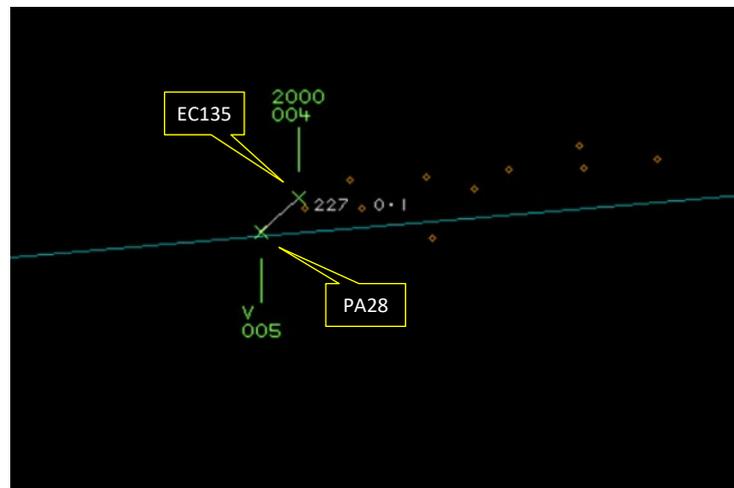
Figure 16 – 1038:18

At 1038:18 the EC135 pilot reported “we’re visual with him”. The controller instructed them to continue, advising that they were No1 (Figure 16).

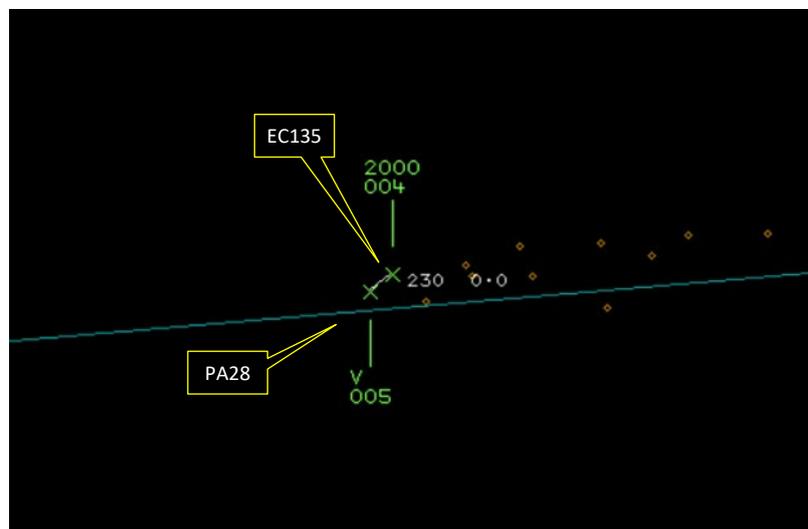
Figure 17 – 1038:23 CPA

With both aircraft having effectively been within 0.1NM and 100ft of each other for nearly 10sec, CPA then occurred at 1038:23 when the lateral distance on the area radar was seen to reduce further (Figure 17).
