AIRPROX REPORT No 2022197

Date: 26 Aug 2022 Time: 0943Z Position: 5150N 00142W Location: 2.5NM S Little Rissington

PART A: SUMMARY OF INFORMATION REPORTED TO UKAB

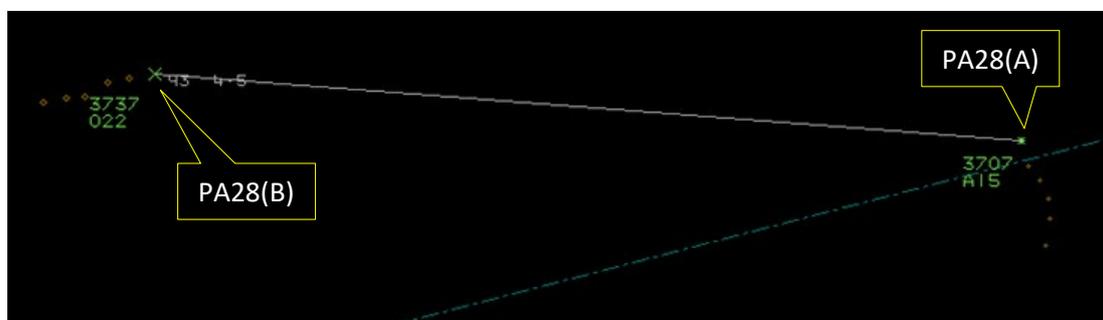
Figure 1 - 0941:10 PA28(A) squawking 3707 left controlled airspace.

The Brize Norton Approach controller reported the PA28(A) left Brize Norton controlled airspace at 0940:46, providing a Basic Service. As per Figure 1, the PA28(A) exited Brize Norton controlled airspace 24sec after this transmission. Horizontal separation was measured as 4.5NM.

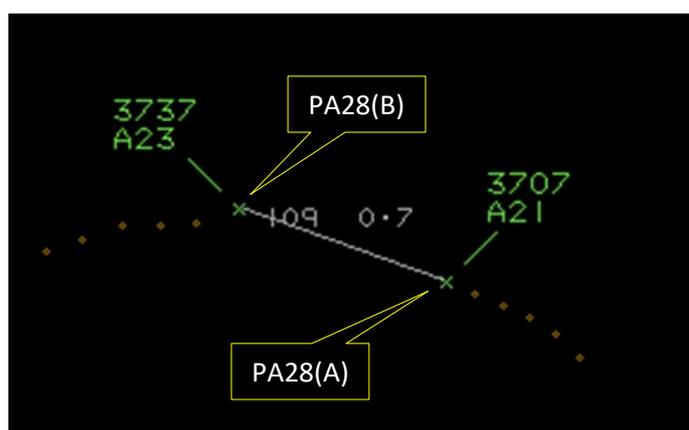
Figure 2 - 0942:23 Brize Norton Approach controller passed Traffic Information.

The Brize Norton Approach controller provided Traffic Information to the PA28(A) (squawking 3707) *“traffic northwest two miles similar altitude”*. [The pilot of] PA28(A) reported visual with PA28(B) (squawking 3737). Separation was measured as 200ft and 0.7NM.

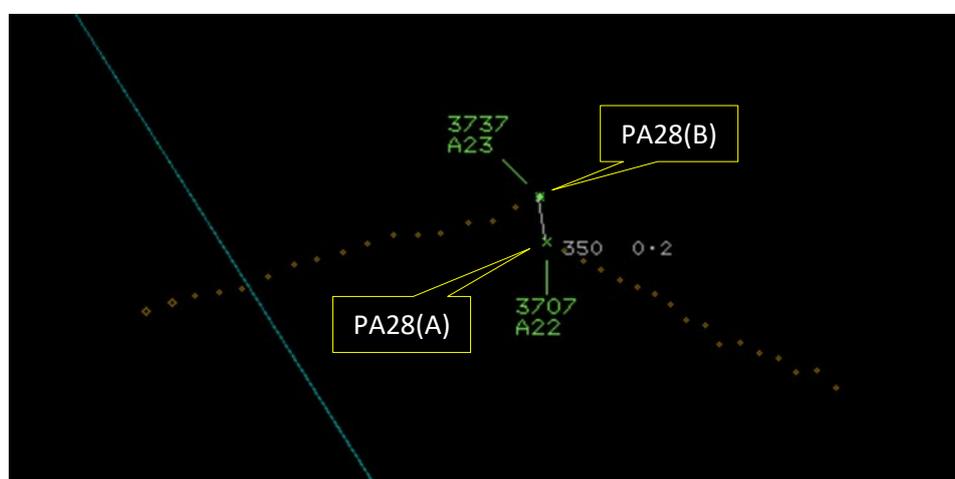
Figure 3 - CPA at 0942:34

The CPA was measured as 100ft and 0.2NM. No Traffic Information was passed to either PA28 aircraft. At 0943:26, the pilot of the PA28(A) declared an Airprox. At 0944:18, the Brize Norton LARS controller asked the PA28(B) pilot if they had seen the PA28(A). The pilot reported it had been alerted on TCAS, “*climbing from a thousand feet below me to my flight level*”.
