AIRPROX REPORT No 2022204

Date: 19 Aug 2022 Time: 1342Z Position: 5356N 00114W Location: 1.5NM SW Rufforth

PART A: SUMMARY OF INFORMATION REPORTED TO UKAB

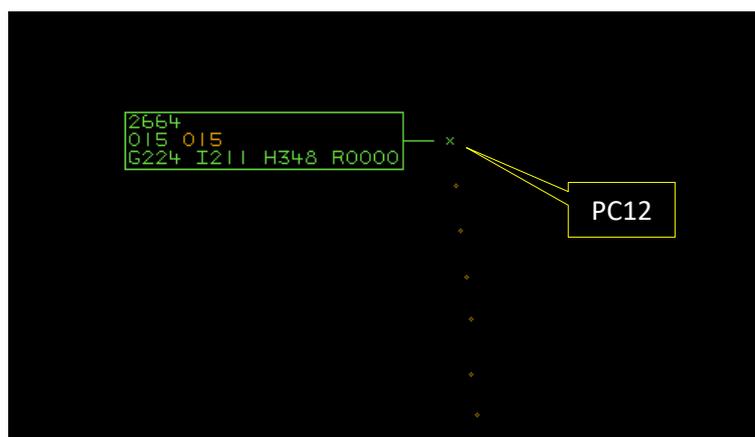
An analysis of the NATS radar replay was undertaken. The PC12 could be positively identified using Mode S data and was observed to be at FL015 (see Figure 1). The atmospheric pressure at Leeds Bradford was recorded as 1013hPa and the altitude of the PC12 was therefore assessed to be approximately 1500ft AMSL. Neither the PA25 nor the ASK13 glider-in-tow could be observed on radar in the vicinity at the time of CPA, but the UKAB Secretariat was able to obtain GPS data detailing the positions of the aircraft. It is with these separate sources that the separation at CPA was estimated.

Figure 1 – No other aircraft were observed on radar in the vicinity of the PC12 at CPA
