AIRPROX REPORT No 2022208

Date: 06 Sep 2022 Time: 1040Z Position: 5329N 00221W Location: Manchester Barton ATZ

PART A: SUMMARY OF INFORMATION REPORTED TO UKAB

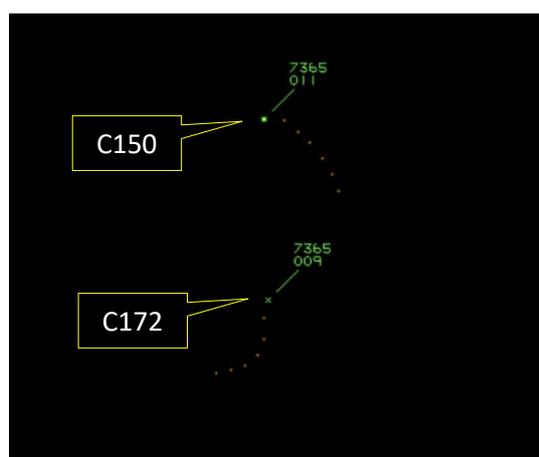
Figure 1 – 1032:34

The pilot of the C172 had initially intended to depart on a local flight, but due to weather had elected to remain in the circuit. The pilot of the C150 joined the circuit about 2.5min later. At 1032:34 the C150 was turning downwind left-hand on its second circuit, with the C172 crosswind on its third (see Figure 1).

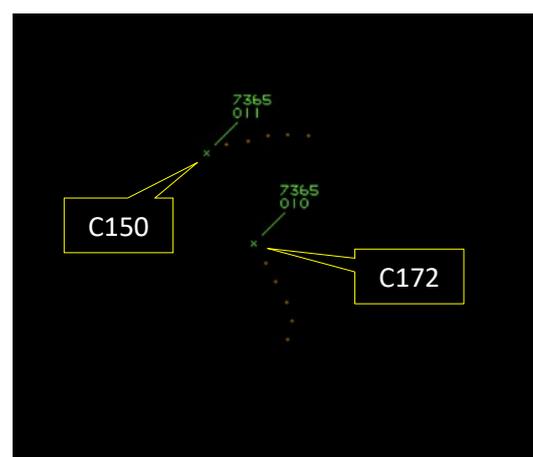
Figure 2 – 1032:52. 10kt speed differential

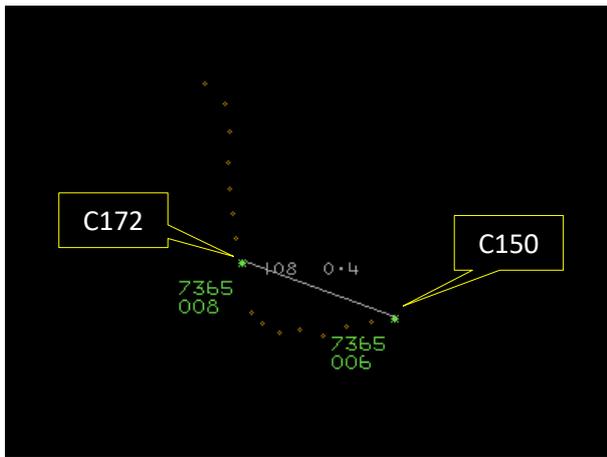
At 1036:00 the pilot of the C150 reported final and was given the runway by the AFISO (see Figure 3). Somewhere between the times of 1037:00 and 1037:15 the pilot of the C172 reported on final, and then 5sec later, before the AFISO could reply, reported going-around (see Figures 4 & 5). At 1037:54 both aircraft were visible in the climb-out, 0.6NM apart (see Figure 6).

Figure 3 – 1036:00. Separation of 0.4NM

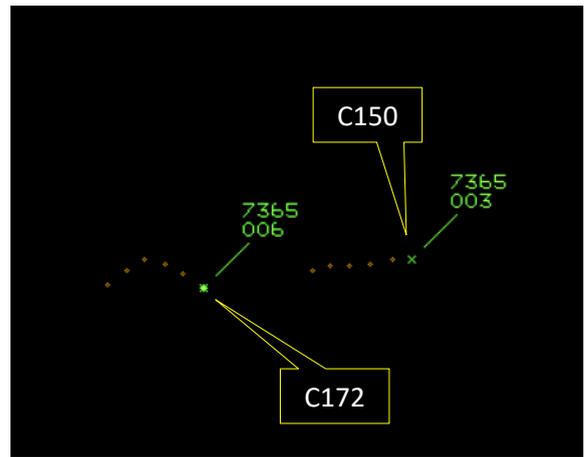
Figure 4 – 1037:00. Separation of 0.6NM

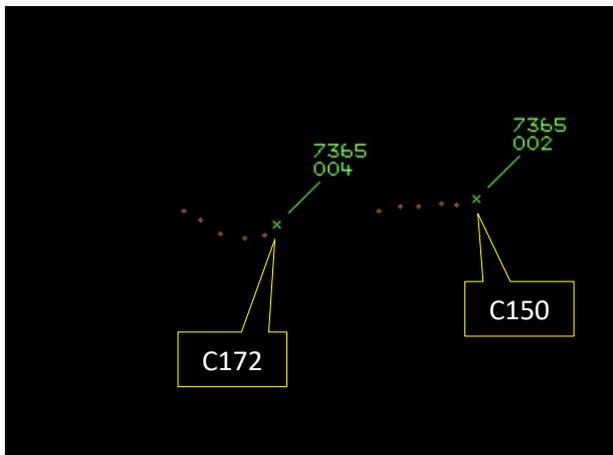
Figure 5 – 1037:10. Separation of 0.7NM

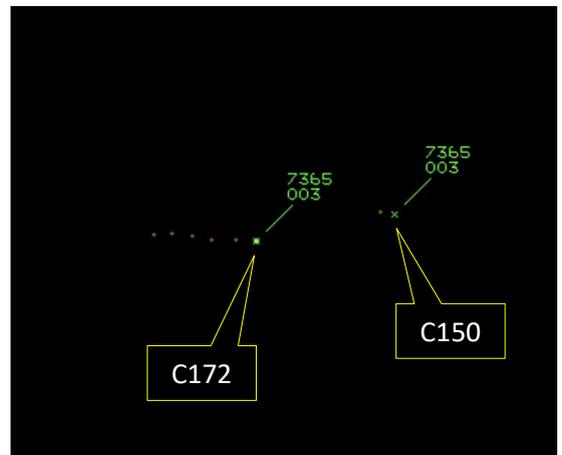
Figure 6 – 1037:54. Separation of 0.4NM

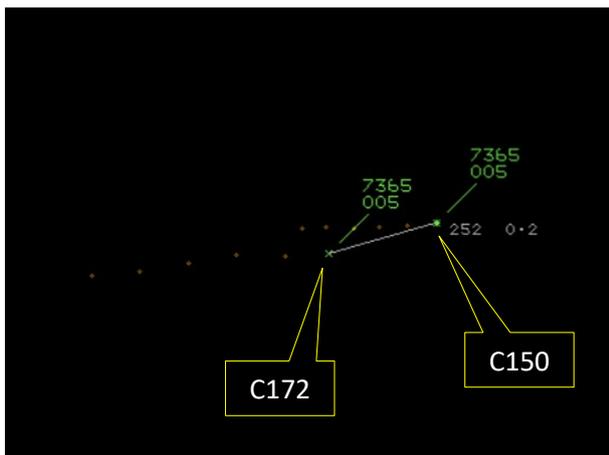
At 1038:17 the distance between both aircraft was observed to be reducing, with the groundspeed of the C172 calculated by the system to be 87kts and the C150 ahead, 54kts (see Figure 7).

Figure 7 – 1038:17. Separation of 0.2NM

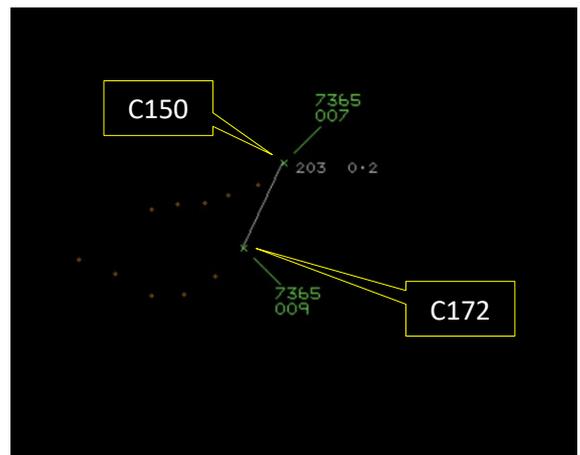
Figure 8 – 1038:45. Separation of 0.2NM

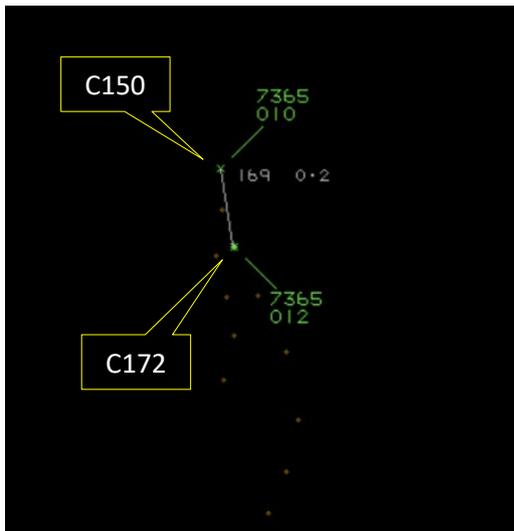
Between the times of 1039:25 and 1039:47 the Barton AFISO asked the pilot of the C172; “(c/s) just confirm you’re visual with the other Cessna in the circuit?”. The C172 pilot reported “negative”, and the AFISO continued “roger – believe that traffic’s on your left-hand side, turning downwind”, to which the C172 pilot replied; “traffic in sight” (see Figures 9 & 10). CPA occurred at 1039:38 with the aircraft 100ft and 0.1NM apart (see Figure 11).

Figure 9 – 1039:25. 29kt speed differential

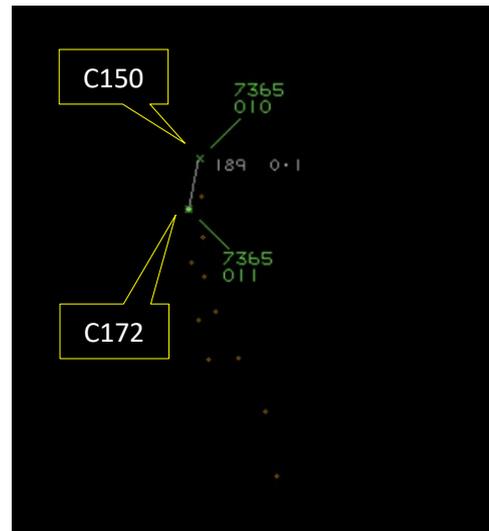
Figure 10 – 1039:31. Separation of 0.1NM

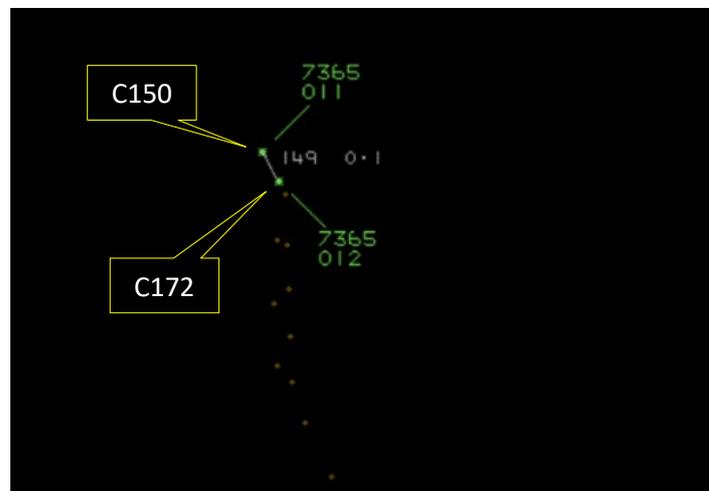
Figure 11 – CPA at 1039:38

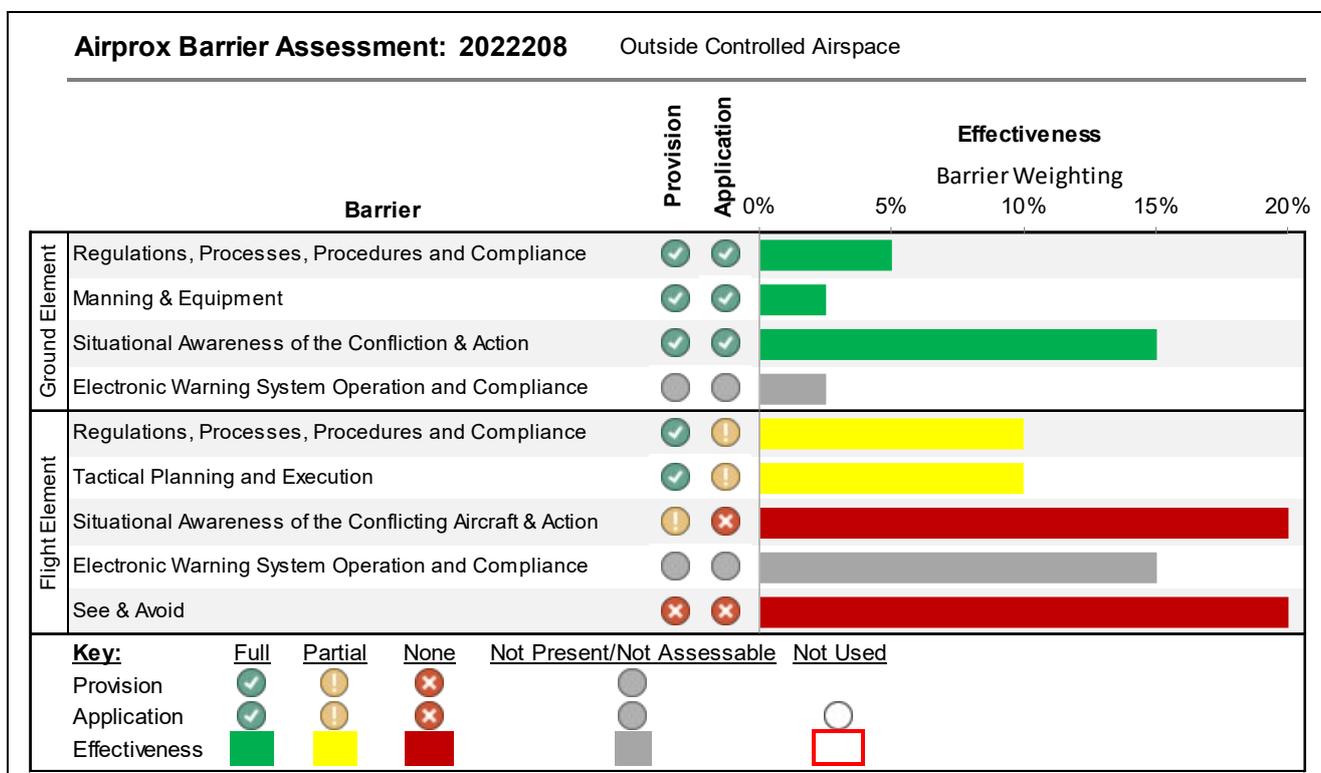
Regulations, Processes, Procedures and Compliance were assessed as **partially effective** because the pilot of the C172 had not maintained visual contact with the C150 in accordance with the go-around procedure published in the entry for Manchester Barton in the AIP.

Tactical Planning and Execution was assessed as **partially effective** because there had been insufficient adaptation of the dynamic plan by the pilot of the C172 following confusion in the execution of the go-around procedure.

Situational Awareness of the Conflicting Aircraft and Action were assessed as **ineffective** because, notwithstanding the generic Situational Awareness that each pilot had, the pilot of the C172 had not garnered specific information to enhance their Situational Awareness as the incident had unfolded.

See and Avoid were assessed as **ineffective** because the pilot of the C172 had effectively not seen the C150 until it had emerged from below and to the left of them.
