AIRPROX REPORT No 2022221

Date: 21 Sep 2022 Time: 1707Z Position: 5116N 00118W Location: 5NM NNW Popham

PART A: SUMMARY OF INFORMATION REPORTED TO UKAB

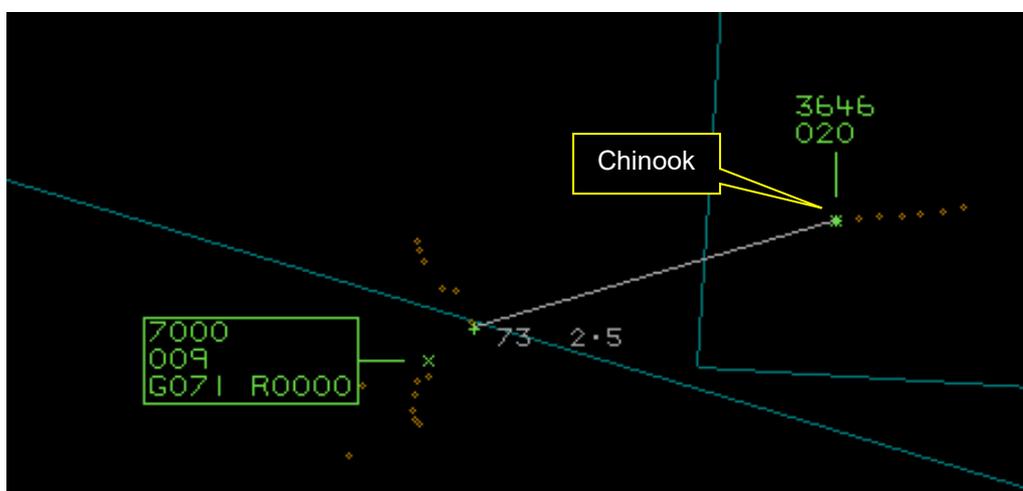
Figure 1: 1658:31 Traffic information provided to the Chinook (3646 Squawk).

The Chinook departed Odiham airfield and requested a Basic Service at 1655:41. The Odiham Approach controller provided Traffic Information at 1658:31, “two tracks, west 2 miles tracking west and correction, east and southeast no height information” (see Figure 1). The Odiham Approach controller reported a hot-air balloon previously reported in the vicinity. The Chinook pilot reported the hot-air balloon in sight along with another track. Further transmissions by the pilot were broken unreadable. The separation was measured at 2.5NM with no height information on the non-squawking aircraft and 2.8NM with 1100ft height separation on the 7000 squawk.

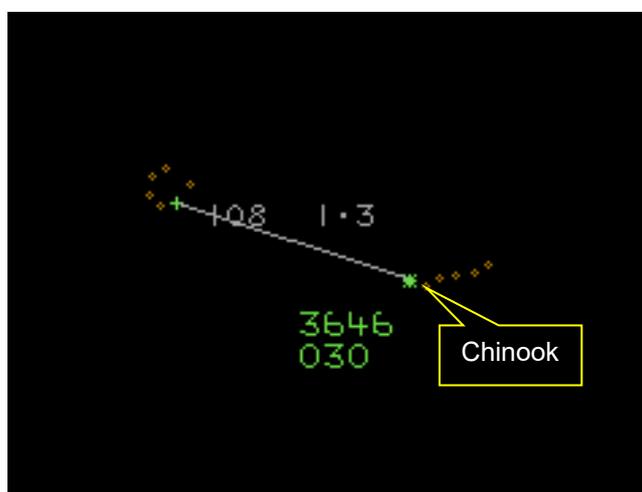
Figure 2: 1706:32 CPA

Figure 2 shows a primary track that transited southeast, before tracking west and then conducting a left-hand orbit, prior to continuing southeast. The primary track displayed intermittently throughout its transit, with Figure 2 displaying the CPA laterally at 1.3NM. The primary track disappeared on the next radar sweep and reappeared 1NM further southeast. The Odiham Approach controller provided the Chinook pilot with Traffic Information at 1706:53, “west 1 mile manoeuvring no height information, slow moving”. The Chinook pilot reported the aircraft in sight.
