AIRPROX REPORT No 2022219

Date: 26 Jul 2022 Time: 1316Z Position: 5244N 00253W Location: 4.5NM WNW Shrewsbury

PART A: SUMMARY OF INFORMATION REPORTED TO UKAB

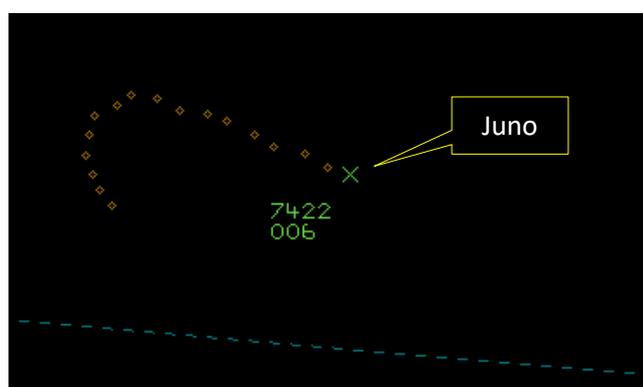
Figure 1 - CPA at 1315:32

An analysis of the NATS radar replay was undertaken and the Juno was positively identified from Mode S data. The Mavic Pro did not appear on radar (see Figure 1).

The Juno was observed on radar to be at FL006 at the time of CPA. The Shawbury QNH had been recorded as 1021hPa a few minutes later and it was therefore determined that the Juno had been at approximately 820ft AMSL and descending. The pilot of the Mavic Pro reported that their drone had been flying to a maximum height of 400ft AGL. The elevation of the terrain at the reported position of the Mavic Pro is approximately 240ft AMSL. It was therefore calculated that the vertical separation at CPA may have been a minimum of 180ft but this could not be positively determined. Based on the radar position of the Juno and the reported position of the Mavic Pro, the horizontal separation at CPA had been approximately 0.1NM but this could not be positively determined either. The diagram was constructed from the radar position of the Juno and its calculated altitude, and the reported position of the Mavic Pro.
