AIRPROX REPORT No 2022233

Date: 11 Aug 2022 Time: 1417Z Position: 5202N 00042W Location: 3.5NM SW Cranfield

PART A: SUMMARY OF INFORMATION REPORTED TO UKAB

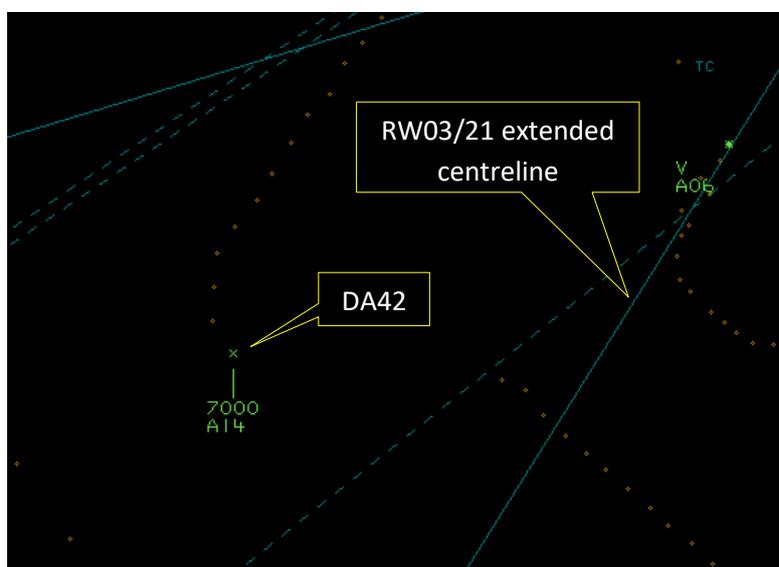
An analysis of the NATS radar replay was undertaken. The DA42 could be positively identified from Mode S data. No aircraft were observed on radar in proximity to the DA42 at the time of the reported CPA (see Figure 1). The diagram was constructed from the radar data and the reported position of the glider.

Figure 1 – The DA42 pilot had turned onto base-leg at approximately 1417
