## AIRPROX REPORT No 2022240

Date: 11 Oct 2022 Time: 0820Z Position: 5150N 00117W Location: Oxford ATZ

### PART A: SUMMARY OF INFORMATION REPORTED TO UKAB

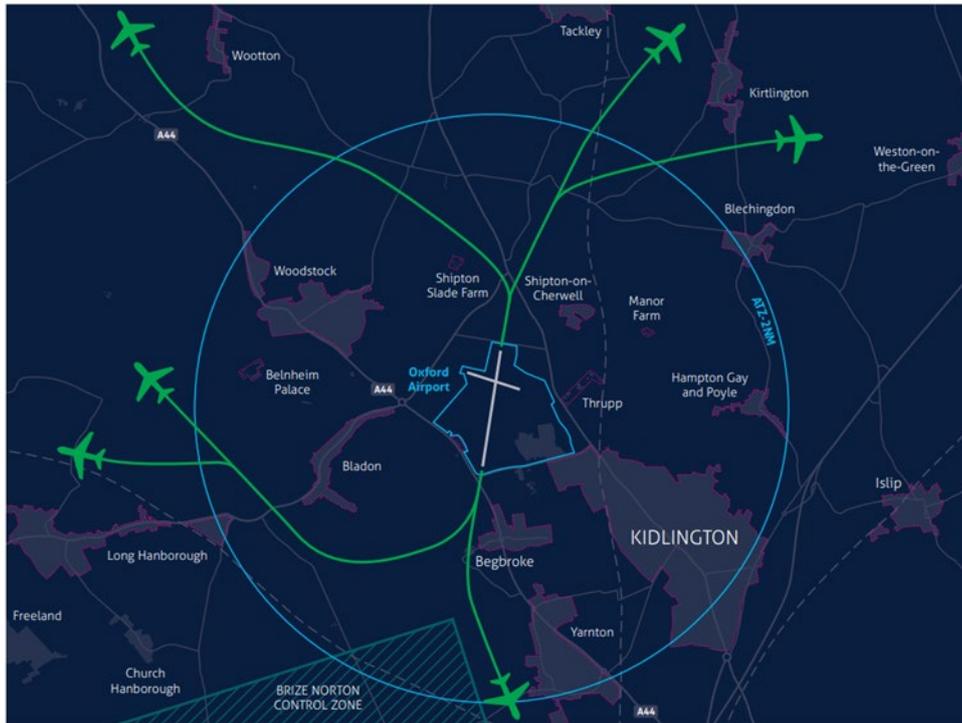
*'After departing from Runway 19, climb straight ahead to 1000ft QNH or 1 DME I-OXF, whichever is earlier, before turning right. Aircraft intending to turn left, climb ahead to 1.5 DME I-OXF (IFR) or until south of Yarnton Village (VFR), .....*

The Oxford Airport website also has more detailed information on the noise abatement requirements including a map of what are effectively the areas to avoid, see Figure 1.

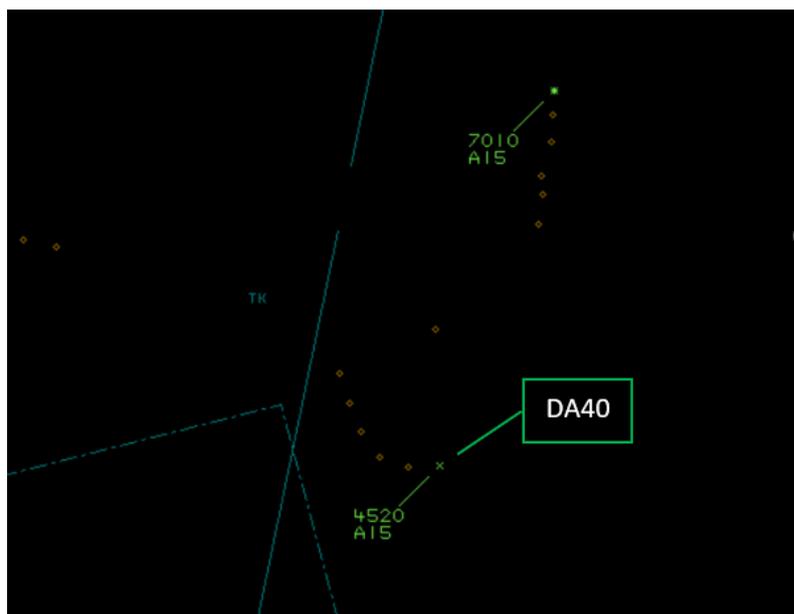
The DA40 pilot's turn into the circuit appears to give a good indication of a "standard pattern", see Figure 2.

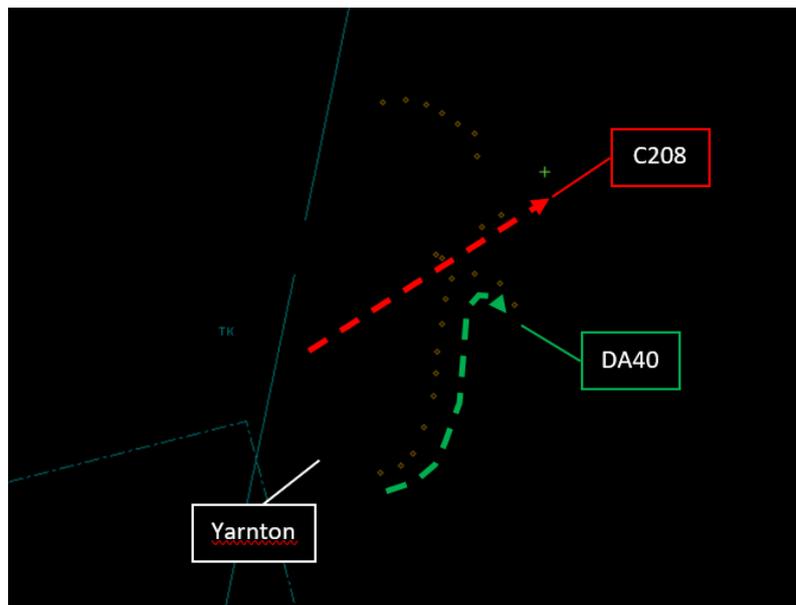
Working backwards, once the track of C208 became visible, it does appear that the turn was made north of Yarnton, Figure 3.

ATSI wondered if, when the pilot of the C208 requested a “left turn”, they had actually meant an “early left turn”, (which, if requested, could not have been approved).

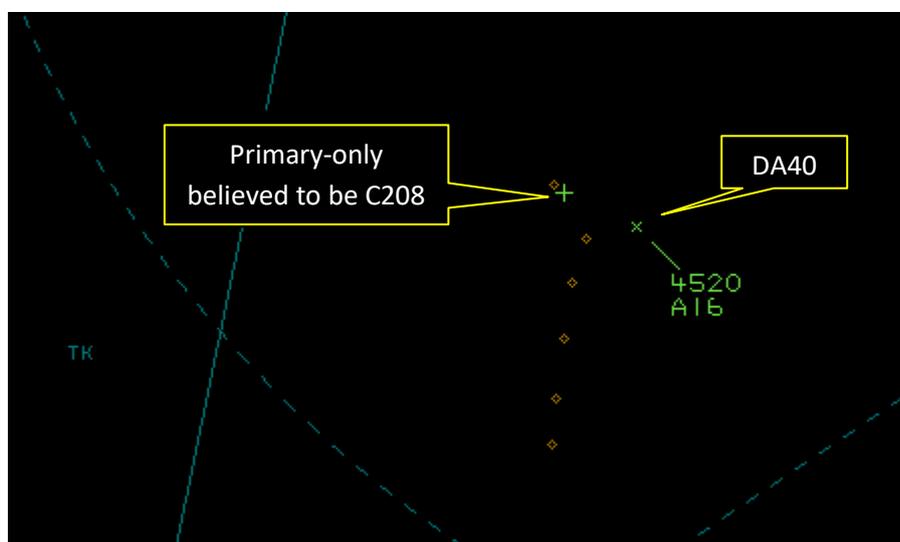
An analysis of the NATS radar replay was undertaken and the DA40 was detected and identified using Mode S data. There was no secondary radar return detected from the C208, however a primary return appeared on the radar one sweep before the orbit carried out by the DA40 pilot was observed, therefore it is likely that this primary return was generated by the C208, Figure 1.

Figure 1 – DA40 and primary return believed to be the C208.

Without radar altitude information for the C208 it has not been possible to measure the vertical separation however, the horizontal separation was measured as 0.3NM.
