## AIRPROX REPORT No 2022251

Date: 18 Oct 2022 Time: 1422Z Position: 5111N 00039E Location: Lashenden/Headcorn ATZ

### PART A: SUMMARY OF INFORMATION REPORTED TO UKAB

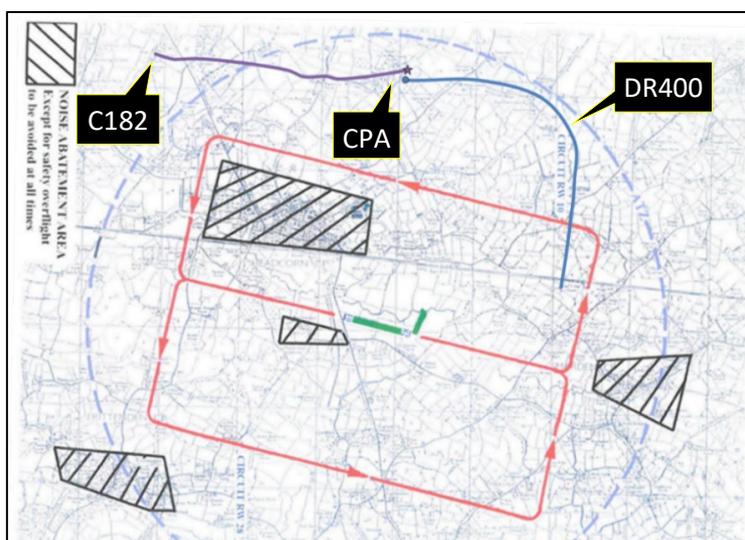
Figure 1 - The noise abatement diagram for Lashenden/Headcorn. The approximate tracks of the DR400 and C182 have been overlaid.

The Board first considered the actions of the pilot of the DR400 and it was noted that they had flown a wide circuit, particularly to the north, but had remained within the ATZ. Whilst curious why that had been the case, members' attention turned to the website for Lashenden/Headcorn and, in particular, the diagram provided that indicated the areas that, for noise abatement purposes, pilots should avoid overflying. Noting that the diagram included a depiction of the circuit within the ATZ, some members suggested that the drawn lines had appeared to indicate the exact track to be followed when in the circuit. Members were keen to point out that such diagrams are often constructed with a line depicting the circuit merely to convey an understanding of circuit direction and typical dimensions. Such a diagram

might be useful to a pilot unfamiliar with the local area and visual reference points for example, but a visiting pilot ought to be mindful that they may encounter a markedly different circuit size on occasion.

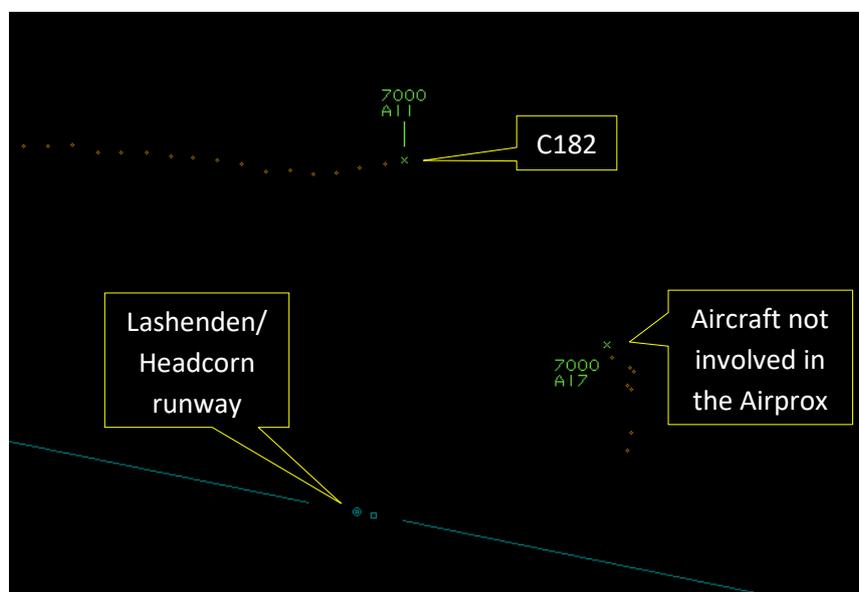
An analysis of the NATS radar replay was undertaken and the C182 was identified from Mode S data (see Figure 2). The DR400 was not observed on radar, even as a primary return. The pilot of the DR400 kindly supplied a GPS data file of their track. It was with these separate sources that the diagram was constructed and the separation at CPA assessed.

Figure 2 – CPA at 1421:35
