AIRPROX REPORT No 2022255

Date: 29 Oct 2022 Time: 1028Z Position: 5112N 00049E Location: 5NM NNW Ashford

PART A: SUMMARY OF INFORMATION REPORTED TO UKAB

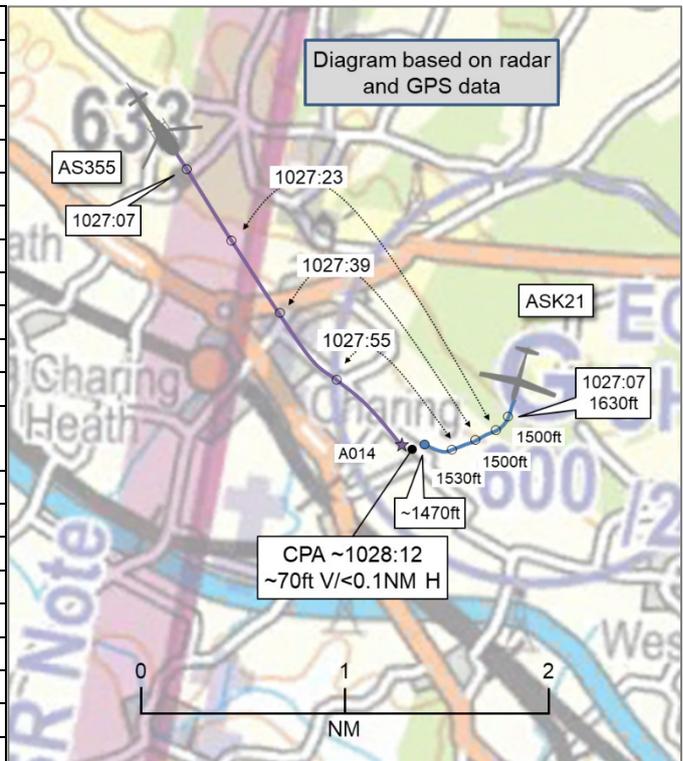
Recorded	Aircraft 1	Aircraft 2
Aircraft	ASK21	AS355
Operator	Civ Gl'd	Civ Comm
Airspace	London FIR	London FIR
Class	G	G
Rules	VFR	VFR
Service	None	None ¹
Provider	Challock (CGFF ²)	Challock (CGFF)
Altitude/FL	1470ft	1400ft
Transponder	Not fitted	A, C, S
Reported		
Colours	White	Blue
Lighting	None	Anti-col, Strobe, Nav
Conditions	VMC	VMC
Visibility	>10km	>10km
Altitude/FL	1000ft	1500
Altimeter	QFE (NK hPa)	QNH (1014hPa)
Heading	225°	170°
Speed	50kt	110kt
ACAS/TAS	FLARM	PilotAware
Alert	None	None
Separation at CPA		
Reported	50ft V/400m H	Not seen
Recorded	~70ft V/<0.1NM H
