AIRPROX REPORT No 2022264

Date: 22 Nov 2022 Time: ~1155Z Position: 5059N 00207W Location: Compton Abbas ATZ

PART A: SUMMARY OF INFORMATION REPORTED TO UKAB

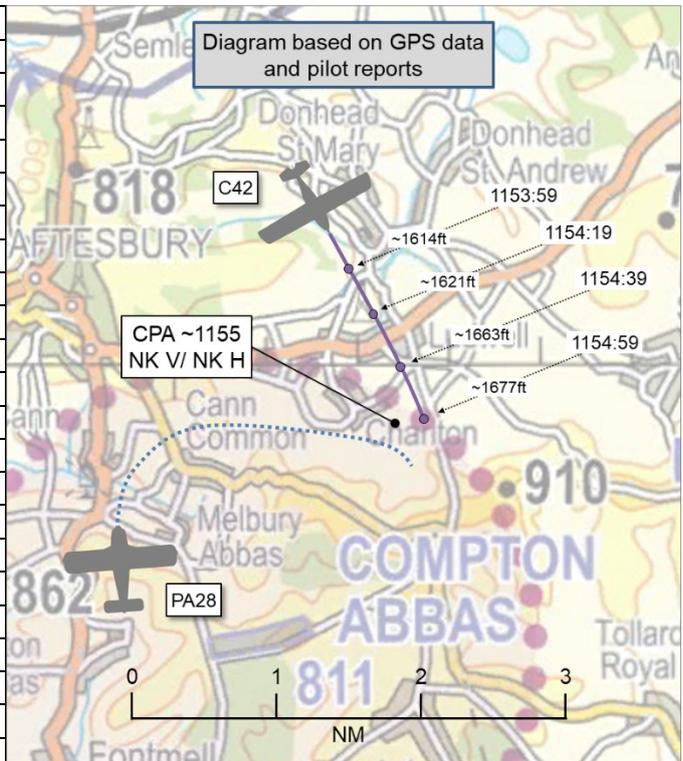
An analysis of the NATS radar replay was undertaken. Due to poor low-level radar coverage in the area, neither aircraft could be observed on radar. The UKAB Secretariat obtained limited GPS data from which the PA28 was observed within the Compton Abbas ATZ although its exact position could not be determined. The pilot of the C42 kindly supplied GPS track data of their flight. It is with the GPS track data and an integration of the pilot's narrative reports that the diagram was constructed and the CPA assessed.
