**AIRPROX REPORT No 2022275**

Date: 08 Dec 2022 Time: 1512Z Position: 5049N 00055W Location: Thorney Island

**PART A: SUMMARY OF INFORMATION REPORTED TO UKAB**

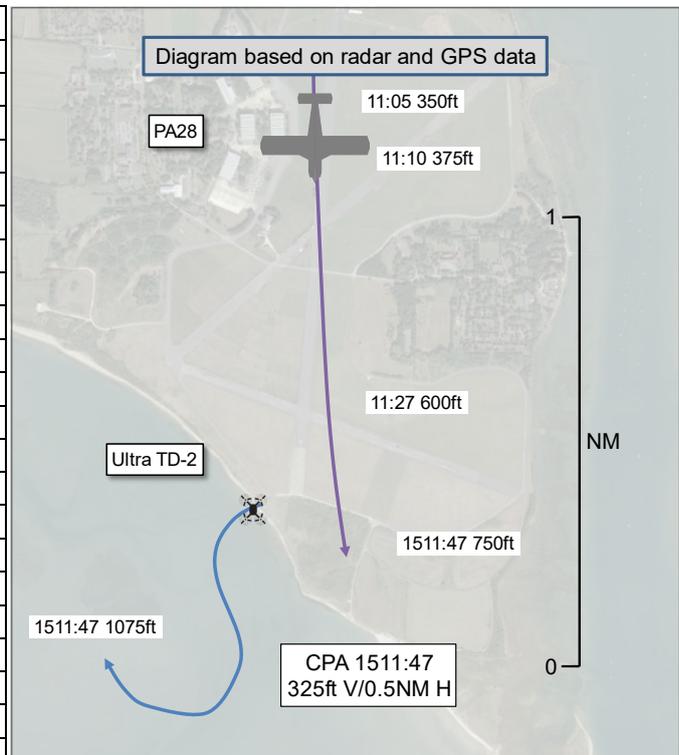
**THE ULTRA TD-2 OPERATOR** reports operating the UAS with a safety pilot and a Ground Control Station (GCS) operator. They were making radio calls on SafetyCom. They did not hear from the other pilot. They were at altitude in the circuit when the other aircraft came in from 600ft (within the NOTAM) which required them to change course. They were downwind left RW29. The other aircraft cut across, heading south.

An Airprox was reported when an Ultra TD-2 UAS and a PA28 flew into proximity at Thorney Island at 1512Z on Thursday 8<sup>th</sup> December 2022. Both pilots were operating in VMC, the UAS pilot under VLOS and not in receipt of a FIS, the PA28 pilot under VFR and listening out on Lee Information.

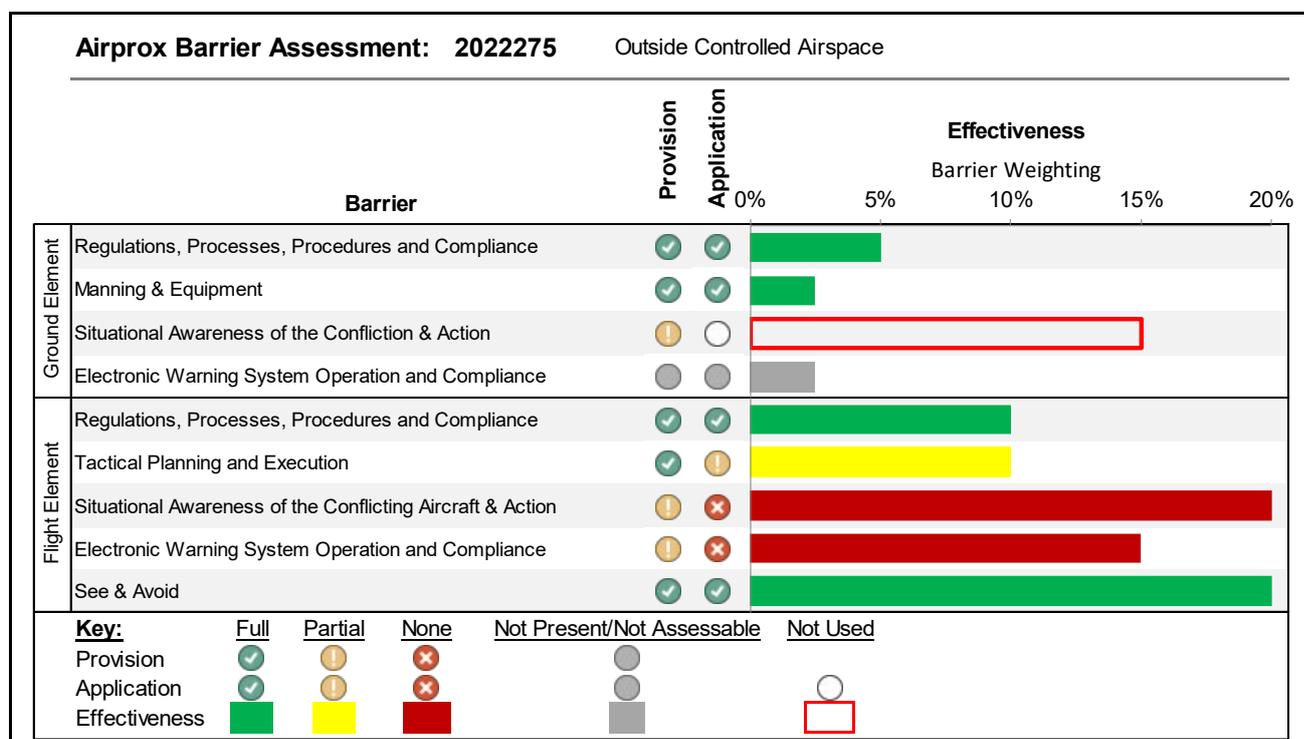
**Situational Awareness of the Confliction and Action** were assessed as **not used** because the AFISO was not required to monitor the PA28.

**Tactical Planning and Execution** was assessed as **partially effective** because the PA28 crew had not included the NOTAM activity in their plan.

**Situational Awareness of the Conflicting Aircraft and Action** were assessed as **ineffective** because the UAS operator was not aware of the PA28 until sighted and the PA28 crew appeared to be unaware of the UAS operation.

**Electronic Warning System Operation and Compliance** were assessed as **ineffective** because the PA28 TAS did not alert when it could have been expected to do so.
