AIRPROX REPORT No 2022277

Date: 18 Oct 2022 Time: 1554Z Position: 5235N 00100W Location: Leicester

PART A: SUMMARY OF INFORMATION REPORTED TO UKAB

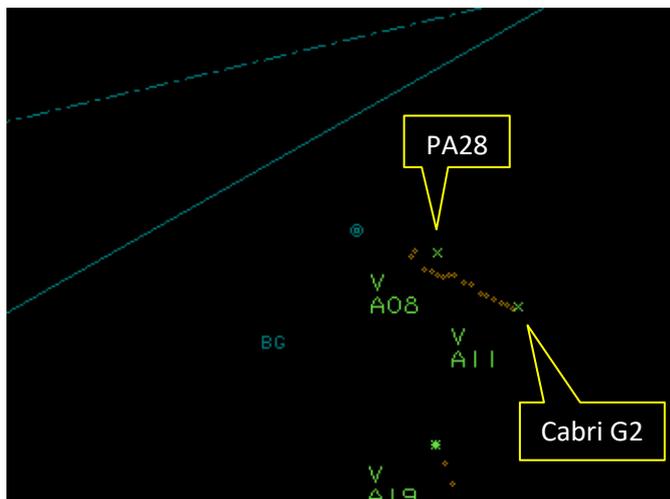
Figure 1 - 1553:28

An analysis of the NATS radar replay was undertaken, both aircraft displayed on the radar replay in SSR only, probably due to being below the primary radar coverage, and both could be identified using Mode S information. The PA28 first appeared on the radar at 1553:28, indicating 800ft (radar QNH 1027hPa).

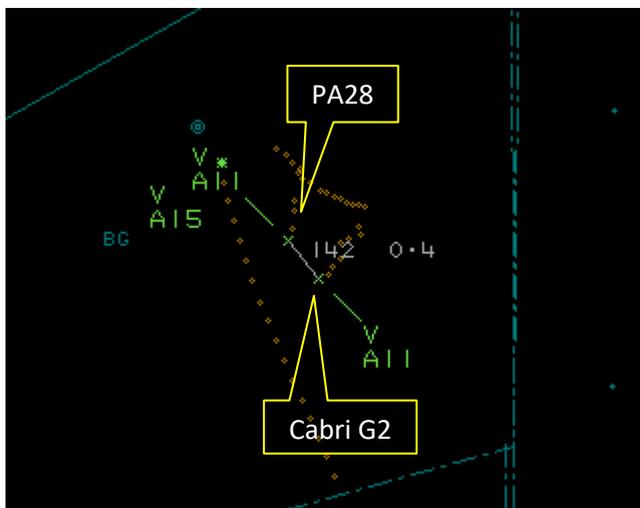
Figure 2 - 1554:03

The PA28 turned onto a southerly heading and at 1554:03 both aircraft were indicating the same altitude at 0.4NM apart, Figure 2.

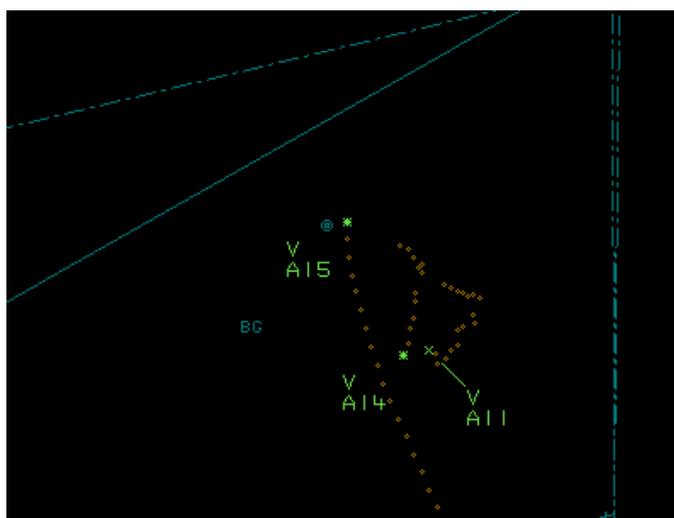
Figure 3 - CPA 1554:11

The radar return for the Cabri was subject to some radar jitter, but the radar appeared to show the Cabri pilot taking avoiding action and CPA was assessed to have occurred at 1554:11, Figure 3.

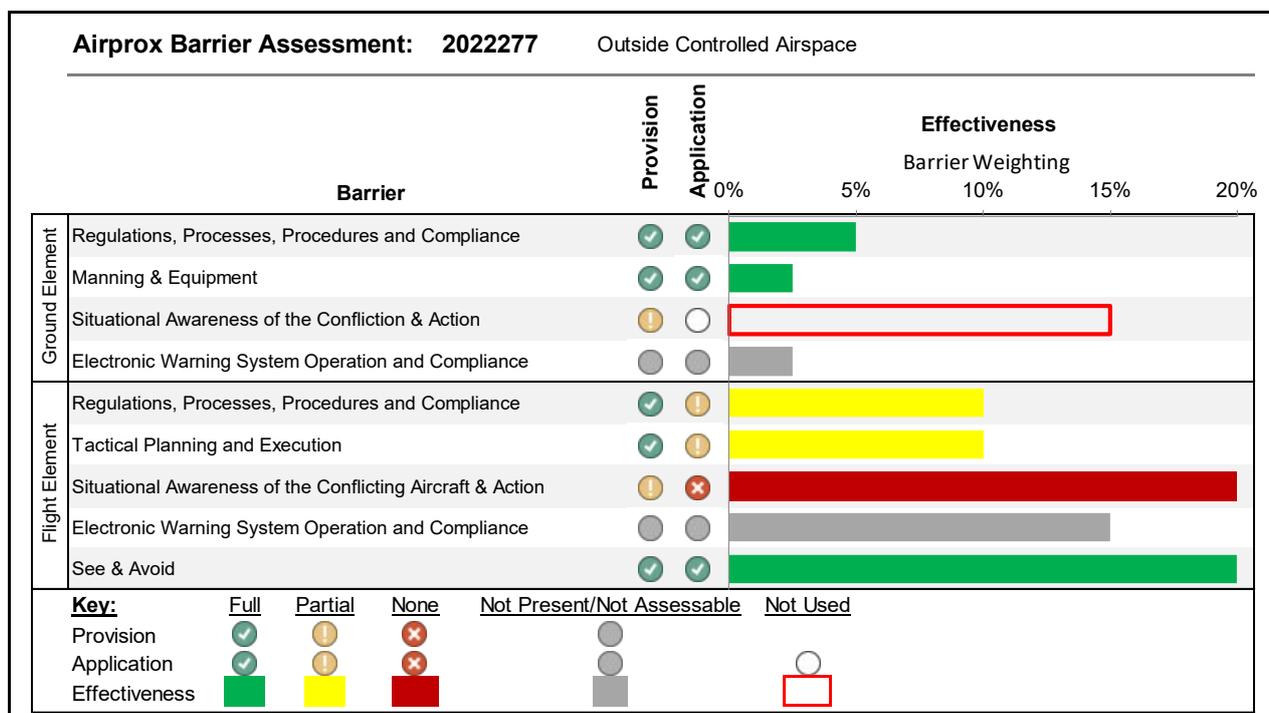
Situational Awareness of the Confliction and Action were assessed as **not used** because the AGO at Leicester had not been required to sequence the aircraft.

Regulations, Processes, Procedures and Compliance were assessed as **partially effective** because the PA28 pilot had flown in front of the Cabri G2 on the downwind leg of the rotary-wing circuit.

Tactical Planning and Execution was assessed as **ineffective** because the PA28 pilot had not conformed to the pattern of traffic formed by the Cabri G2.

Situational Awareness of the Conflicting Aircraft and Action were assessed as **ineffective** because the PA28 pilot had not assimilated the position of the Cabri G2.
