## AIRPROX REPORT No 2022209

Date: 29 Jul 2022 Time: 1343Z Position: 5208N 00036W Location: 4NM N Cranfield

### PART A: SUMMARY OF INFORMATION REPORTED TO UKAB

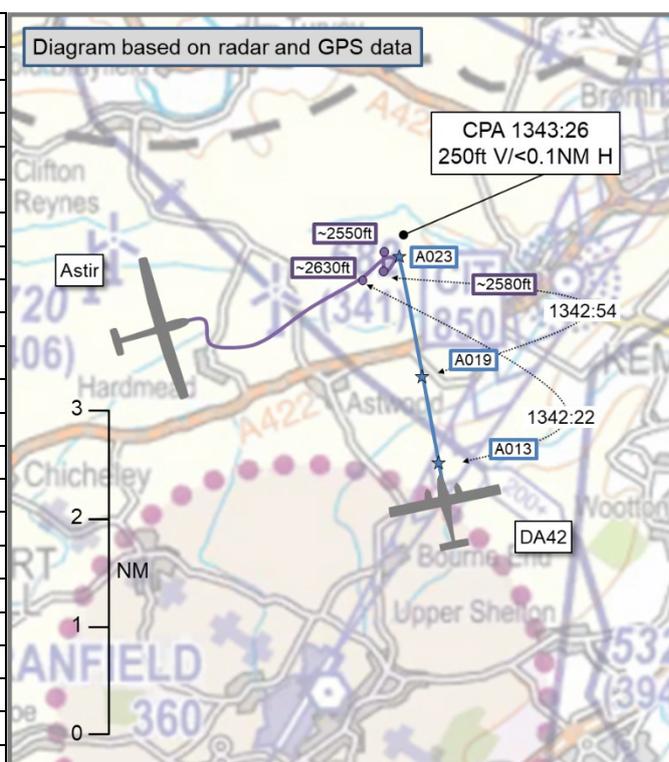
Recorded	Aircraft 1	Aircraft 2
Aircraft	DA42	Grob Astir
Operator	Civ FW	Civ Gld
Airspace	London FIR	London FIR
Class	G	G
Rules	VFR	VFR
Service	Establishing	None
Provider	Cranfield	
Altitude/FL	2300ft	~2550ft
Transponder	A, C, S	Not fitted
Reported		
Colours	White	White
Lighting	NR	None
Conditions	VMC	VMC
Visibility	NR	NR
Altitude/FL	2500ft	NK
Altimeter	NK	NK
Heading	North	NK
Speed	100kt	NK
ACAS/TAS	TAS	FLARM
Alert	None	None
Separation at CPA		
Reported	300ft V/100m H	Not Seen
Recorded	~250ft V/<0.1NM H

Initially, a transponder equipped glider (squawking 7000 on Figure 1), was traced as the likely Airprox glider because, at around 1345, the DA42 crossed 300ft above this glider. However, given that this did not accord with the DA42 pilot's report on descending to avoid, further analysis was undertaken using a GPS data tool which showed numerous gliders in the area at this time, including the Astir thermalling at around 2600ft. The Cranfield RT available did not have a relevant time stamp, however, after initially calling Cranfield "[C/S] Cranfield Approach just passing 2400" the call appeared to be abruptly stopped. The controller replied with an acknowledgement and applied a Basic Service, and the DA42 pilot reported "Yeah, Basic Service, er, that was a glider just going across us". The controller confirmed that there were no gliders on frequency (Cranfield is not equipped with radar). Given that the NATS radar indicated that the DA24 was approaching 2400ft at 1343, it is likely that the Airprox occurred at around this time. As a consequence to initially tracing the incorrect glider pilot, there was a significant delay and, when contacted, the Astir pilot had no recollection of the event. GPS data was compared to the radar data to compile the diagram at the top of the report and provide an approximate separation.

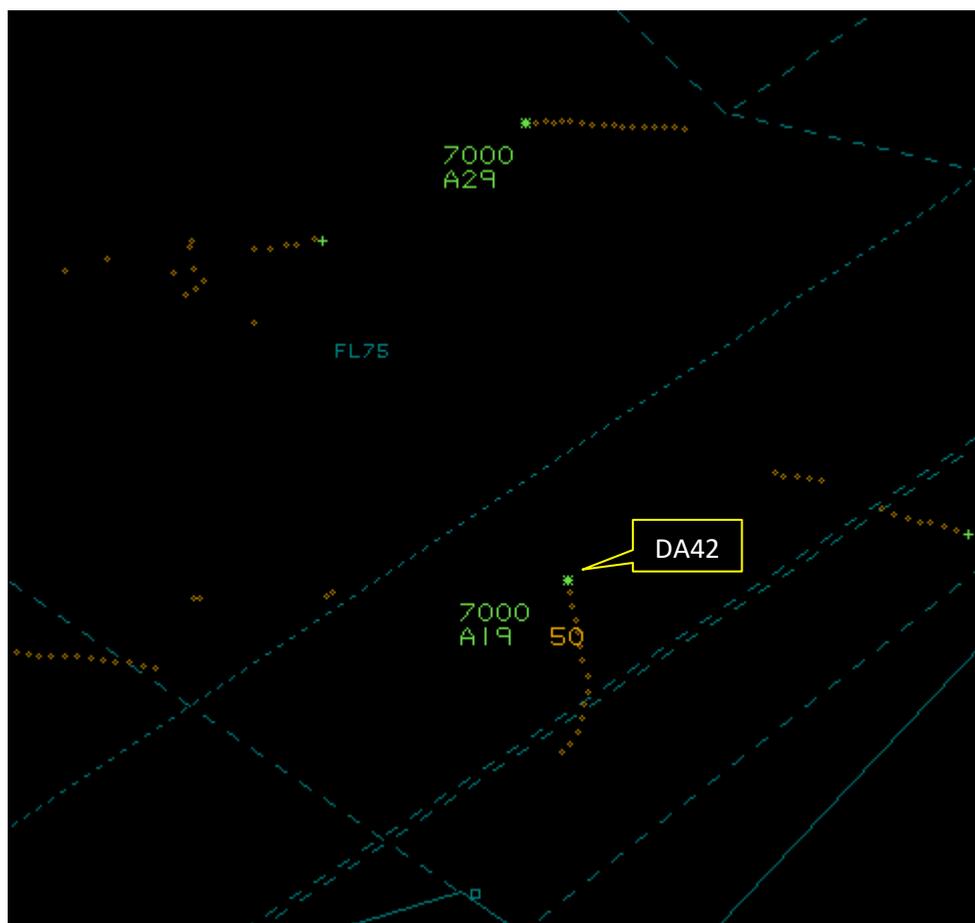
Figure 1- 1342:52

An analysis of the NATS radar replay was undertaken. The DA42 could be seen climbing out of Cranfield (see Figure 1). A number of primary radar returns, which were possibly gliders, could be seen in the area, although none in close proximity to the DA42.

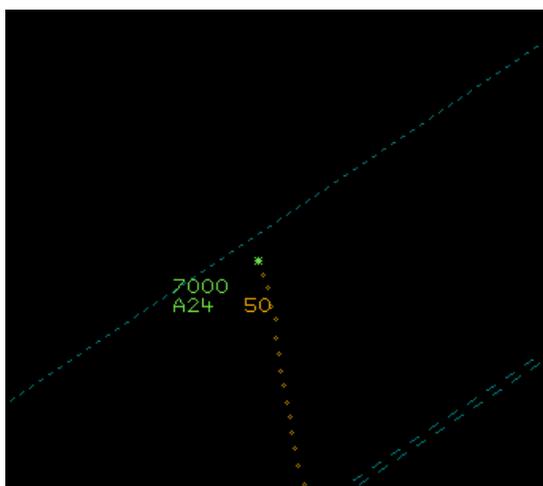
Figure 2 -1343:22

By 1343:22 the DA42 could be seen passing 2400ft, still climbing (Figure 2), however, on the next radar sweep the DA42's altitude indicated 2300ft (Figure 3), before returning to 2400ft and continuing the climb. No other radar returns could be seen in the area at this time.
