ASSESSMENT SUMMARY SHEET FOR UKAB MEETING ON 14 SEPTEMBER 2011

AIRPROX REPORT No 2011024

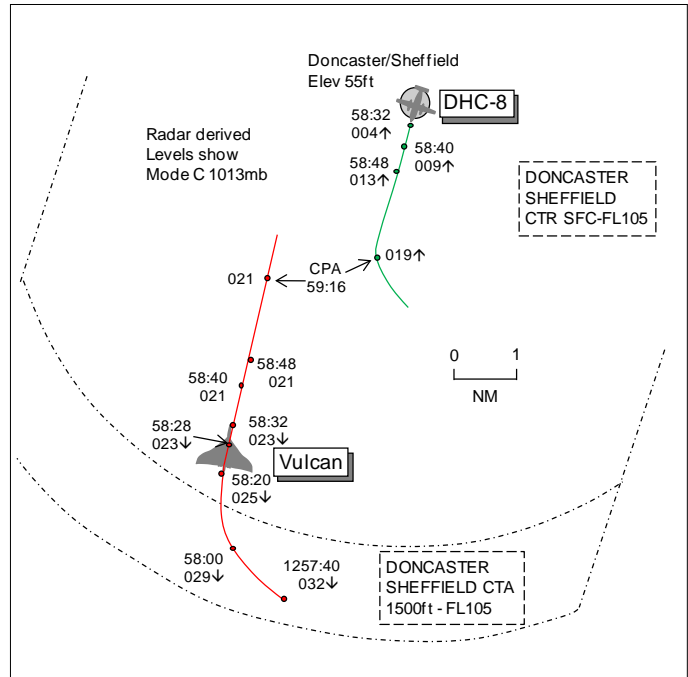
Cause: Late recognition that the Vulcan was not flying in accordance with the controller's expectations.

CAA ATSI recommends that the ATSU reminds controllers of the requirement to ensure that non-operational conversations must not be permitted to interfere with a controller's operational duties. MATS Part1, Appendix E, Page 2, paragraph 2, states:

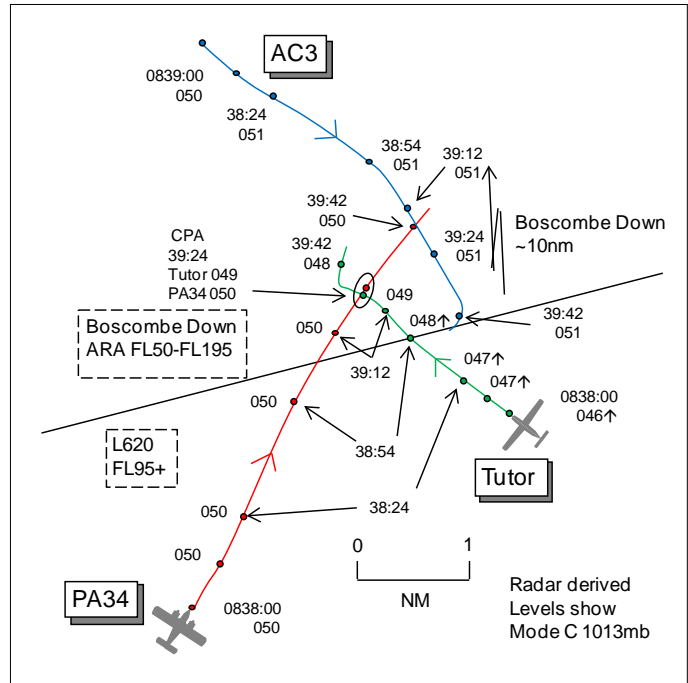
Cause: A non-sighting by the PA34 crew and effectively a non-sighting by the Tutor pilot.

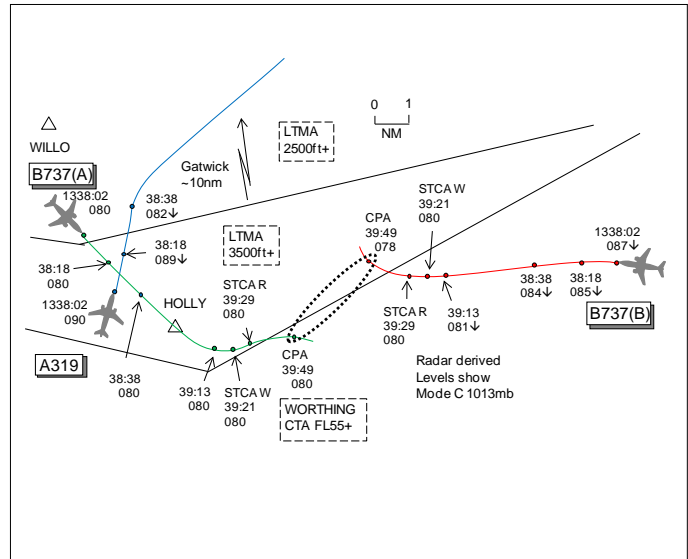
Cause: The Gatwick INT DIR vectored B737(B) into conflict with B737(A).

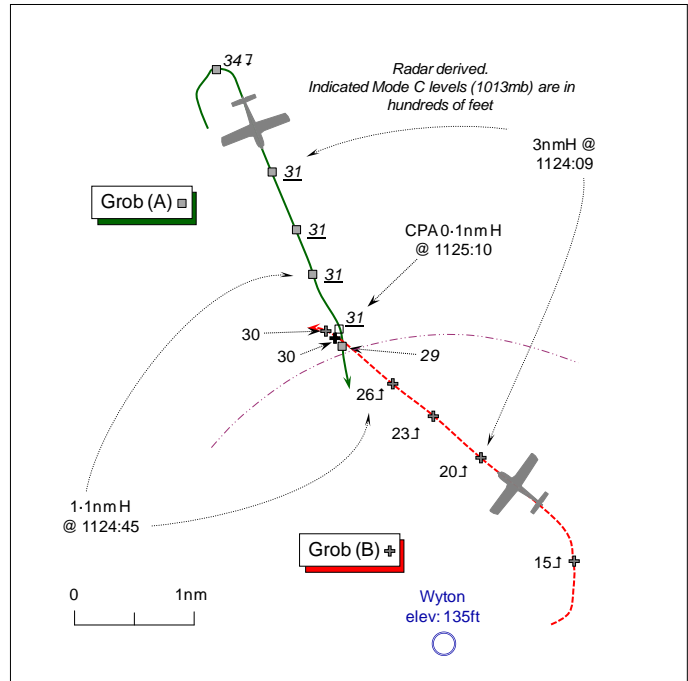
Cause: Effectively a non-sighting by Tutor (B) pilot and a late sighting by Tutor (A) crew.

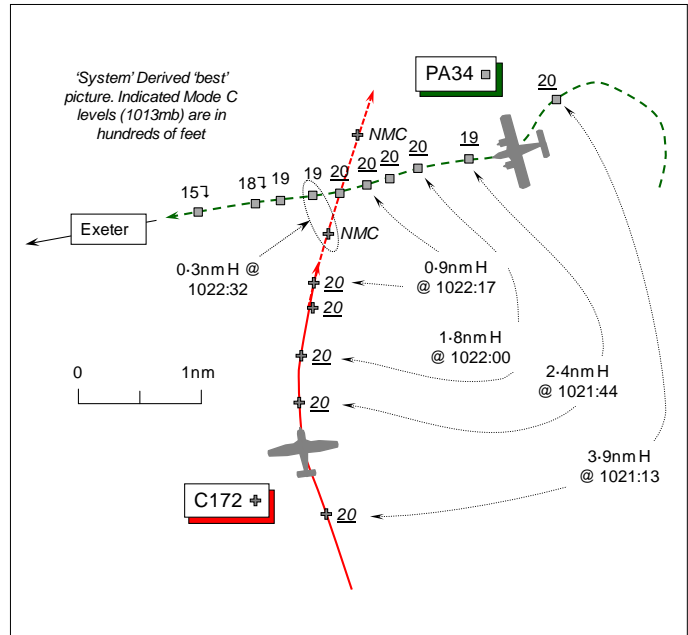
Cause: A late sighting by the C172 pilot.

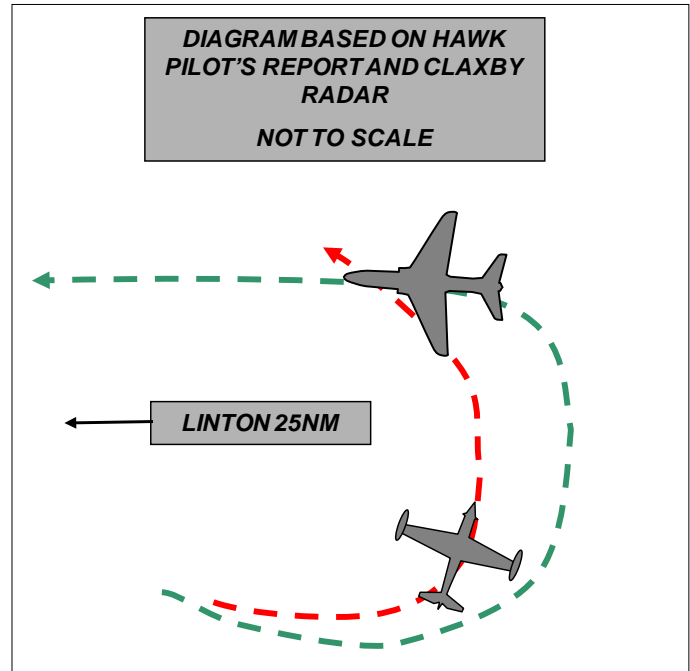
Cause: Sighting report.

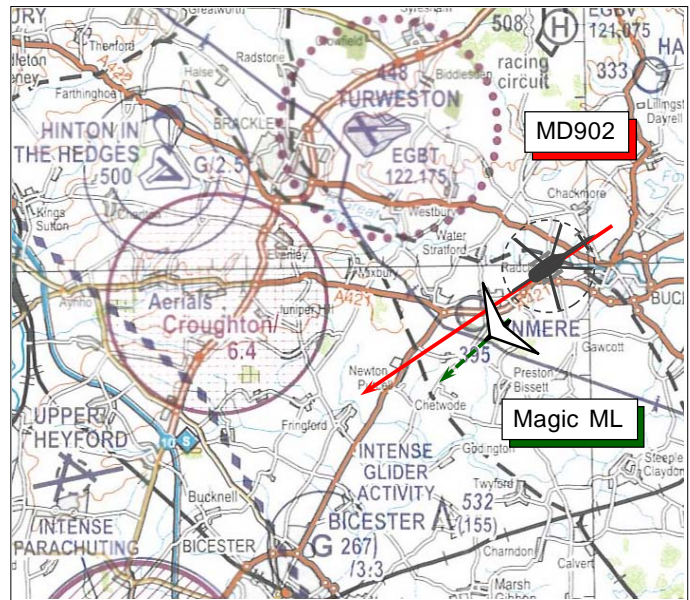
Cause: The MD902 pilot flew close enough to cause the flexwing ML pilot concern.

Recommendation: The Board was concerned that there have been a number of incidents in which Microlight/para gliders/hang gliders etc appear to have been affected by helicopters at unexpected distances and aspects. Director UKAB was

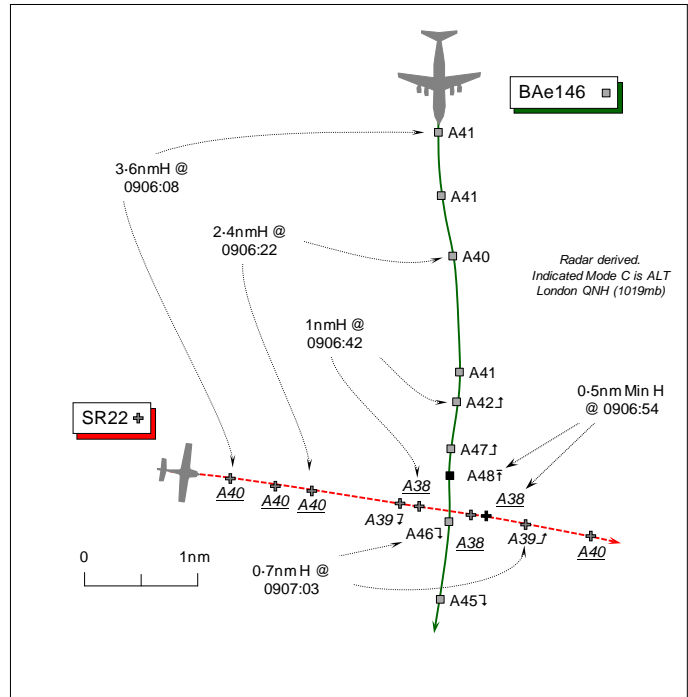
Cause: In the absence of specific TI, a conflict in Class G airspace resolved by the BAe 146 crew using TCAS.

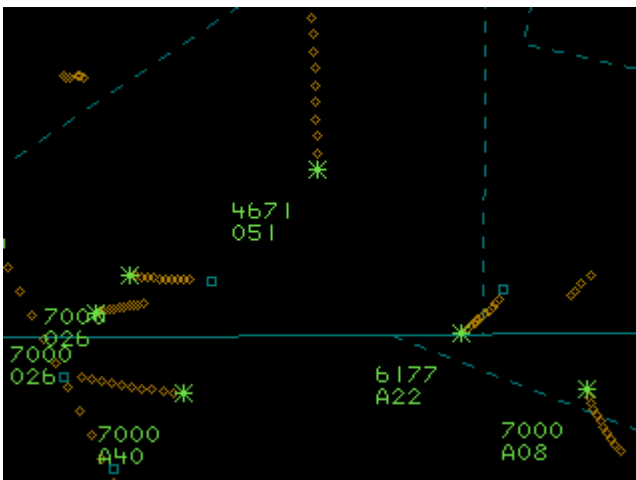
The traffic visible to Luton RADAR at this time is shown on the radar snapshot below:

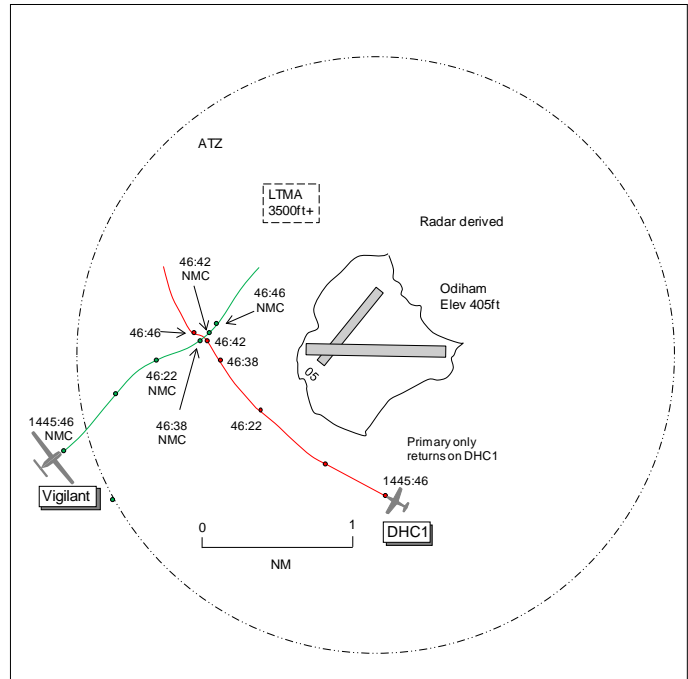
Cause: The DHC1 pilot flew unreasonably close to the Vigilant, causing its pilot concern.

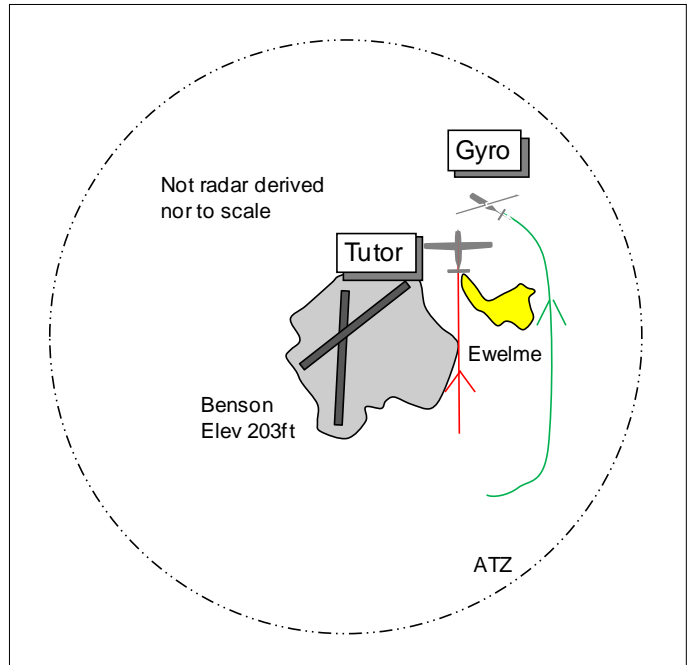
Cause: The Tutor pilot flew into conflict with the Gyroplane on final.

HQ AIR (TRG) agrees that the potential for conflict caused by the fact that the dissimilar ccts overlap make them unacceptable. Lapses in lookout are inevitable so deconfliction plans based solely on maintaining visual contact between dissimilar types (speeds or patterns) are not robust. That said, the FOB did require flying club ac to conform to 'oval (military) patterns'. It would appear that the flying club pattern conformed to the letter if not the spirit of the order, which would have been included to avoid just this sort of conflict. The safe integration of Stn-based ac is an implicit responsibility of the Stn Cdr, which he discharges through the FOB. Thus, SATCO's concerns should be staffed to the Stn Cdr for resolution of safety concerns and to ensure that operational, training and other priorities are balanced appropriately.

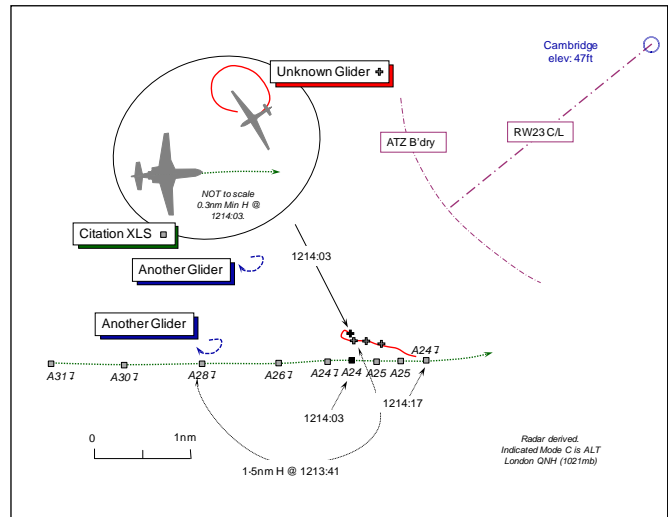
Cause: A late sighting by the Citation pilot.

CAA ATSI recommends that Cambridge ATSU promulgates any withdrawal of the radar service outside of the notified hours of operation by NOTAM.

CAA ATSI recommends that Cambridge ATSU, in the absence of radar, and during the notified of hours of gliding activity, remind pilots, that the Gransden Lodge Gliding Site is active.
