AIRPROX REPORT No 2011001

Date/Time: 4 Jan 2011 1549Z

Position: 5128N 00028W (O/H
Heathrow - elev 83ft)

Type: A319 BH06 JetRanger

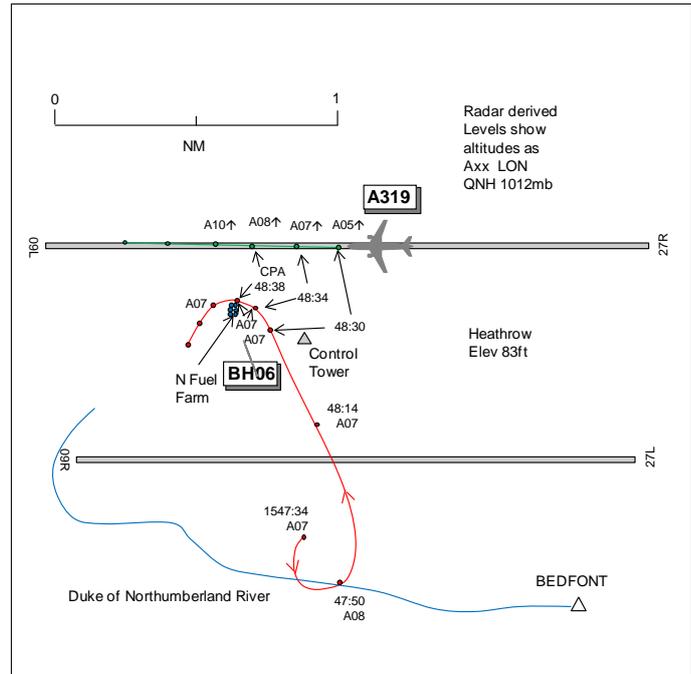
Reported Separation:

300ft V/<300m H NR

Recorded Separation:

100ft V/0.2nm H

At 1548:38 radar recording showed the BH06 at the most N'ly point of the loop in a L turn passing through a W'ly heading, indicating altitude 700ft. The A319 was indicating altitude 800ft and was positioned 0.2nm (370m) N of the helicopter.

The routing and height of the BH06 resulted in the helicopter disappearing from the view of both controllers for a short period. This together with the speed of the helicopter and sharp L turn over the Northern fuel farm gave the controllers an impression that the helicopter was adjacent to the A319. Radar recording showed that at the closest point, the helicopter was 370m S of the A319.
