AIRPROX REPORT No 2011019

Date/Time: 15 Mar 2011 1151Z

Position: 5146N 00156W
(2nm N Cirencester)

Type: Merlin DA42

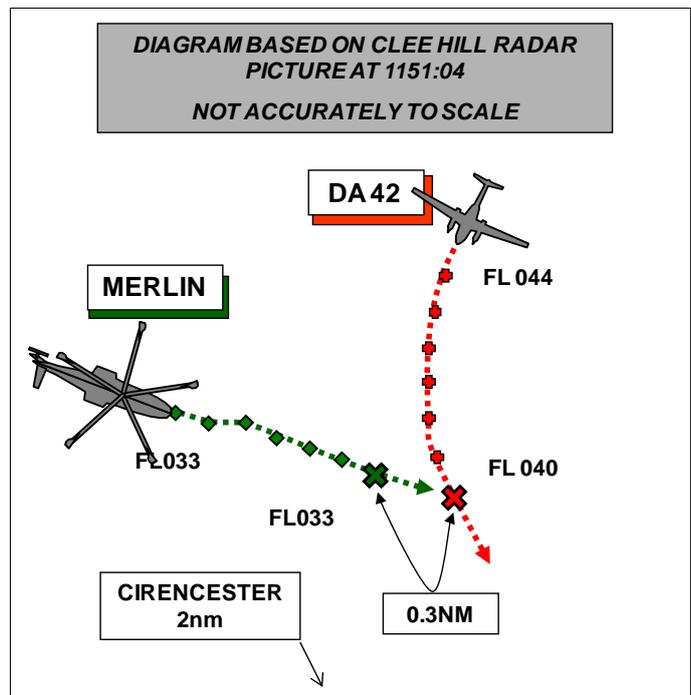
700ft V/0.3nm (540m) H

At 1149:23, the DA42 was approximately 5.6nm E of the Merlin, descending through 6000ft in a LH turn, with the Merlin maintaining 3300ft (SSR Mode C), which it does throughout the period. At some point after 1149:26, APP commenced a handover of the control position to another controller. The

At 1149:55 the DA42 rolled out of the left turn tracking W and then re-commenced the left turn at 1150:04, bringing it into conflict with the Merlin.

At 1150:55 it is clear that the handover of control position was complete since the voice recording showed a different voice as APP was liaising with TWR. It has not been possible to determine for how long this controller had assumed responsibility for the control position. At that point, the DA42 was 0.5nm E of the Merlin [at 3300ft] indicating 4100ft. The CPA occurred 1151:04 as the DA42 passed through the Merlin's 12 o'clock at 0.3nm and indicating 700ft above.
