AIRPROX REPORT No 2011072

Date/Time: 8 Jul 2011 0921Z

Position: 5259N 00104W (8nm E of ROBIN)

1st Ac BE200 King Air 2nd Ac Cessna C525

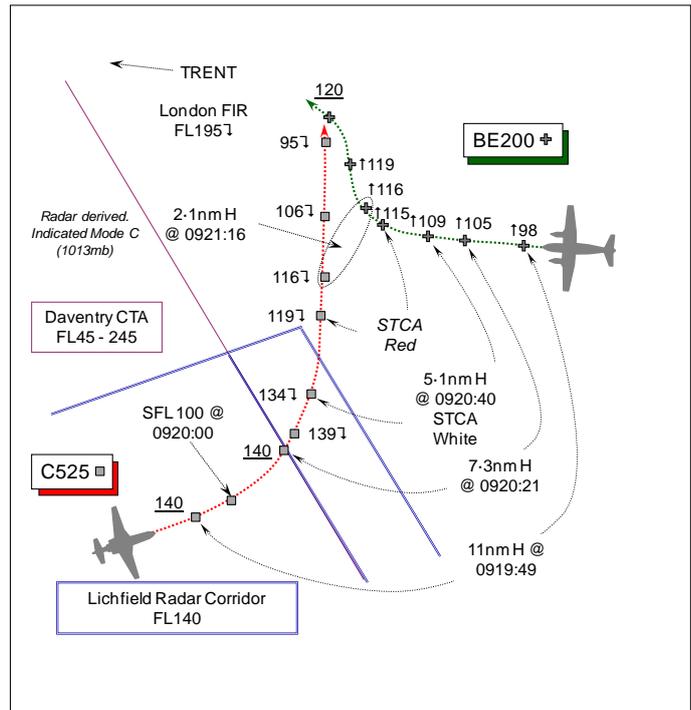
Nil V @ 2.1nm H

0.3nm Min H @ 2900ft V

its R turn. At a range of 2.5nm the BE200 was climbing through FL115 and the C525 descending through FL119 [STCA triggered high severity red, at 2.1nm the levels of the two ac crossed, both ac indicating FL116]. Vertical separation then increased with the C525, subsequently, passing 0.3nm behind the BE200, with vertical separation of 2900ft indicated.
