## AIRPROX REPORT No 2011100

Date/Time: 5 Aug 2011 1551Z

Position: 5308N 00033W (2nm SSW  
Waddington - elev 231ft)

Type: BN2T Islander BE350

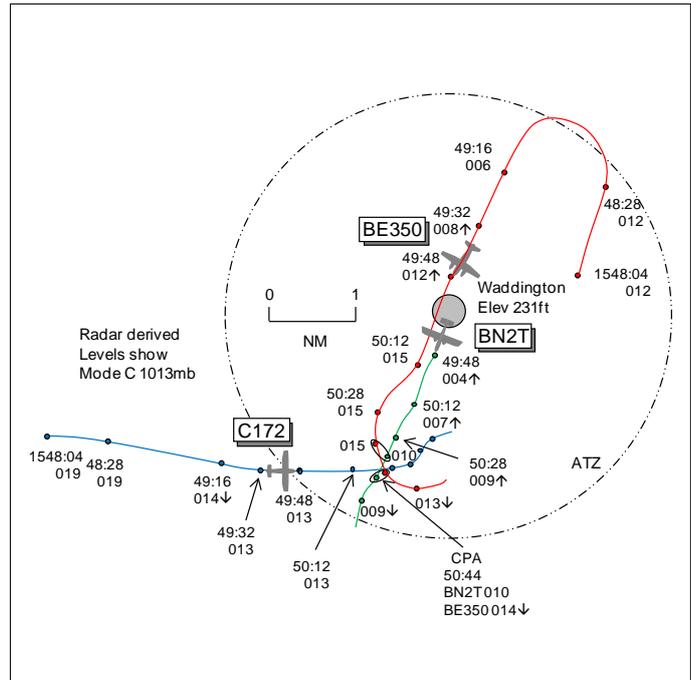
The CPA occurred at 1550:44 as the BE350 passed 0.1nm through the Islander’s 6 o’clock, indicating 400ft above.

Cause: In the absence of TI, the BN2T crew was concerned by the proximity of the BE350.

Degree of Risk: C.

Following this incident, RAF Waddington has reviewed their Flying and ATC Order Books and has adopted the use of VHF as the primary TWR freq.
