## AIRPROX REPORT No 2011158

Date/Time: 19 Nov 2011 1330Z (Saturday)

Position: 5050N 00017W (0.4nm  
E of Shoreham Airport -  
elev 7ft)

Airspace: Shoreham ATZ (Class: G)

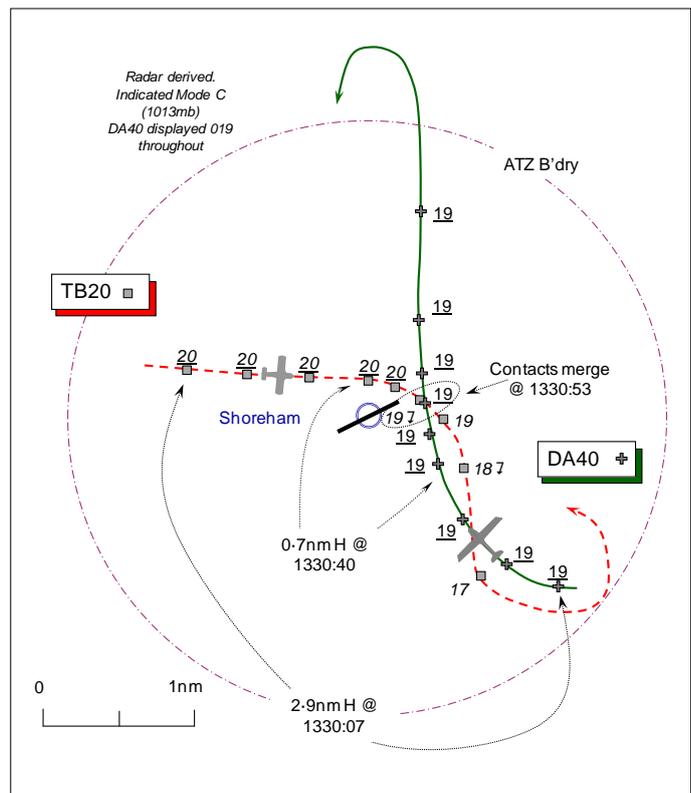
[At 1330:40, radar recordings show the TB20, just N of the A/D tracking E and indicating 2000ft (1013hPa), with the DA40 approaching from the SE, tracking NW, indicating 1900ft (1013hPa), in the TB20’s 2 o’clock position at a range of 0.7nm.]

[At 1330:53, radar recordings show the two ac 0.3nm NE of the A/D with both ac indicating 1900ft (1013hPa) - about 1990ft Shoreham QNH (1016hPa). The contacts of the two ac merge in azimuth. The DA40 was steadying on a N'y heading as the TB20 was crossing from L - R in a R turn through SE.]

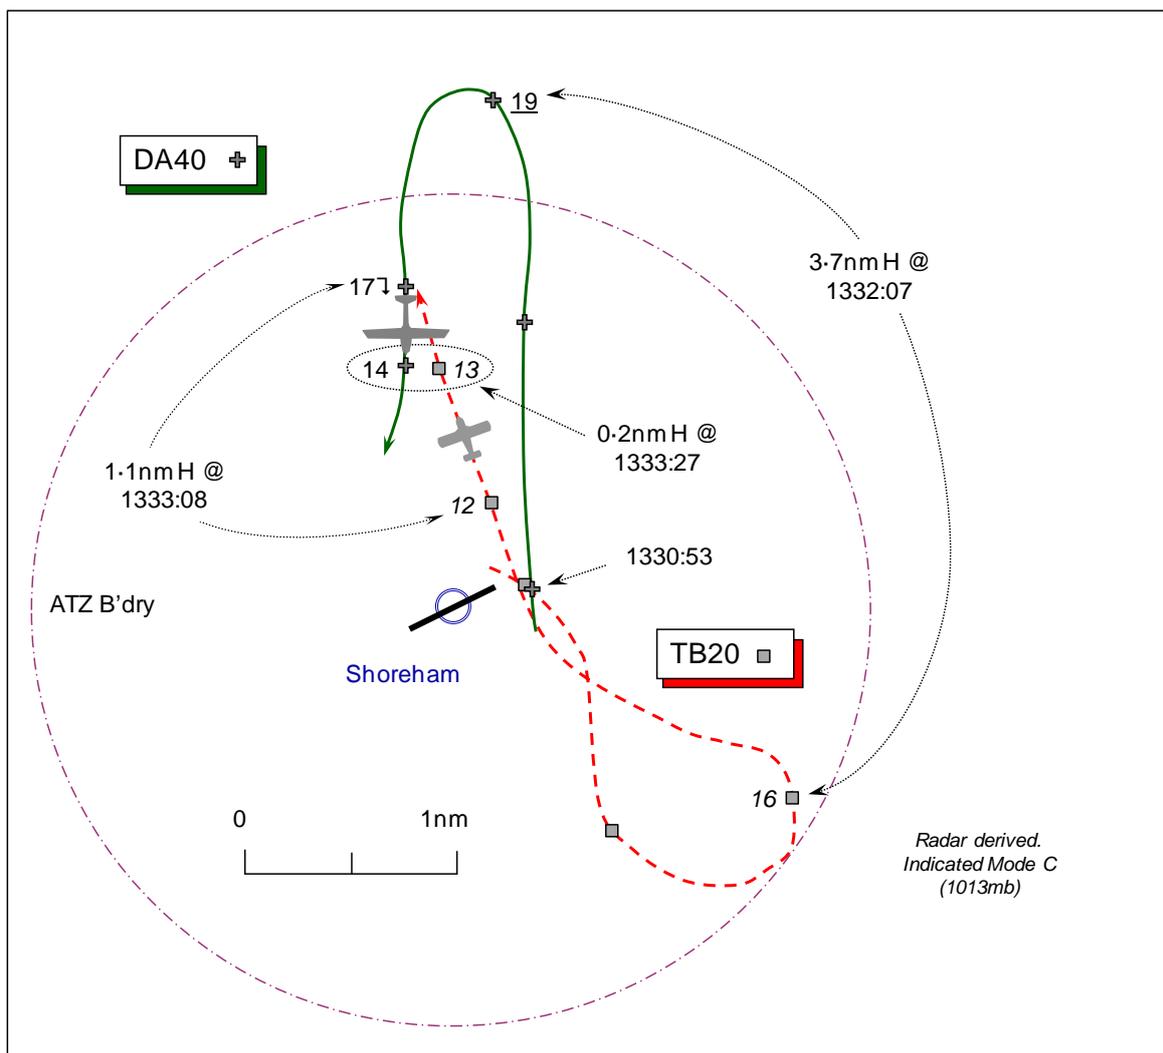
Fig 2

[UKAB Note (2): After the Airprox had occurred at 1330:53, both ac opened from the A/D overhead as illustrated at Fig 2. The two ac then turn toward the A/D and converge on broadly reciprocal headings to a range of 1.1nm at 1333:08; the TB20 indicating level at 1200ft Mode C as the DA40 descends through 1700ft Mode C. The two ac pass for the second time - port-to-port - about 1.1nm N of the A/D, the TB20 indicating 1300ft, 100ft below the DA40 that is shown descending through 1400ft Mode C.]
