## AIRPROX REPORT No 2011165

Date/Time: 30 Nov 2011 1332Z

Position: 5348N 00304W  
(2nm NW Blackpool  
Airport - elev 34ft)

Airspace: Blackpool ATZ    (Class: G)  
Reporting Ac    Reported Ac

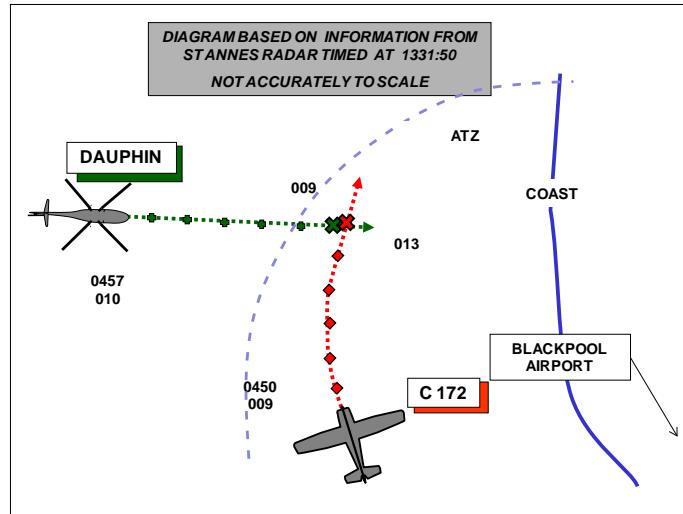
400ft V/0.1nm H

UKAB Note (2): The recording of the St Annes Radar shows the incident. The Dauphin approaches the CPA from the W, squawking 0457 with Mode C indicating FL010. After getting airborne the C172 is first seen at FL005 commencing a right turn and squawking 0450. The C172 rolls out on N at

1331:37 continuing its climb and the Dauphin continues tracking E at FL010. The C172 crosses 0.1nm in front of the Dauphin and 400ft above it at 1331:50 just inside the ATZ, as shown in the diagram above.
