AIRPROX REPORT No 2014002

Date/Time: 10 Jan 2014 1101Z

Position: 5106NN 00203W
(12.1nm SW of Boscombe Down)

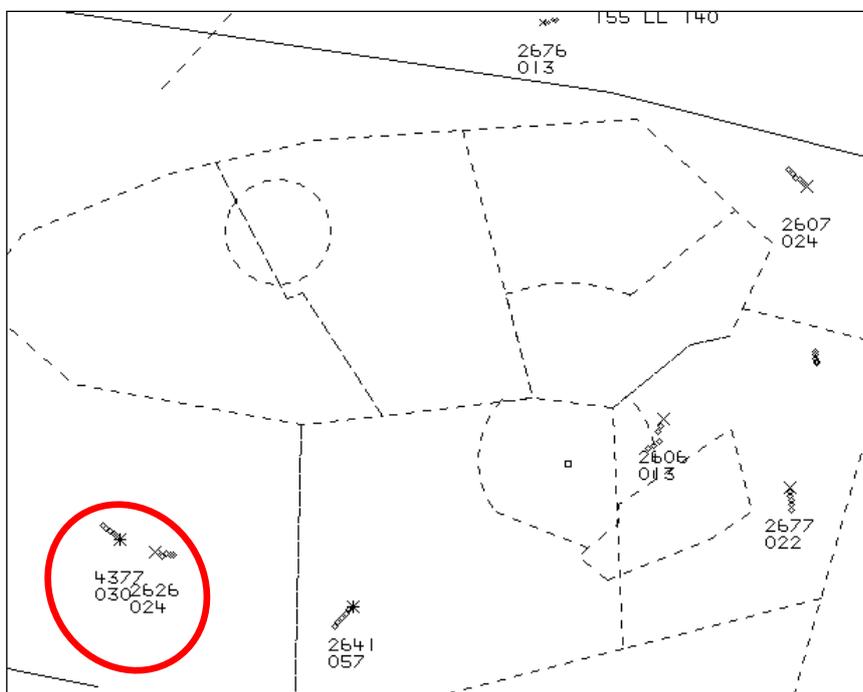
At 1048:43 the Puma was placed under a Basic Service by the Boscombe Approach controller, who was providing Traffic Service to three other callsigns, including an IFR recovery, and regularly updated the traffic situation from the fully serviceable primary and secondary radar. Figure 1 shows the aircraft geometry at 1101:14 with 1nm horizontal separation.

Figure 1: Approach traffic situation at 1101:14 (Puma squawking 2626; Tobago squawking 4377).

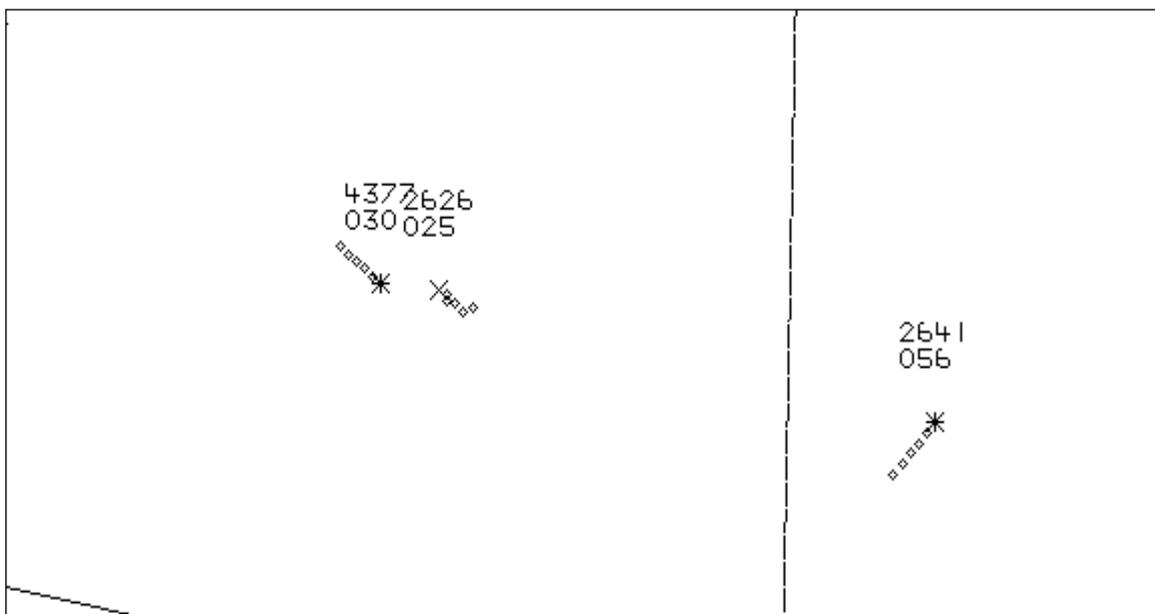
Figure 2 shows the aircraft geometry at 1101:20; the radar replay shows the CPA⁴ between 1101:26 and 1101:35 at 0.5nm lateral and 500ft vertical separation.

Figure 2: Aircraft geometry at 1101:20 with 0.8nm separation.

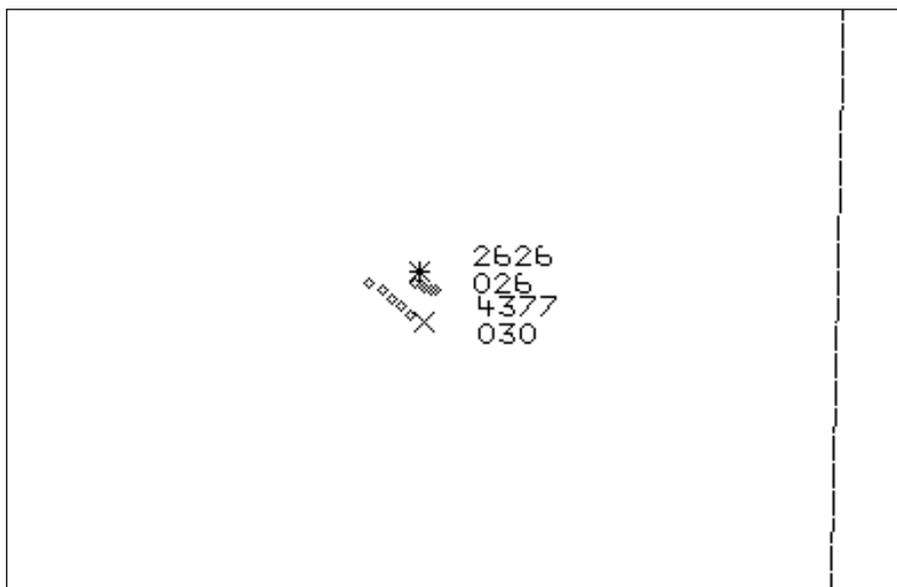
As per Figure 3, at 1101:37, the Puma requested an upgrade to Traffic Service. Approach immediately responded at 1101:42 with, “[Puma callsign] roger, you are identified, traffic service

and traffic south 2 miles tracking southeast indicating 500' above." The Puma reported visual with the traffic.

Figure 3: At 1101:42 when Traffic Information is passed.
