AIRPROX REPORT No 2014004

Date/Time: 15 Jan 2014 1150Z

Position: 5303N 00014W
(9nm ne RAF Cranwell)

Type: Tutor F-15

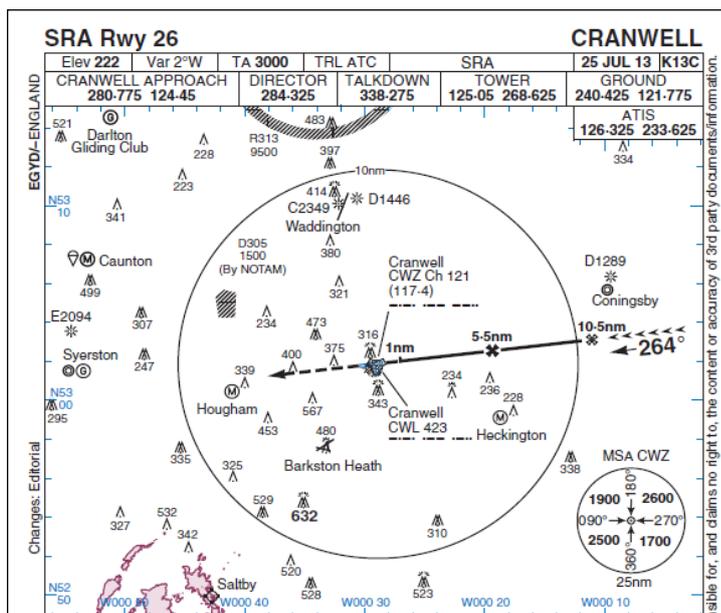
Figure 2: Cranwell SRA profile for RW26.

The Cranwell Dir reported the workload as ‘low’ and task difficulty as ‘low-to-medium’. He recalls Coningsby calling on the landline to co-ordinate, and Cranwell passed Traffic Information on two tracks in the RTC that would be not below 1800ft QFE 988hPa until 6nm finals. Figure 2 demonstrates the Cranwell SRA profile for RW26; the Tutor was being fed in from the south. No co-ordination was agreed after Coningsby requested to ‘disregard’; the Cranwell Dir continued to vector the Tutor from a base leg to a finals heading. The Coningsby controller rang back and the Cranwell Supervisor dealt with the call; Cranwell were advised that the F-15s would be requested to depart from the downwind leg of the Coningsby visual circuit to de-conflict with the Cranwell radar traffic. Cranwell did not deem Traffic Information necessary for the Tutor. Following an instruction to the Tutor to contact the Talkdown frequency, there was a delay prior to the Tutor reporting the F-15 sighting on Dir’s frequency.

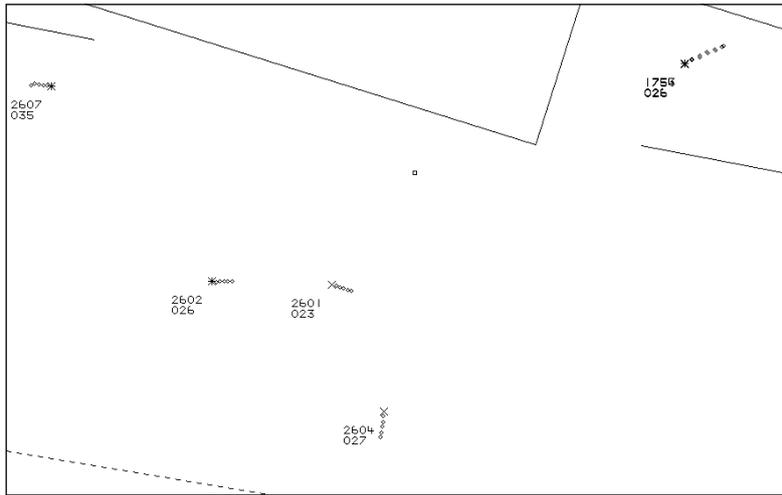
Figure 3: Aircraft geometry at 1144:17 (F15s squawk 1753/1754; Tutor 2604).

Coningsby APP called Cranwell for co-ordination at 1144:17, as per Figure 3, and were told that Cranwell squawks 2601 and 2604 were both not below 1800ft Cranwell QFE 988 until 6nm finals. The change of Coningsby QFE prompted the Coningsby controller to abandon the co-ordination.

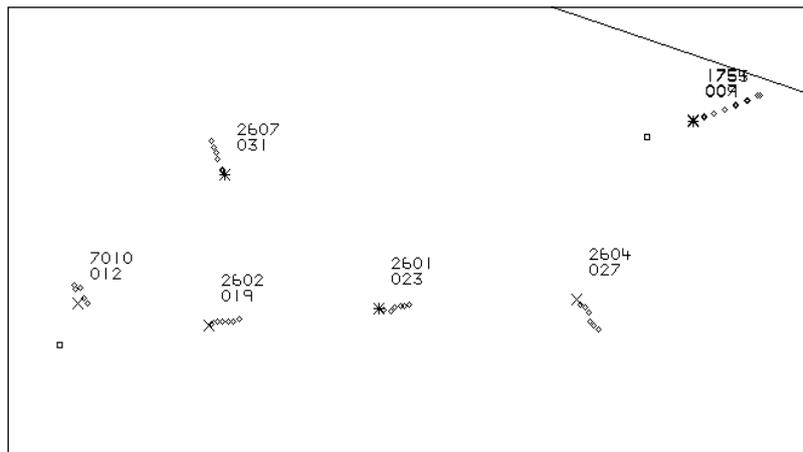
Figure 4: Aircraft geometry at 1146:18.

At 1145:26 Coningsby APP requested that the Aerodrome Controller keep the F-15s in the visual circuit for a second visual approach because of the QFE change and also requested that they depart from the downwind leg. At 1146:18 the Coningsby APP controller called the Cranwell Supervisor to inform them that they would try to get the F-15s to depart from the downwind leg of the visual circuit to keep out of the way of Cranwell traffic, as per Figure 4.

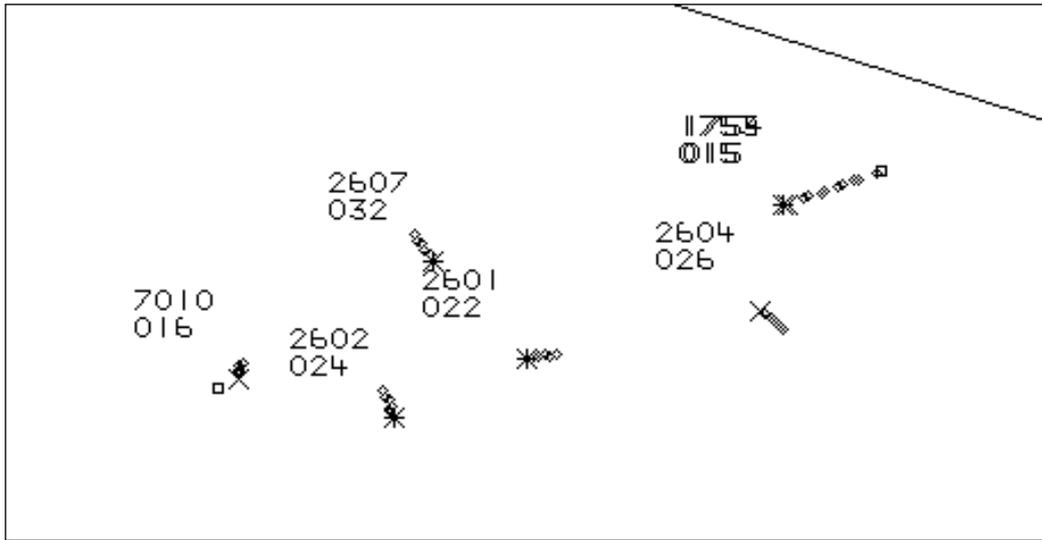
Figure 5: Aircraft geometry at 1146:58.

At 1146:48 the F-15s call APP, “Coningsby Approach [F-15 callsign] on the climbout unable to er to keep the pattern up with er...well lets get to climbout to 100.” As per Figure 5, at 1146:58 APP replies with “[F-15 callsign] er Coningsby Approach er roger, avoiding action, turn right immediately with terrain alert, traffic was er, south one mile tracking east inbound to Cranwell 700 feet below – above [controller correction] stop climb flight...1500 feet.” The F-15s reply with “[F-15 callsign] tally, no factor.”

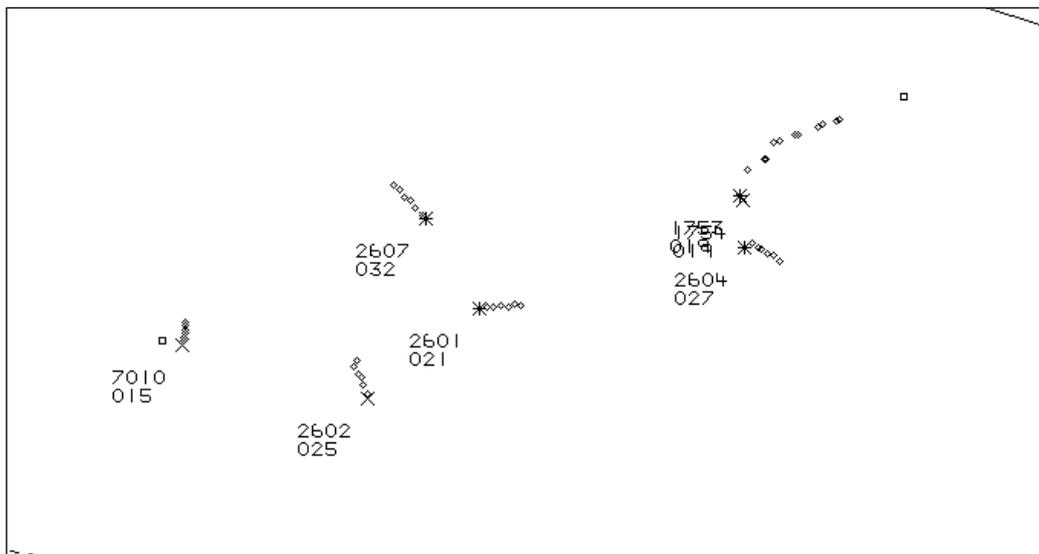
Figure 6 Aircraft geometry at 1147:11.

At 1147:16 the Tutor reports on the Cranwell Dir frequency, “[Tutor callsign] *Director two F-15s appeared half a mile, just in front of me.*” Dir replies with, [Tutor callsign] *that traffic is uh now slightly below, climbing, half a mile in front of you, not pre-noted by Coningsby.*”
