AIRPROX REPORT No 2014026

Date/Time: 24 Mar 2014 1548Z

Position: 5311N 00023W
(Waddington RTC)

Type: BAe146 C172

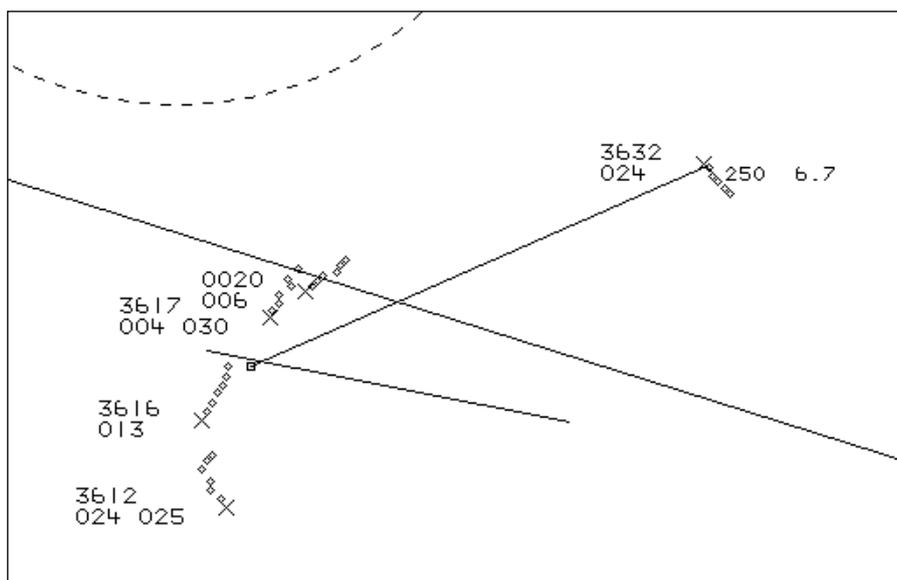
At 1546:34, the BAe146 climbed out and was provided a Traffic Service by DIR in the climb to 2500ft QFE, heading 045°. As per Figure 1, the C172 pilot was manoeuvring 6.7nm to the northeast of Waddington.

Figure 1: BAe146 climbing out on 3612 squawk; C172 squawking 3632 at 1546:34

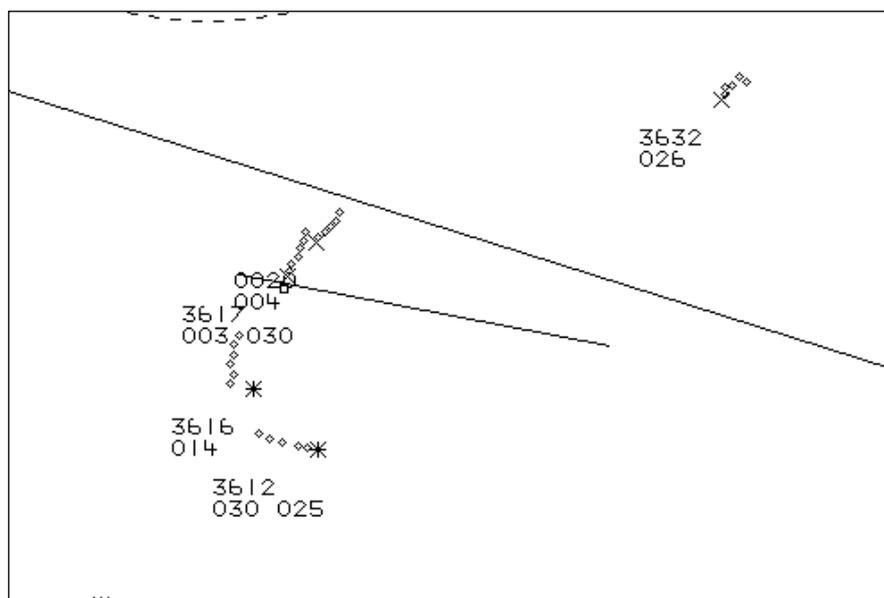
At 1546:45, the DIR transferred the other radar traffic to the TDN and asked the BAe146 pilot to report steady and level, as per Figure 2.

Figure 2: Aircraft geometry at 1546:54

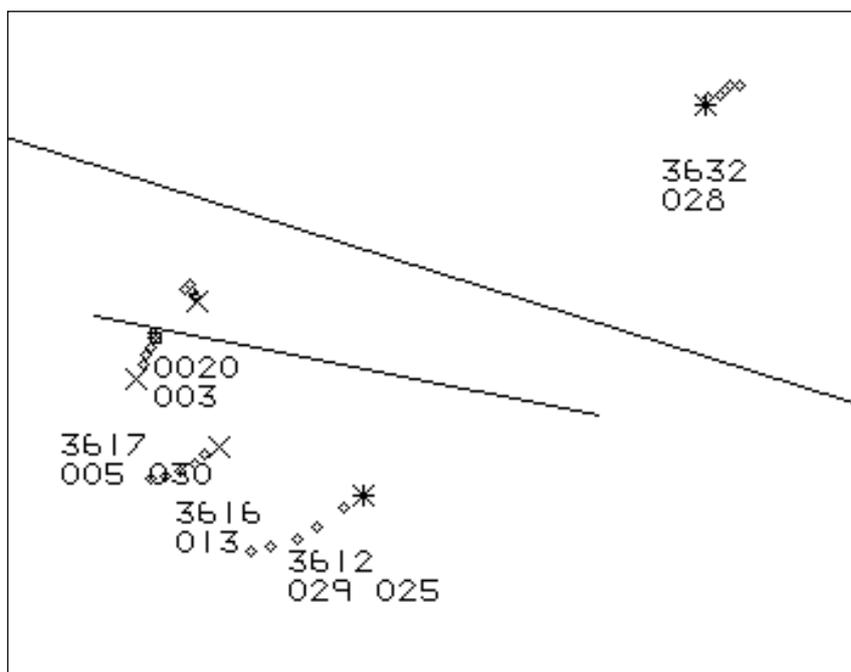
At 1546:54, the DIR called the ADC to pass the 8nm liaison call; the conversation was protracted as the ADC was transmitting to aircraft in the visual circuit; the conversation was terminated at 1547:19, to answer the landline from ZONE. Upon answering the ZONE line, the DIR passed Traffic Information to the BAe146 pilot, at 1547:25, as per Figure 3. “[BAe146 C/S] *traffic north west three miles, tracking south west indicating similar level climbing*”. At this point, it is uncertain which track the Traffic Information related to. At the time of the information the C172 was on a bearing of 045° at 5nm from the BAe146 and therefore on a north easterly bearing.

Figure 3: Traffic Information at 1547:25

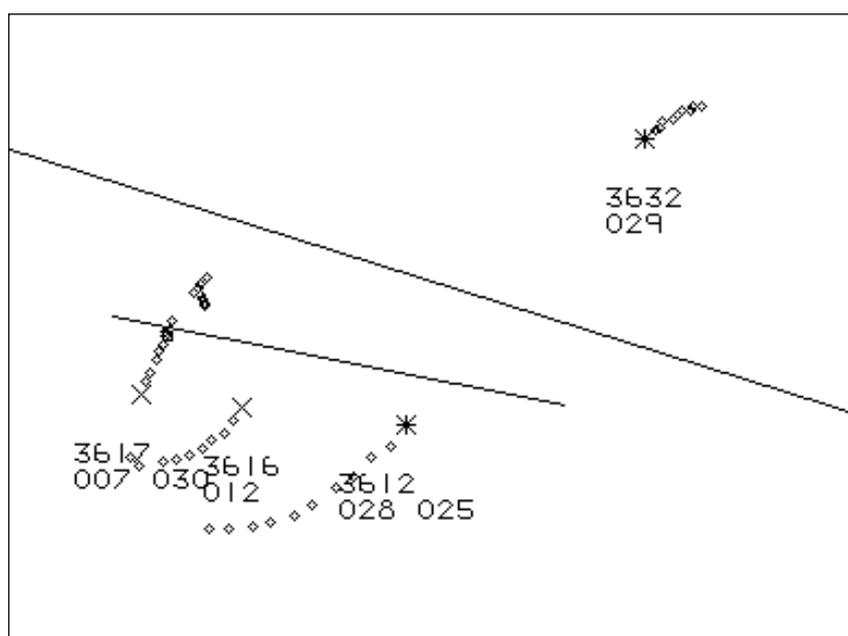
At 1547:33, the DIR amplified to the BAe146 pilot, “that’s inbound to Waddington, turn right heading 090 degrees”.

Figure 4: Aircraft geometry at right hand turn 090 degrees at 1547:33

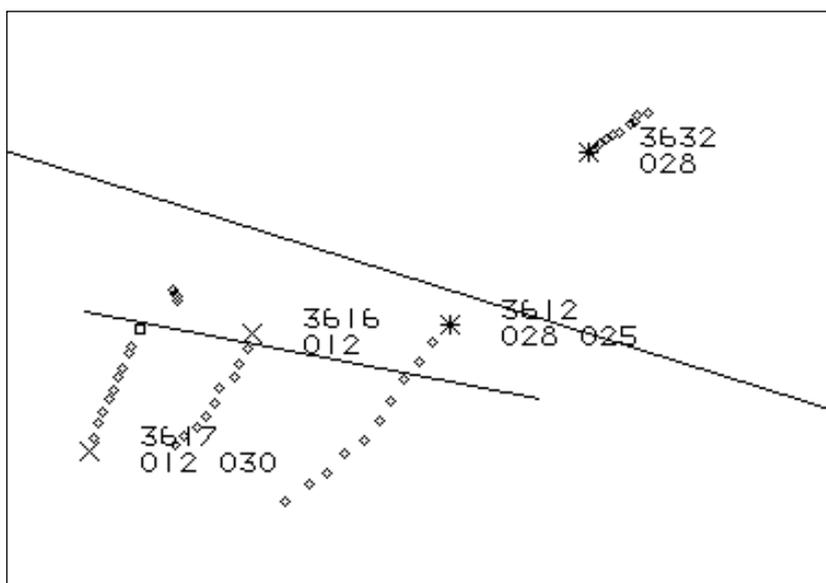
At 1547:45, the DIR called ZONE and received Traffic Information on the C172 at not below 2500ft QFE. As the DIR was reading back the information the BAe146 pilot declared at 1547:53, “TCAS RA climbing”. Figure 5 displays the geometry as the BAe146 pilot announced the TCAS RA climb; the Mode S on the radar replay demonstrates that the BAe146 was still heading 045°.

Figure 5: Aircraft geometry at TCAS RA at 1547:53

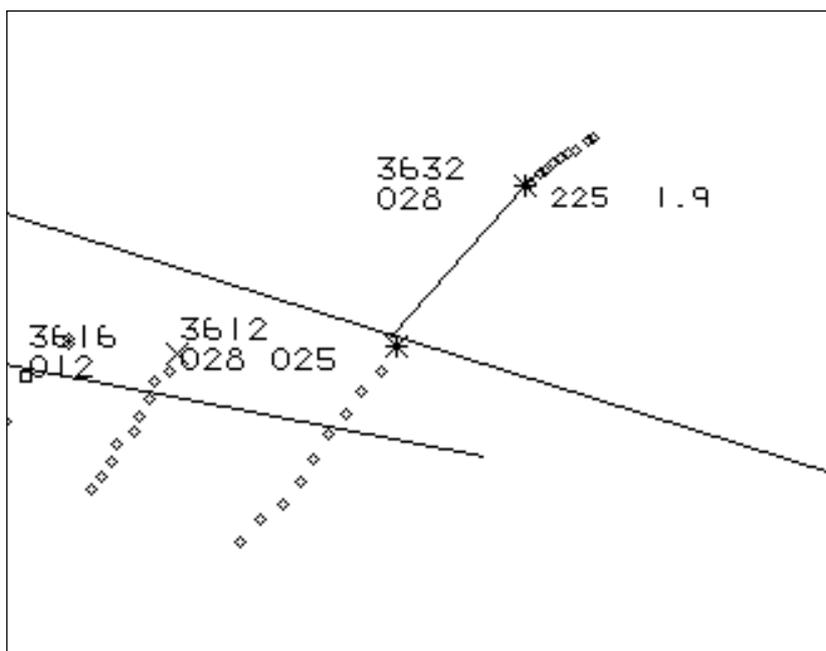
At 1547:59, the ZONE transmitted, “[C172 C/S] traffic south west, one mile, tracking north east, two hundred feet above”. The C172 pilot reported visual with the BAe146, as per Figure 6, with 1.9nm between aircraft and the BAe146 maintaining a heading of 045°.

Figure 6: Zone Traffic Information at 1547:59

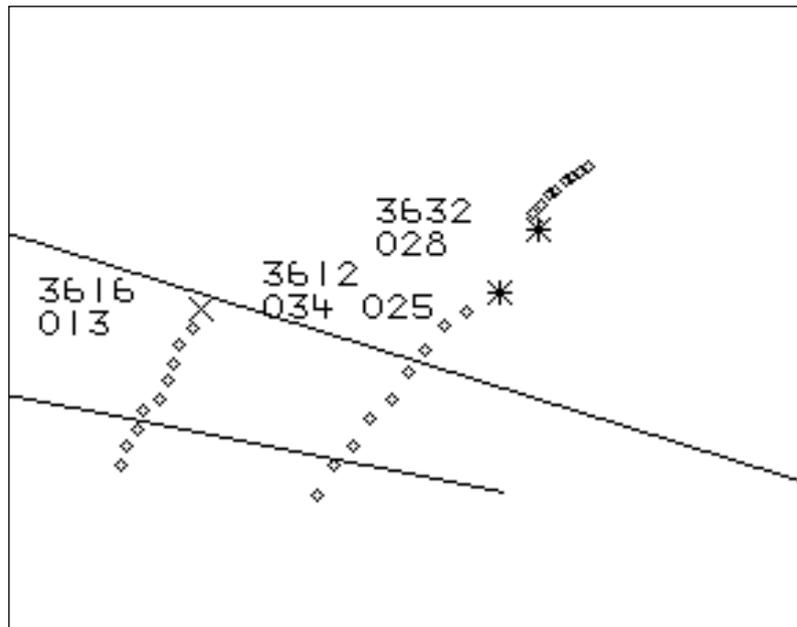
At 1548:03, the BAe146 pilot began a right hand turn and a climb from 2500ft Waddington QFE (replay taken from Claxby radar on London QNH 1010hPa). Figure 7 depicts the geometry from the radar replay at 1548:17, just prior to the CPA at 1548:24, with 0.2nm horizontal and 700ft vertical separation between aircraft. By the time of the CPA the BAe146 was at a height of 3800ft on the radar replay and a heading of 076°.

Figure 7: Aircraft geometry at 1548:17
