AIRPROX REPORT No 2014051

Date/Time: 1 May 2014 1411Z

Position: 5352N 00140W
(1nm S Leeds Bradford airport)

Airspace: Leeds CTR (Class: D)

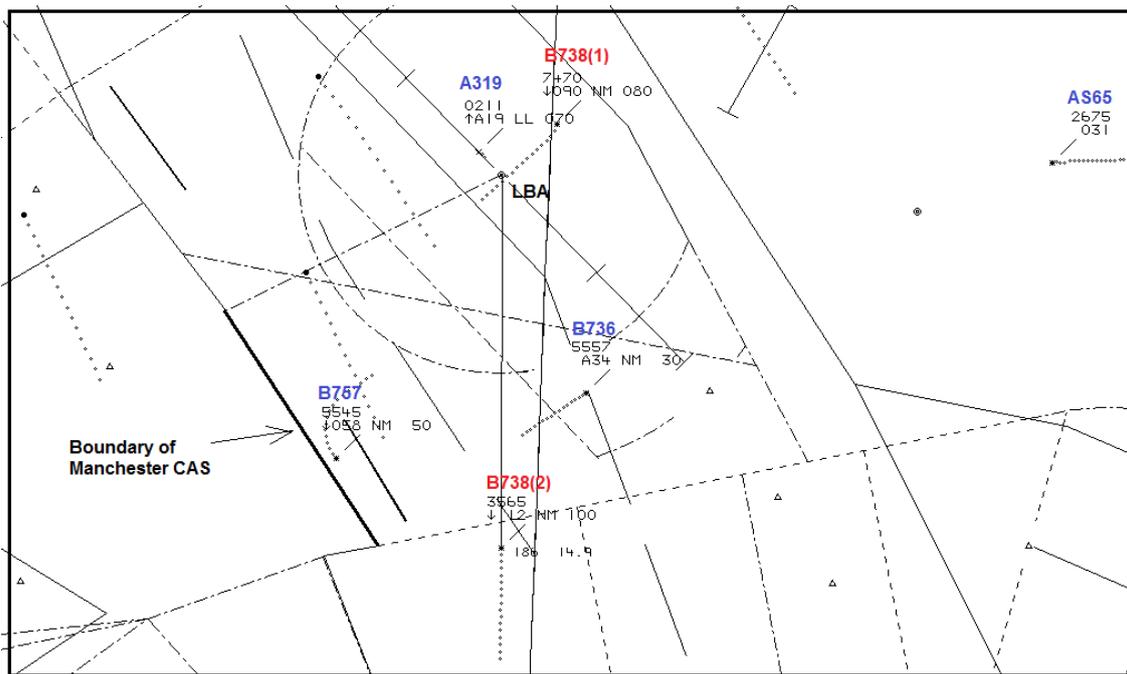
Figure 3 – Prestwick MRT at 1407:26

The Radar controller did not annotate FL80 on B737(2)'s FPS. At this point [1407:26], B737(1) entered the hold and was passing FL90 whilst B737(2) was 15nm south of the LBA NDB passing FL112 (Figure 3)

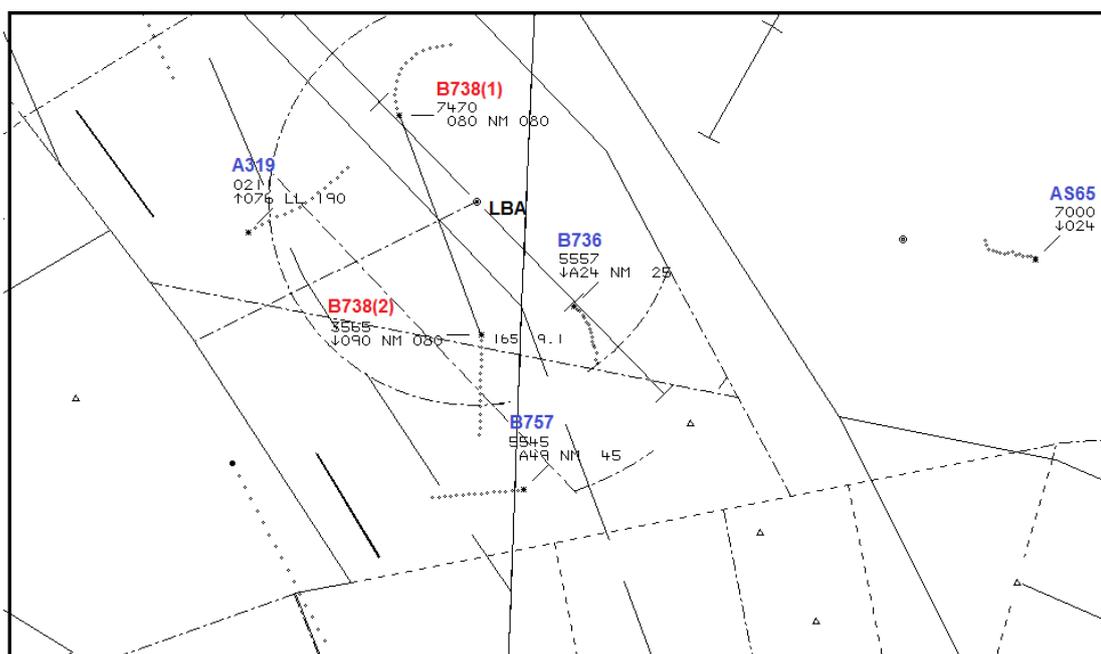
Figure 4 – Prestwick MRT at 1409:53

At 1409:53 the pilot of B737(1) was turning inbound in the hold at FL80 and B737(2) was passing FL90 for FL80. The two aircraft were on reciprocal tracks and the horizontal distance between the two aircraft was 9.1nm (Figure 4).

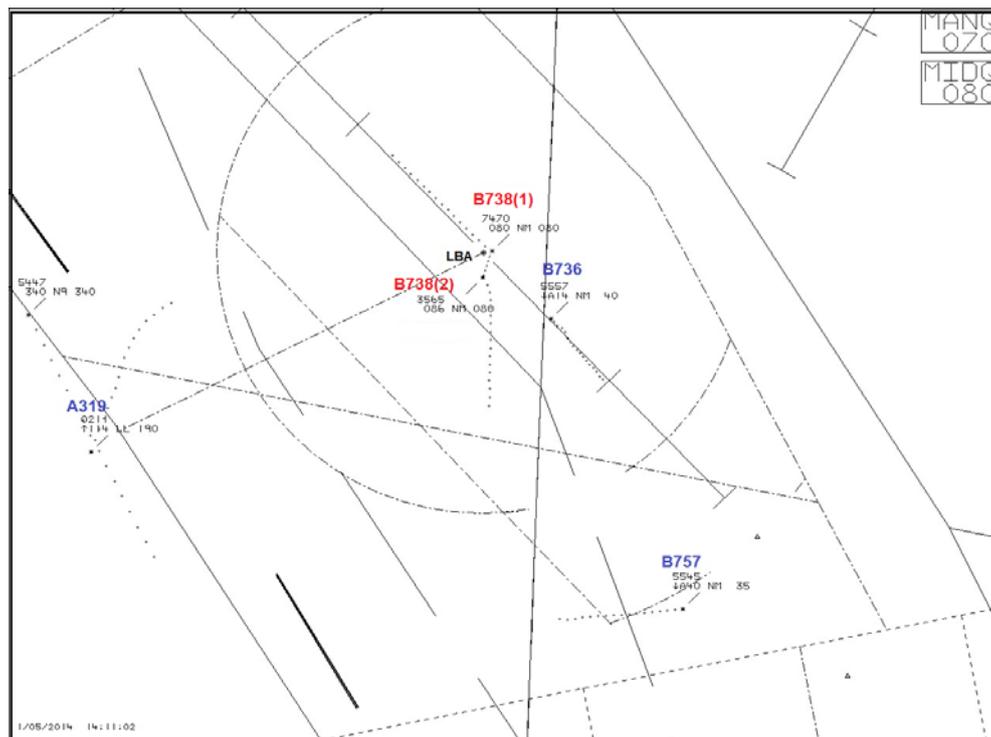
Figure 5 – Prestwick MRT at 1411:02

[Note: B737(1) crossed the LBA and the pilot of B737(2) commenced the left turn. The distance between the two aircraft was 1.2nm horizontally and 600ft vertically]

B737(1) *"[B737(1) C/S] TCAS RA" [Figure 5]*

[Note: CPA as both aircraft start a left turn. Distance 0.8nm horizontally and 600ft vertically]
