AIRPROX REPORT No 2014060

Date/Time: 7 May 2014 1124Z

Position: 5057N 00010W
(Hurstpierpoint)

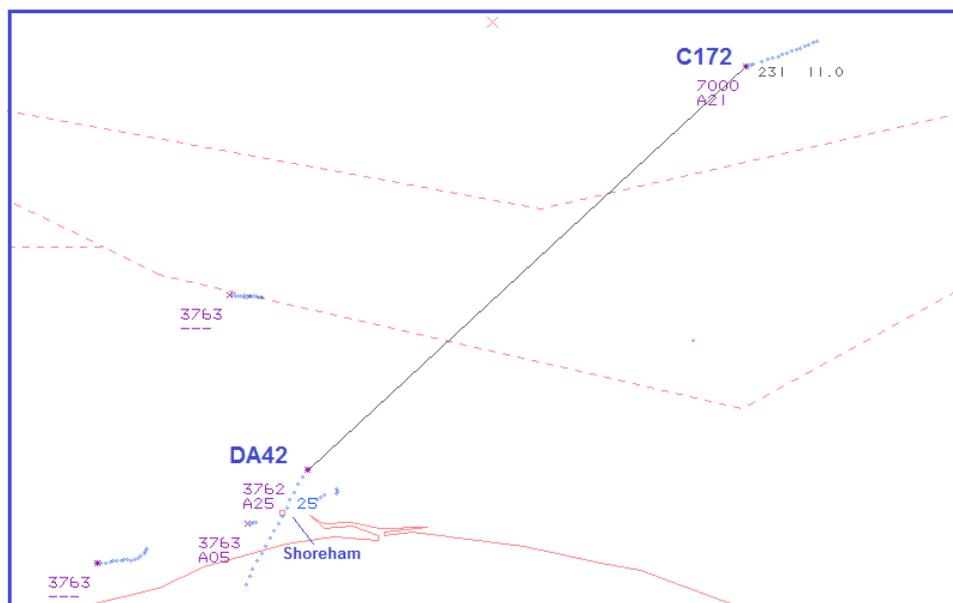
Figure 2 - Swanwick MRT at 1121:16

At 1119:50, the DA42 pilot reported outbound in the hold and ready for the procedure. The controller instructed him to report beacon outbound at 2500ft, to cross NITEN at 2200ft, and then cleared him for the RNAV approach RW20. At 1121:16, the DA42 pilot reported beacon outbound and the controller instructed him to report at NITEN. The C172 is shown squawking 7000, 11nm northeast of the DA42 in Figure 2 below:

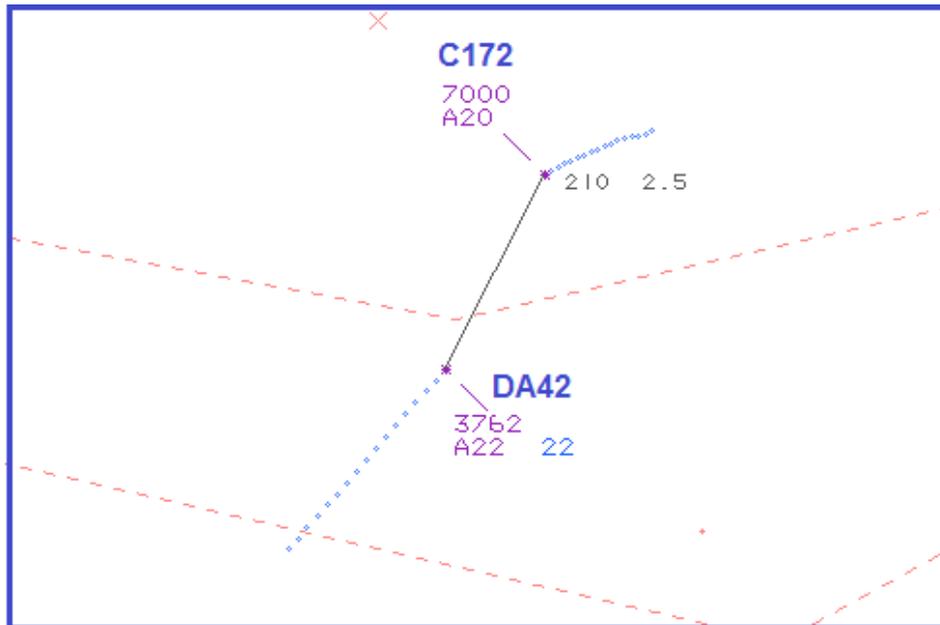
Figure 3 - Swanwick MRT at 1123:34

At 1123:34, the C172 was 2.5nm north-northeast of the DA42, see Figure 3 below:

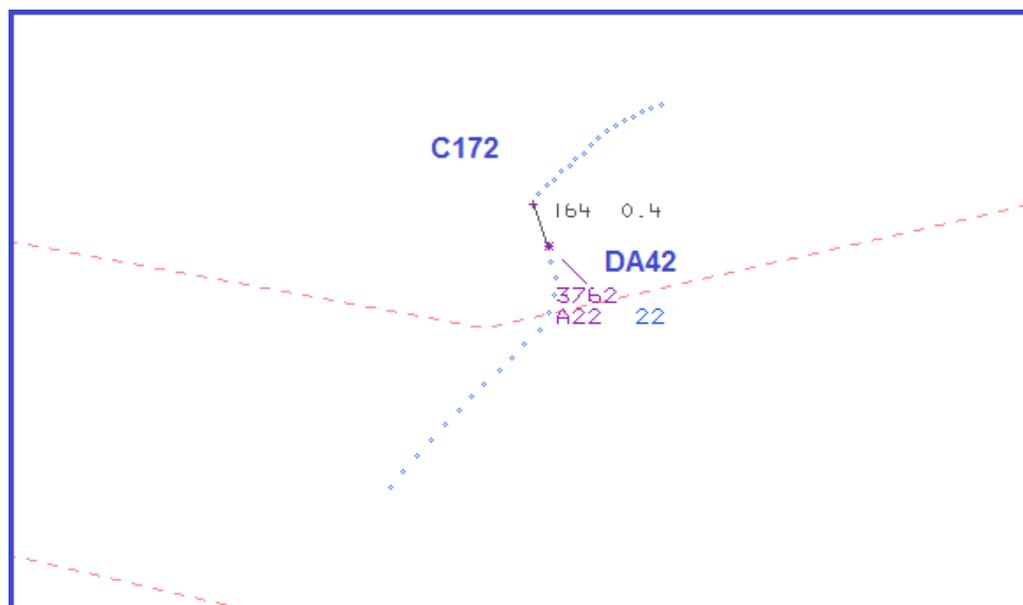
Figure 4 - Swanwick MRT at 1124:14

At 1123:37, the C172 pilot contacted Shoreham APP and reported at Burgess Hill at 2000ft on QNH 1011hPa, in receipt of information 'G'. The C172 pilot was instructed to squawk 3763 [Shoreham VFR conspicuity code] and to join overhead at 2000ft for RW25 left-hand circuit with QFE 1010hPa. This was acknowledged by the C172 pilot who asked for confirmation of RW25 left-hand, which was confirmed by the controller who then, at 1124:14, passed traffic information, "there is traffic shortly in the instrument er approach routeing via NITEN, that's Parham more or less, towards Henfield and er at two thousand two hundred feet initially". The C172 pilot did not reply and a number of other aircraft transmitted in quick succession with a number of crossed transmissions. Swanwick MRT recording showed the DA42 pilot had commenced a left turn with the C172 0.4nm north-northwest and without an SSR label, see Figure 4 below:

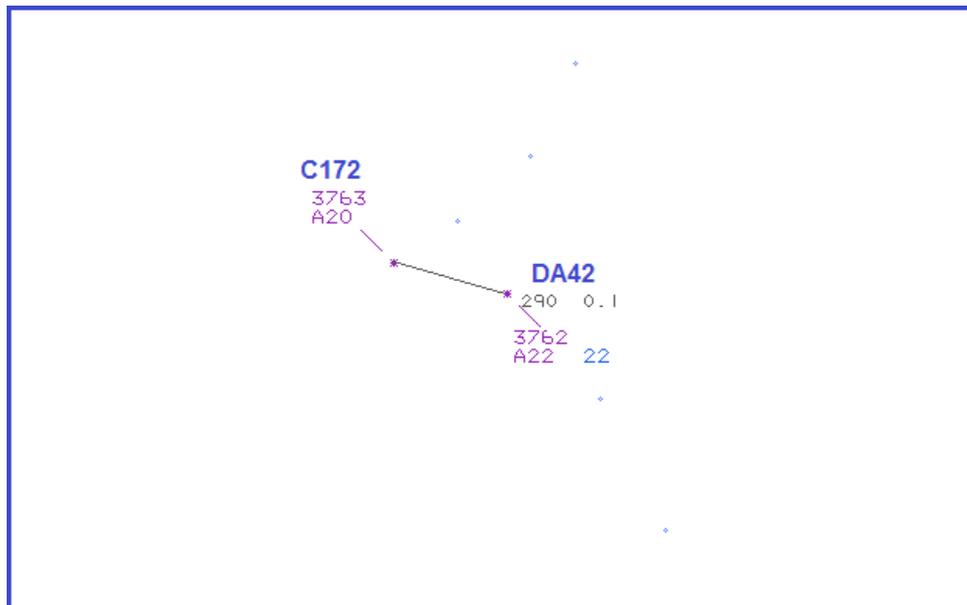
Figure 5 - Swanwick MRT at 1124:22

CPA occurred at 1124:22, when the C172 is shown squawking 3763, 0.1nm west-northwest of the DA42, see Figure 5 below:

The Board quickly agreed that the cause of this Airprox was a non-sighting by both pilots and many Board members considered that the separation at CPA warranted a risk category of A – separation reduced to the minimum, chance played a major part in events, and nothing more could have been done to improve matters. The Board then discussed the clearances given to the pilots and agreed that a degree of separation had been 'built-in' by the controller's clearance to the DA42 pilot to cross NITEN at 2200ft and to the C172 pilot to join overhead at 2000ft. Whilst this did not oblige the C172 pilot to be at 2000ft immediately, he was already at this altitude before contacting Shoreham and remained at it after the clearance. In light of this, the Board agreed that chance had not played such a major part in events, but that safety margins had nonetheless been much reduced below the normal.

<u>Cause:</u>	A non-sighting by both pilots.
<u>Degree of Risk:</u>	B
<u>ERC Score⁵:</u>	20
<u>Recommendation:</u>	Shoreham considers reviewing the integration of IFR traffic with joining and transiting VFR traffic.

After debating the existence of 'built-in' separation, members agreed that this incident demonstrated potential for a more formal examination of integration of traffic at Shoreham in order to separate IFR traffic on a known procedure from VFR traffic. The Board resolved to recommend that Shoreham considers reviewing the integration of IFR traffic with joining and transiting VFR traffic.
