AIRPROX REPORT No 2014075

Date/Time: 30 May 2014 1309Z

Position: 5558N 00359W
(Cumbernauld)

Airspace: Cumbernauld ATZ (Class: G)

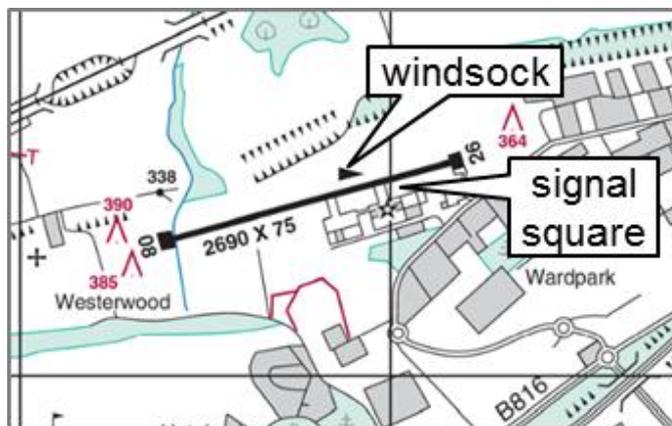
The windsock at Cumbernauld is situated on the north side of the airfield at the mid-point of the runway. The signal square is located on the south side of the airfield, between the hangar and the runway.
