AIRPROX REPORT No 2014078

Date/Time: 5 Jun 2014 1558Z

Position: 5145N 00117W
(RAF Brize Norton RTC¹)

Type: Voyager KC3 SK76
(A330)

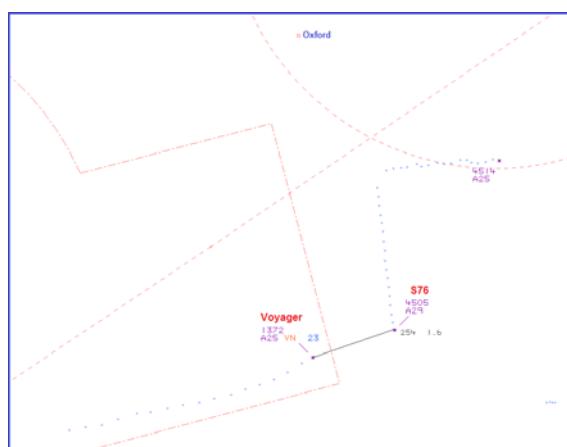
Figure 1 – Swanwick MRT at 1558:02

At 1555:45, the S76 was at an altitude of 2900ft, 1.2nm northeast of Oxford Airport tracking south. The Voyager was at an altitude of 4700ft, 2.6nm south of Brize Norton positioning downwind left-hand for Brize RW26. At 1556:45, the Voyager passed an altitude of 3500ft and entered the Brize CTR, Class D airspace, from above. The Oxford Radar controller passed Traffic information to the S76 pilot, who reported sighting the Voyager as it commenced a left turn. At 1558:02, the horizontal distance between the aircraft was 1.6nm as the Voyager started its turn, see Figure 1.

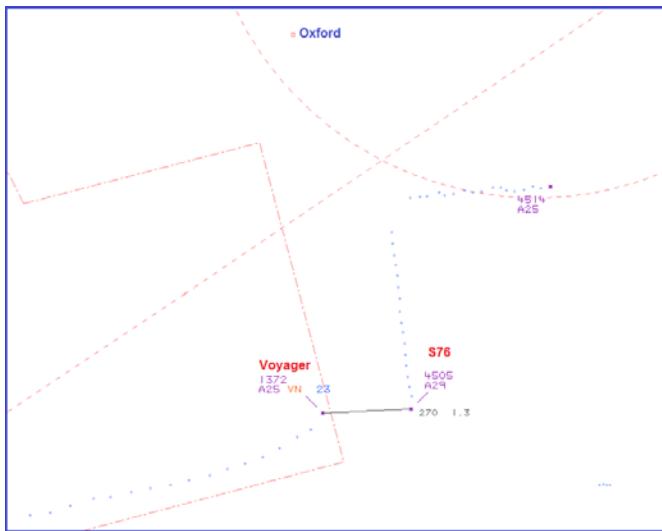
Figure 2 – Swanwick MRT at 1558:06

At 1558:06 (CPA), the aircraft passed abeam with a horizontal distance of 1.3nm and vertical distance of 400ft, (Figure 2). The Voyager's turn resulted in the Voyager leaving CAS on base leg.

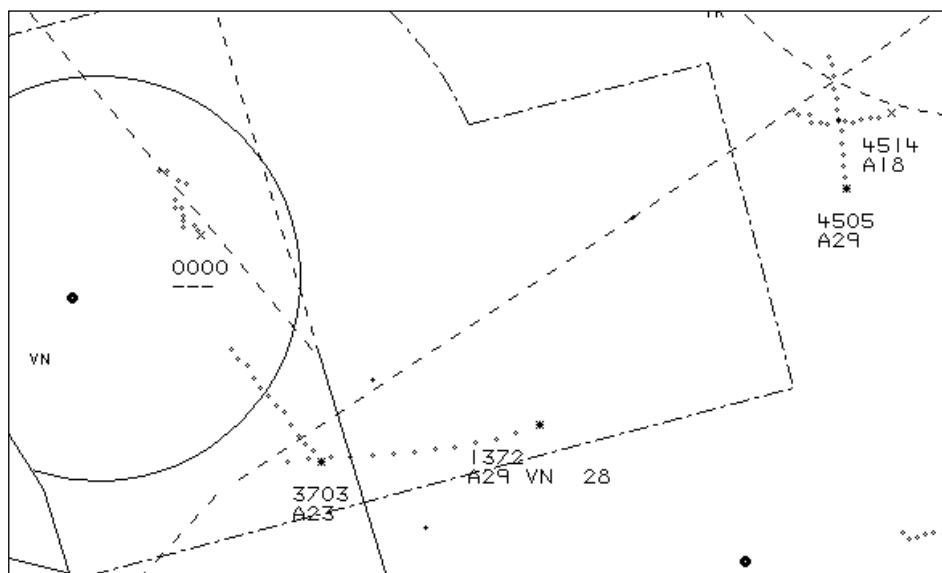
Figure 1: Geometry at 1557:14

The Brize DIR was also the ATCO I/C responsible for the shift. The DIR had just received the Voyager on frequency in the BZN Class D CTR, under radar vectors for a PAR. Having noticed a slow rate of turn on previous vectors, the DIR provided an early base leg turn on to 340°. As the turn was issued, the pilot reported an Airprox with a rotary aircraft outside the BZN CTR. The DIR placed her own workload as medium-to-low, but the overall unit workload as high-to-medium. As the ATCO I/C and DIR, the controller commented that the APR and ZONE controllers were busy with an unusual occurrence and she was attempting to monitor the situation and check the PAR console set-up. At 1557:14, the Voyager was on the downwind leg for RW26 (squawking 1372) and the SK76 (squawking 4505) was transiting to the east of the BZN CTR, see Figure 1.

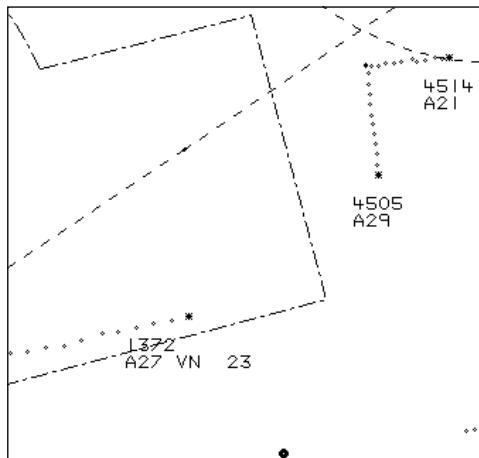
Figure 2: Geometry at 1557:37

At 1557:37, the DIR passed the Voyager pilot a base leg turn, left onto 340°, see Figure 2.

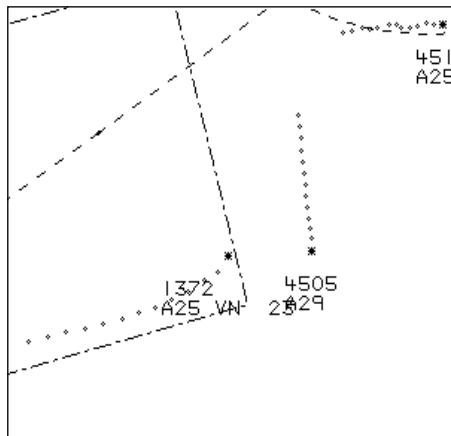
Figure 3: CPA at 1558:06

The radar replay showed that the Voyager pilot initiated a left turn at 1557:55. The CPA was at 1558:06 with 1.3nm lateral separation and 400ft vertical separation, see Figure 3.

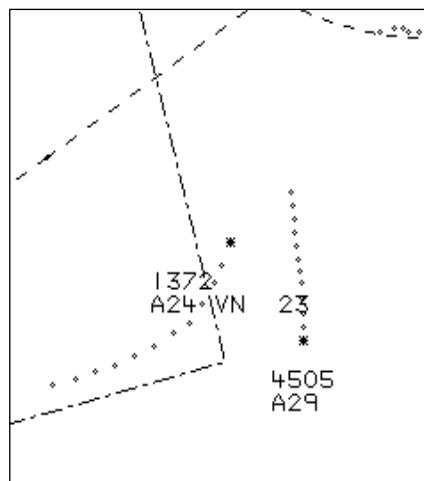
Figure 4: Geometry at 1558:21

At 1558:12, the Voyager pilot declared, “Left heading two eight zero degrees and for your information we may have had an Airprox, traffic was in our twelve o'clock range about two miles.” The radar replay picture at 1558:21, as the Voyager left the BZN CTR, is shown at Figure 4.
