AIRPROX REPORT No 2014093

Date/Time: 13 Jun 2014 1210Z

Position: 5101N 00236W
(RNAS Yeovilton)

Airspace: Yeovilton ATZ (Class: G)

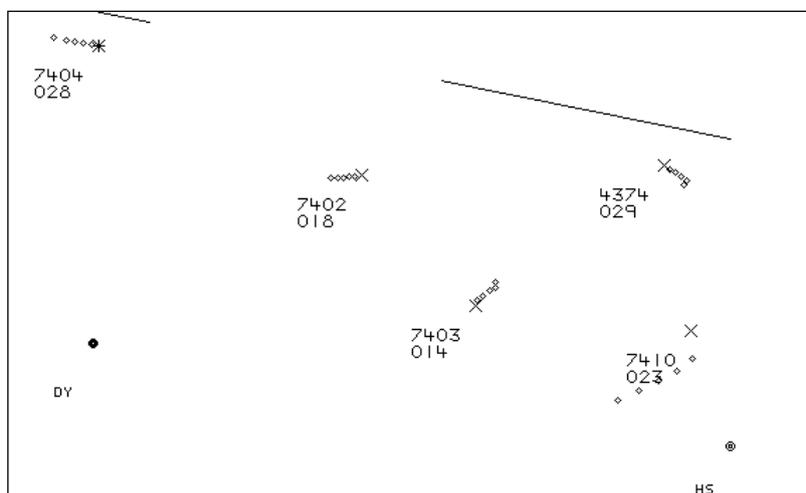
Figure 1: Sea King 6-mile call at 1207:03 (Sea King 7403; Hawks 7410)

At 1207:03, the PAR controller liaised with TWR to provide the 6-mile call on instrument traffic inbound, "Sea King six miles low approach runway two seven.", see Figure 1.

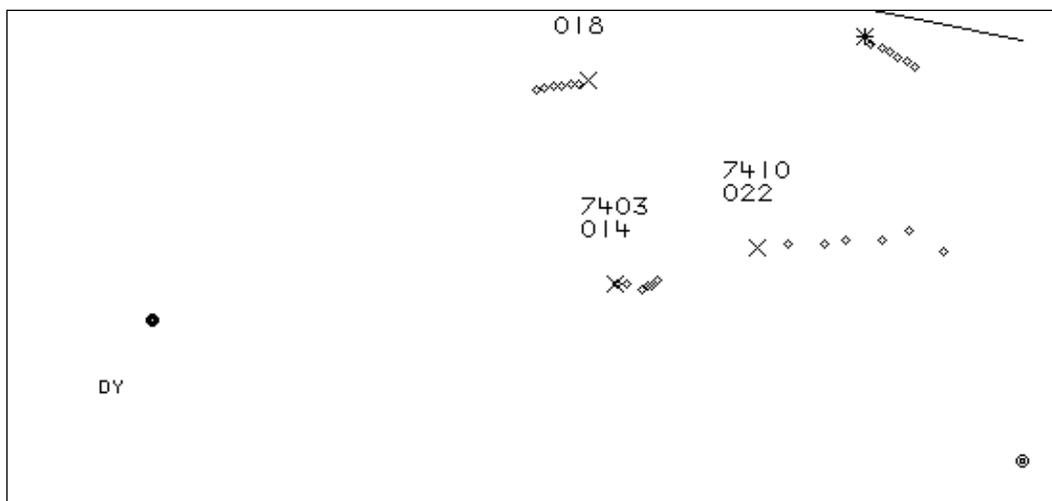
Figure 2: Geometry at 1207:34 as Hawks were given visual circuit join

The Sea King pilot was informed of the Hawks passing down their right hand side. At 1207:34, (see Figure 2), the ADC transmitted, “[Hawk C/S] *Yeovil Tower, join runway two seven, QFE one zero two three, circuit’s clear, radar traffic approaching five miles.*” The Hawk pilot called visual with the radar traffic and, at 1207:40, the high pitched tone was heard on the RT replay. The transcript described that transmissions can still be heard although reduced in volume and clarity.

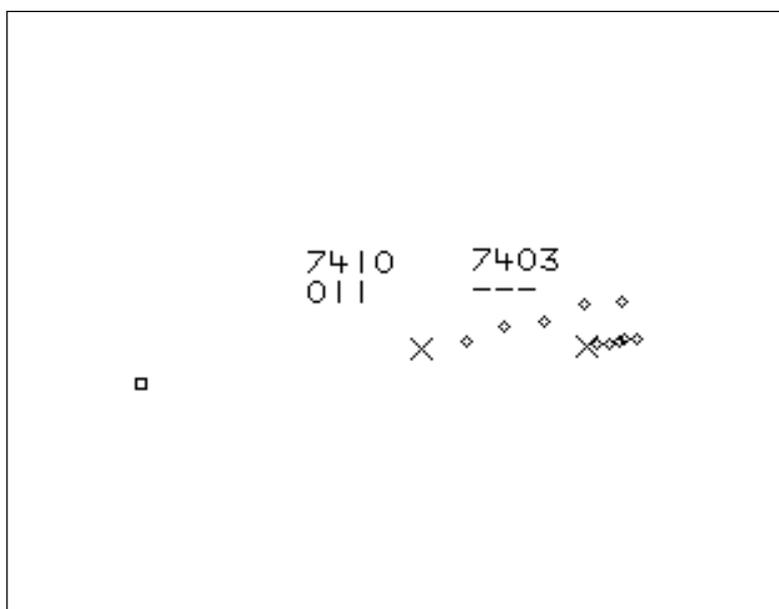
Figure 3: Geometry at initials call at 1208:28

At 1208:28, (see Figure 3), the Hawk pilot called initials for a low break into the circuit, and the ADC approved the low break and announced the circuit as clear. Both tracks disappear from radar shortly afterwards.

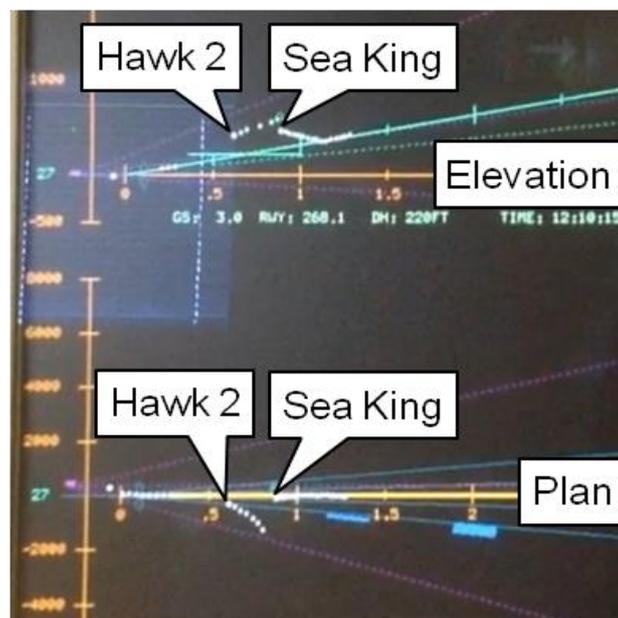
Both pilots shared an equal responsibility for collision avoidance and not to fly into such proximity as to create a danger of collision². A video frame of the PAR controller’s display was provided, which was used to estimate the recorded separation of 0ft V/0.25nm H. The CPA of 1210 was deduced from the TWR tape transcript.
