AIRPROX REPORT No 2014097

Date/Time: 25 Jun 2014 1358Z

Position: 5151N 00118E
(1nm NE of Oxford Kidlington)

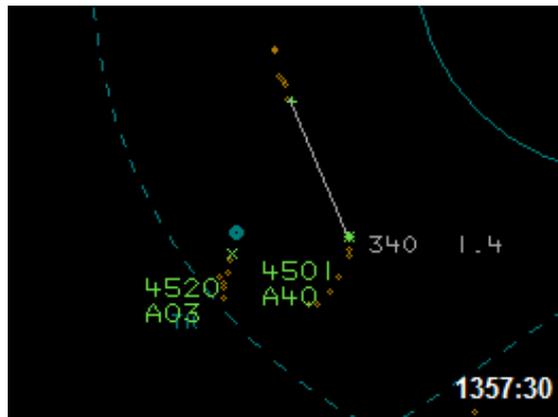
Figure 1.

At 1357:10 the Oxford radar controller advised the Puma of a primary contact due north of the field which appeared to be entering the ATZ, 2nm north of Oxford, southbound, height unknown. This was acknowledged by the Puma pilot. The Oxford Radar controller clarified that the traffic was north of the Puma by 1.5nm, south-southeast bound (Figure 1 shows the positions of the Puma and the primary return at the end of the Traffic Information passed by Oxford).

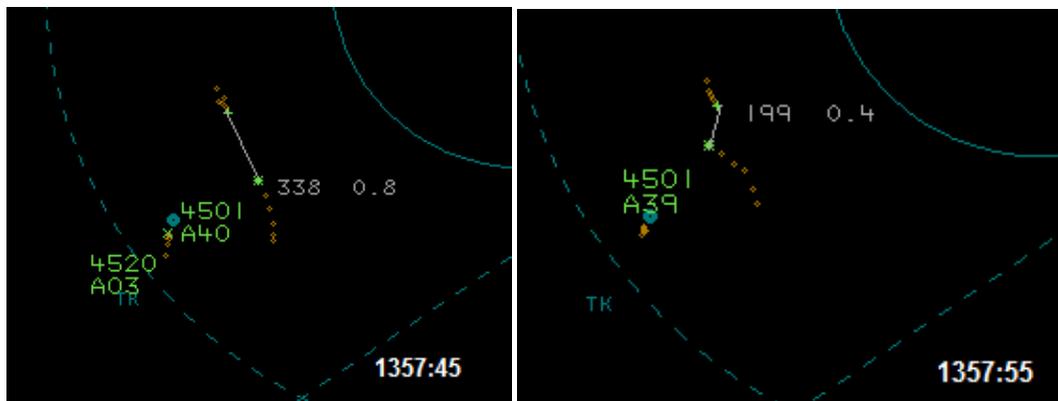
Figure 2

The tracks of the Puma and the primary contract continued to converge (Figures 2 and 3) with the CPA occurring at 1357:55 when the lateral distance between the aircraft, as displayed by the area radar recordings, was 0.4nm.
