## **AIRPROX REPORT No 2014141**

**Date/Time:** 9 Aug 2014 1349Z (Saturday)

**Position:** 5212N 00010E  
(Cambridge)

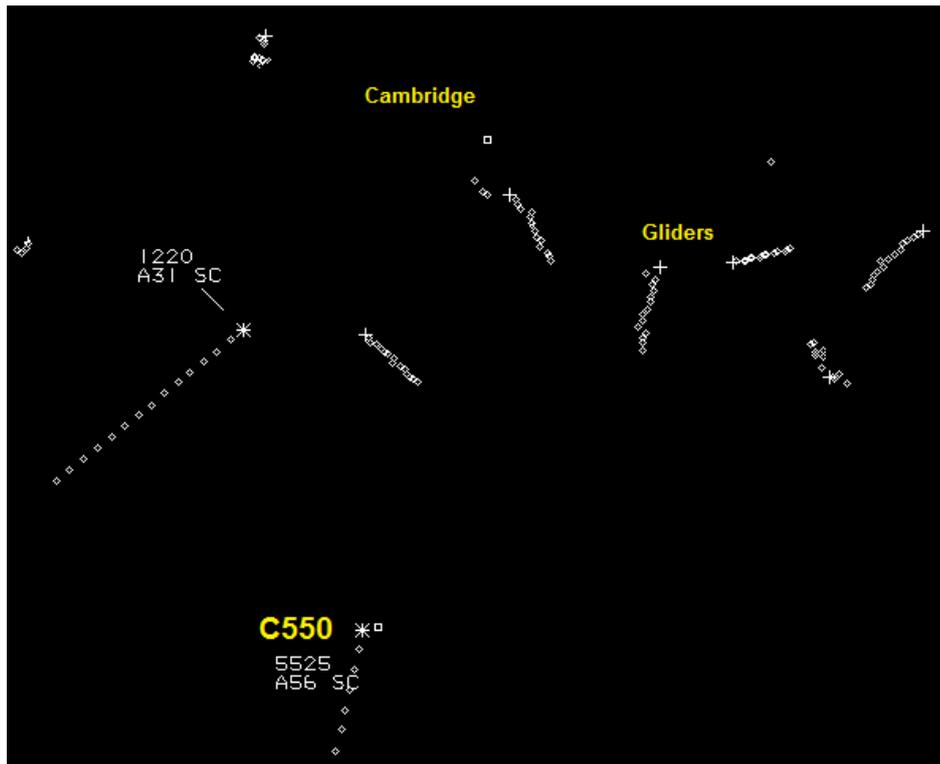
Figure 1: Stansted single source radar at 1347:00

At 1347:00, the Stansted single source radar replay showed the inbound C550, 7.3nm south of Cambridge, passing 5600ft following an ATR 42 at 3100ft. Both aircraft's pilots were inbound IFR in receipt of a Procedural service. Also shown are a number of intermittent glider contacts, see Figure 1.

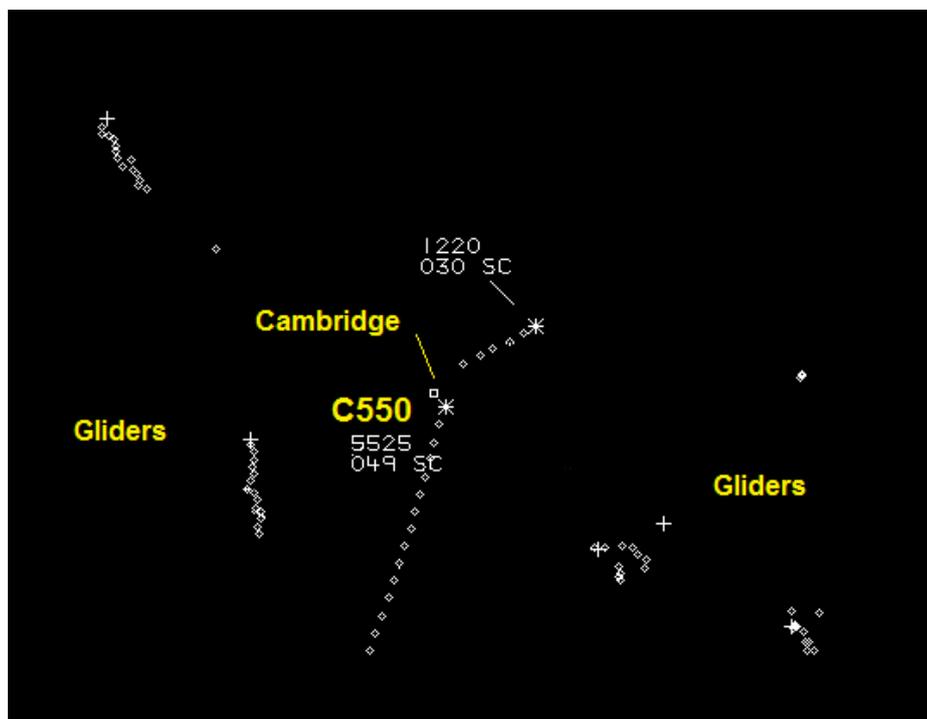
Figure 2: Stansted single source radar at 1348:52

At 1348:52, radar replay showed the C550 overhead the airfield at FL049 (5000ft) with intermittent gliders showing 2.5nm west and 2.7nm southeast. It was likely that other gliders in the area were not shown on the radar replay, see Figure 2.
