AIRPROX REPORT No 2014161**Date/Time:** 16 Aug 2014 1223Z (Saturday)**Position:** 5052N 00045W
(0.8nm N Goodwood)**Airspace:** Goodwood ATZ (**Class:** G)**Aircraft 1** **Aircraft 2****Type:** R44 Piper Cruiser**Operator:** Civ Comm Civ Pte**Alt/FL:** 900ft 1100ft
QFE (1010hPa) QFE (NK)**Conditions:** VMC VMC**Visibility:** >10km >10km**Reported Separation:**

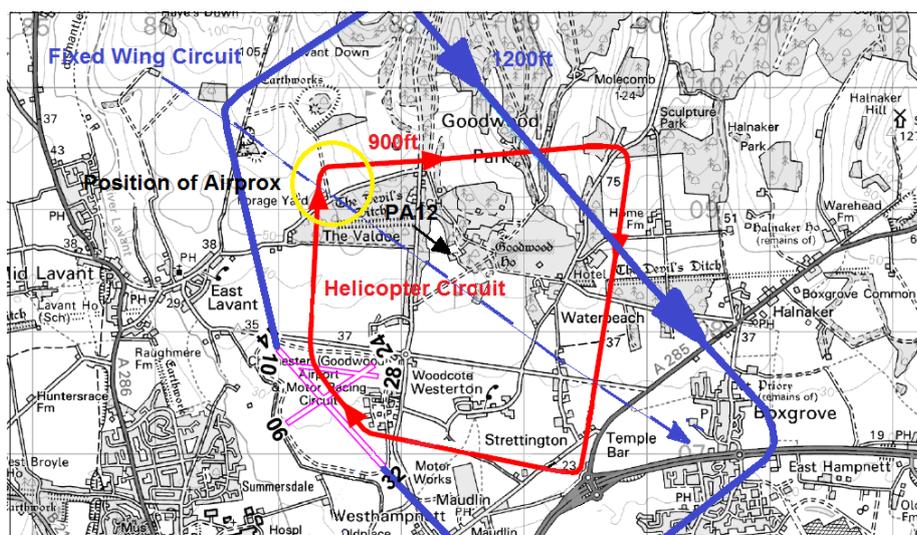
Figure 1 – Extract of circuit patterns with track flown by the PA12.

For illustrative purposes, Figure 1 is an extract showing the circuit patterns. A representation of the track flown by the PA12 is shown.

Turning to the PA12 pilot, the Board noted that he had flown inside the recommended fixed-wing circuit, and was commencing a gentle descent through circuit height when he encountered the R44. There followed a long discussion about whether it was compulsory for pilots to follow recommended circuit procedures and why, because he was flying an older aircraft, the PA12 pilot might fly a tighter circuit than a modern aircraft in case of engine malfunction; it was noted that this would be a common practice for pilots flying vintage aircraft. However, if he was doing so then the Board opined that he had a responsibility to articulate his non-standard positioning to other circuit users so that they could adjust accordingly. The Board considered that in the absence of any such information, the R44 pilot could have reasonably expected other aircraft to fly the standard circuit track.

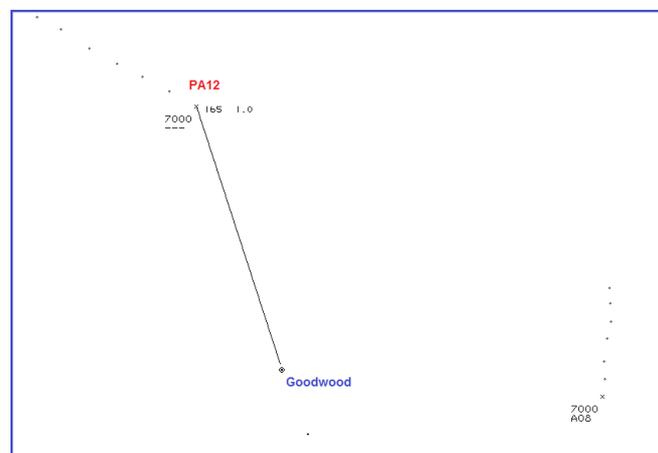
Figure 2 – Swanwick MRT at 1223:10

At 1223:10, the area radar replay showed the PA12 1nm north-northwest of Goodwood, tracking southeast but without Mode C. The PA12 then faded from radar. The PA12 pilot's written report specified a height of 1100ft (QFE) at the time of the Airprox – Figure 2.

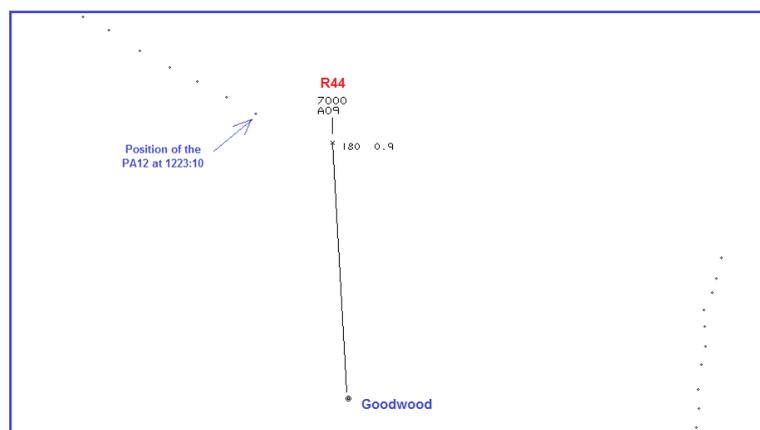
Figure 3 – Swanwick MRT at 1223:26

Neither aircraft was shown on radar for the next four sweeps until at 1223:26 the R44 appears 0.9nm north of Goodwood tracking northeast and indicating an altitude of 900ft (800ft height).

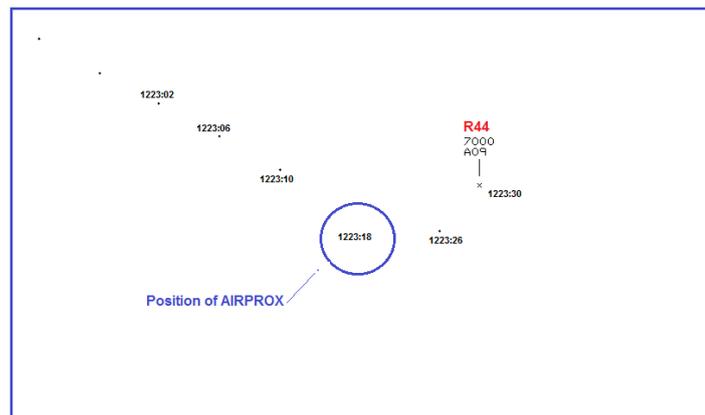
Figure 4 – Swanwick MRT at 1223:30

At 1223:30, the R44 is shown tracking northeast. The CPA was estimated to have occurred at 1223:18 at the position shown in figure 4.
