AIRPROX REPORT No 2014169**Date/Time:** 10 Sep 2014 1127Z**Position:** 5153N 00209W
(Gloucester Airport Visual Circuit)**Airspace:** Gloucester ATZ (**Class:** G)**Aircraft 1** **Aircraft 2****Type:** AS355 Helicopter Robin DR400**Operator:** Civ Comm Civ Club**Alt/FL:** 650ft 1000ft
QNH (1021hPa) QNH (1021hPa)**Conditions:** VMC VMC**Visibility:** 10km Good Visibility**Reported Separation:**

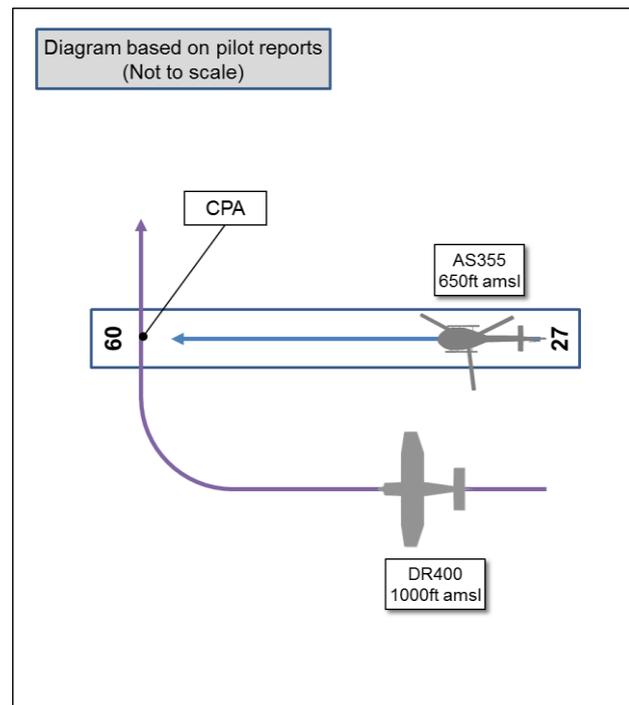
50ft V/25m H 60ft V/NK H

Recorded Separation: NK V/NK H
